## **Geotechnical Evaluation of the Brownsville Levee Cracking and Partial Slope Failure**

Lucas A. Walshire, Joseph B. Dunbar, Isaac J. Stephens,  
Maureen K. Corcoran, Carla Roig-Silva, and Julie R. Kelley

July 2015

Final report

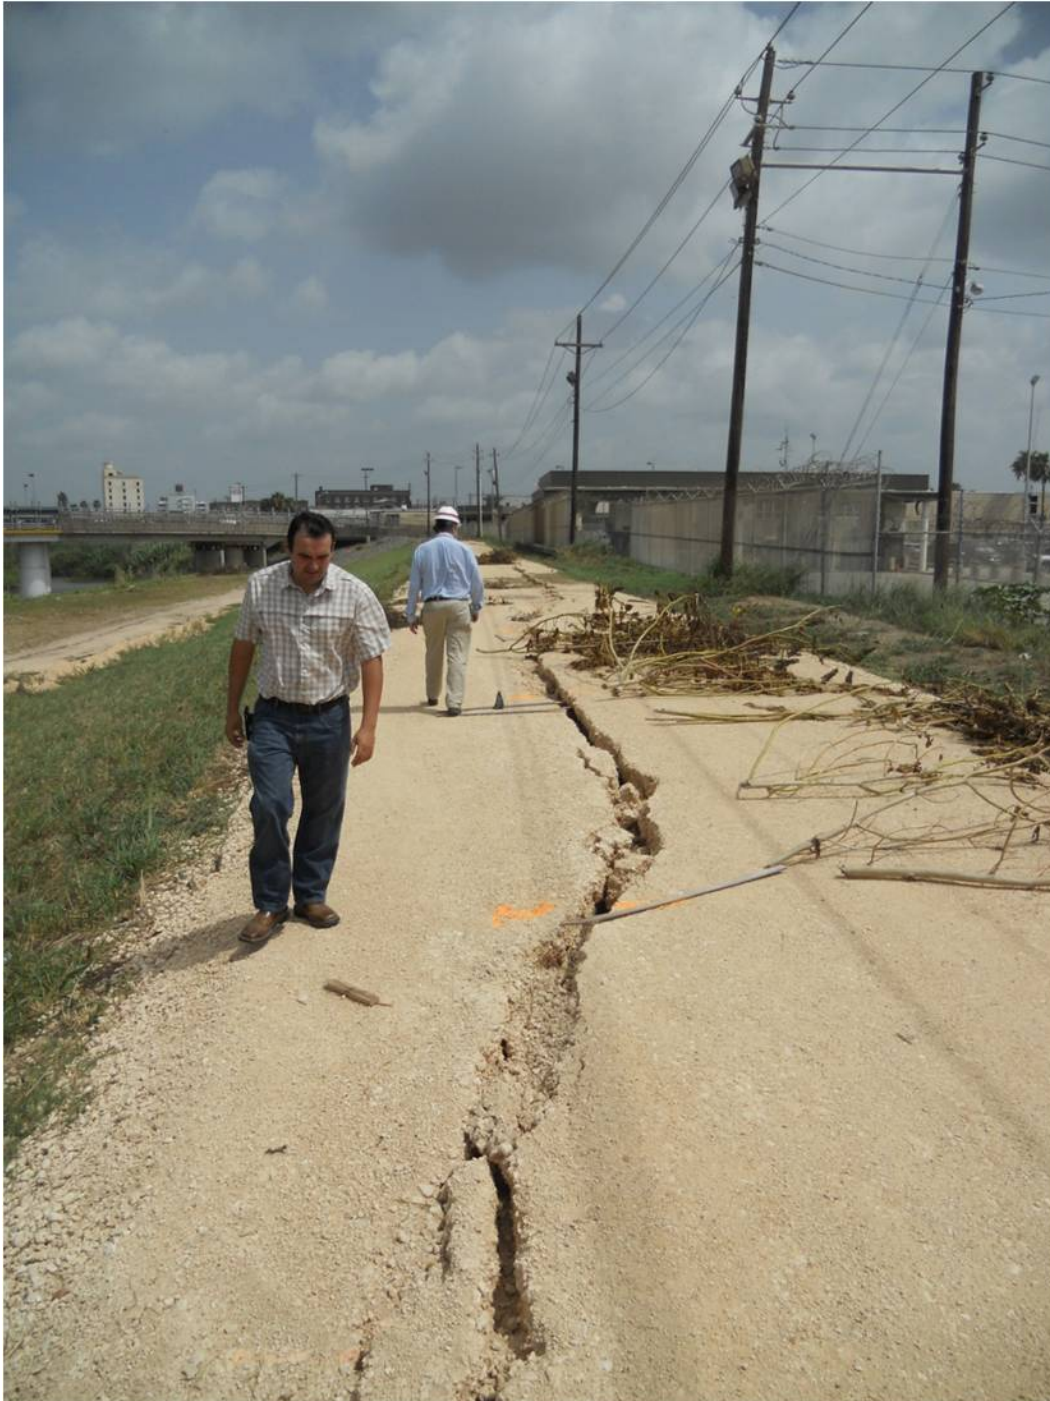
Figure 1.4. Close-up view of levee cracking and settlement at the crest. View is looking upstream. Gateway Bridge is in the background and corresponds to the upper limits of the study area.

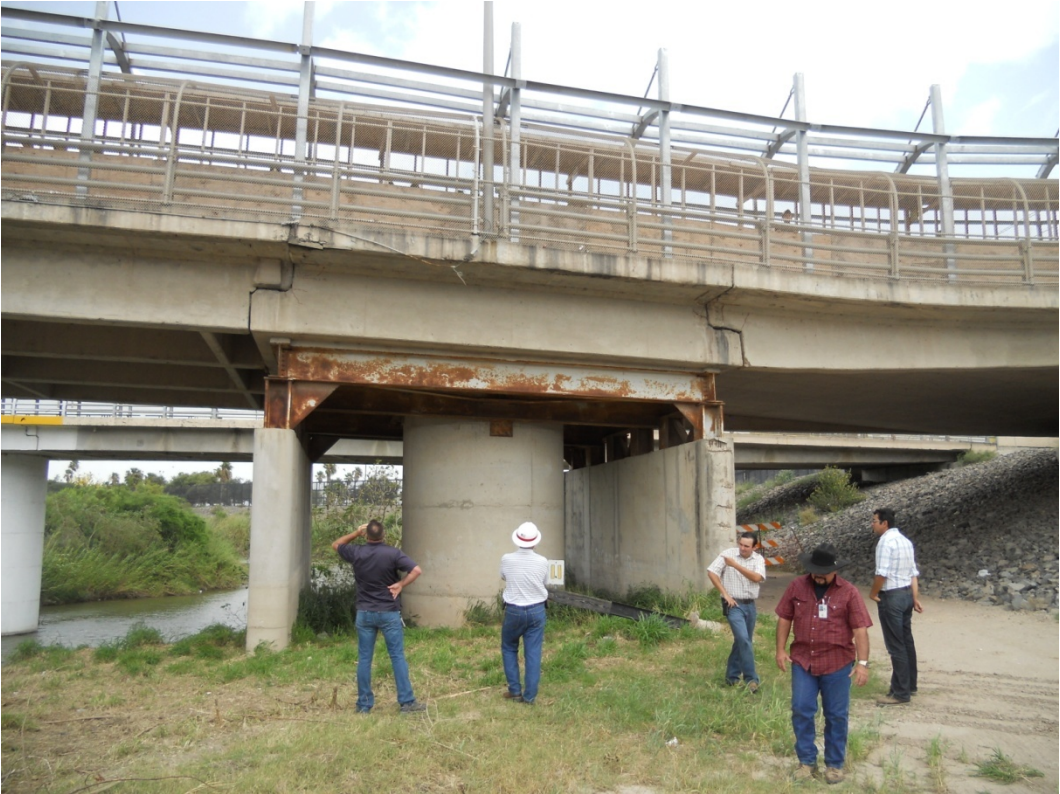
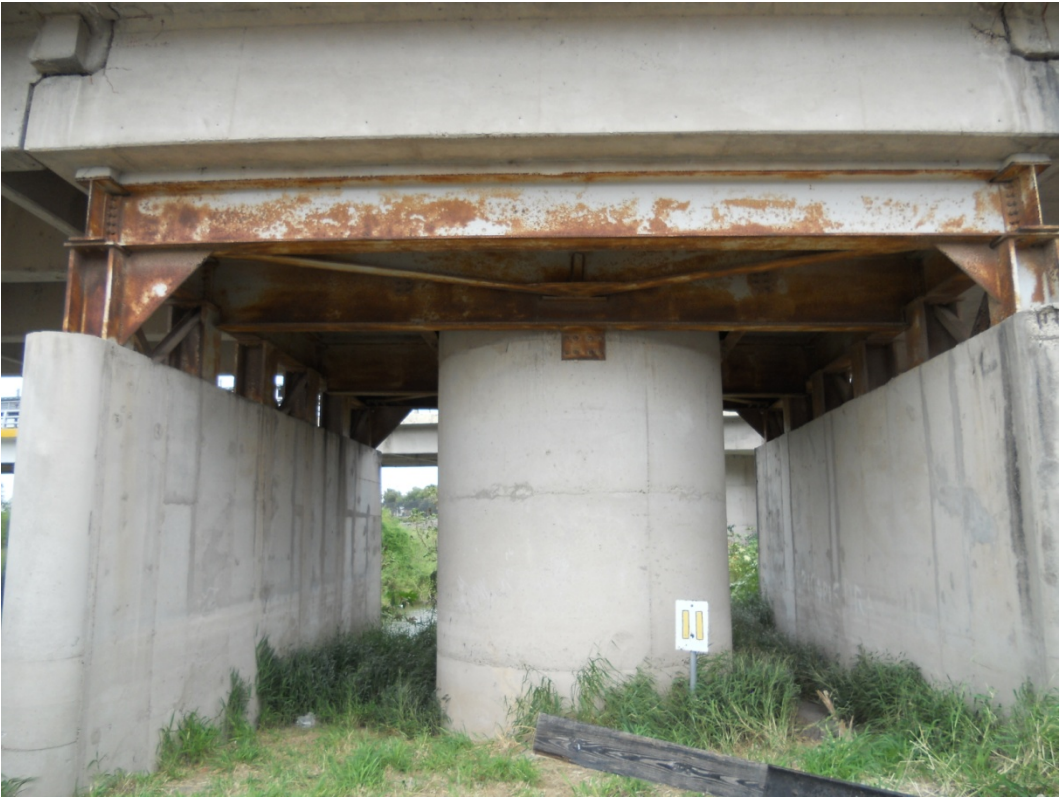
Figure 2.4. Support frame to remediate settlement of the International Gateway Bridge pier in 1984.

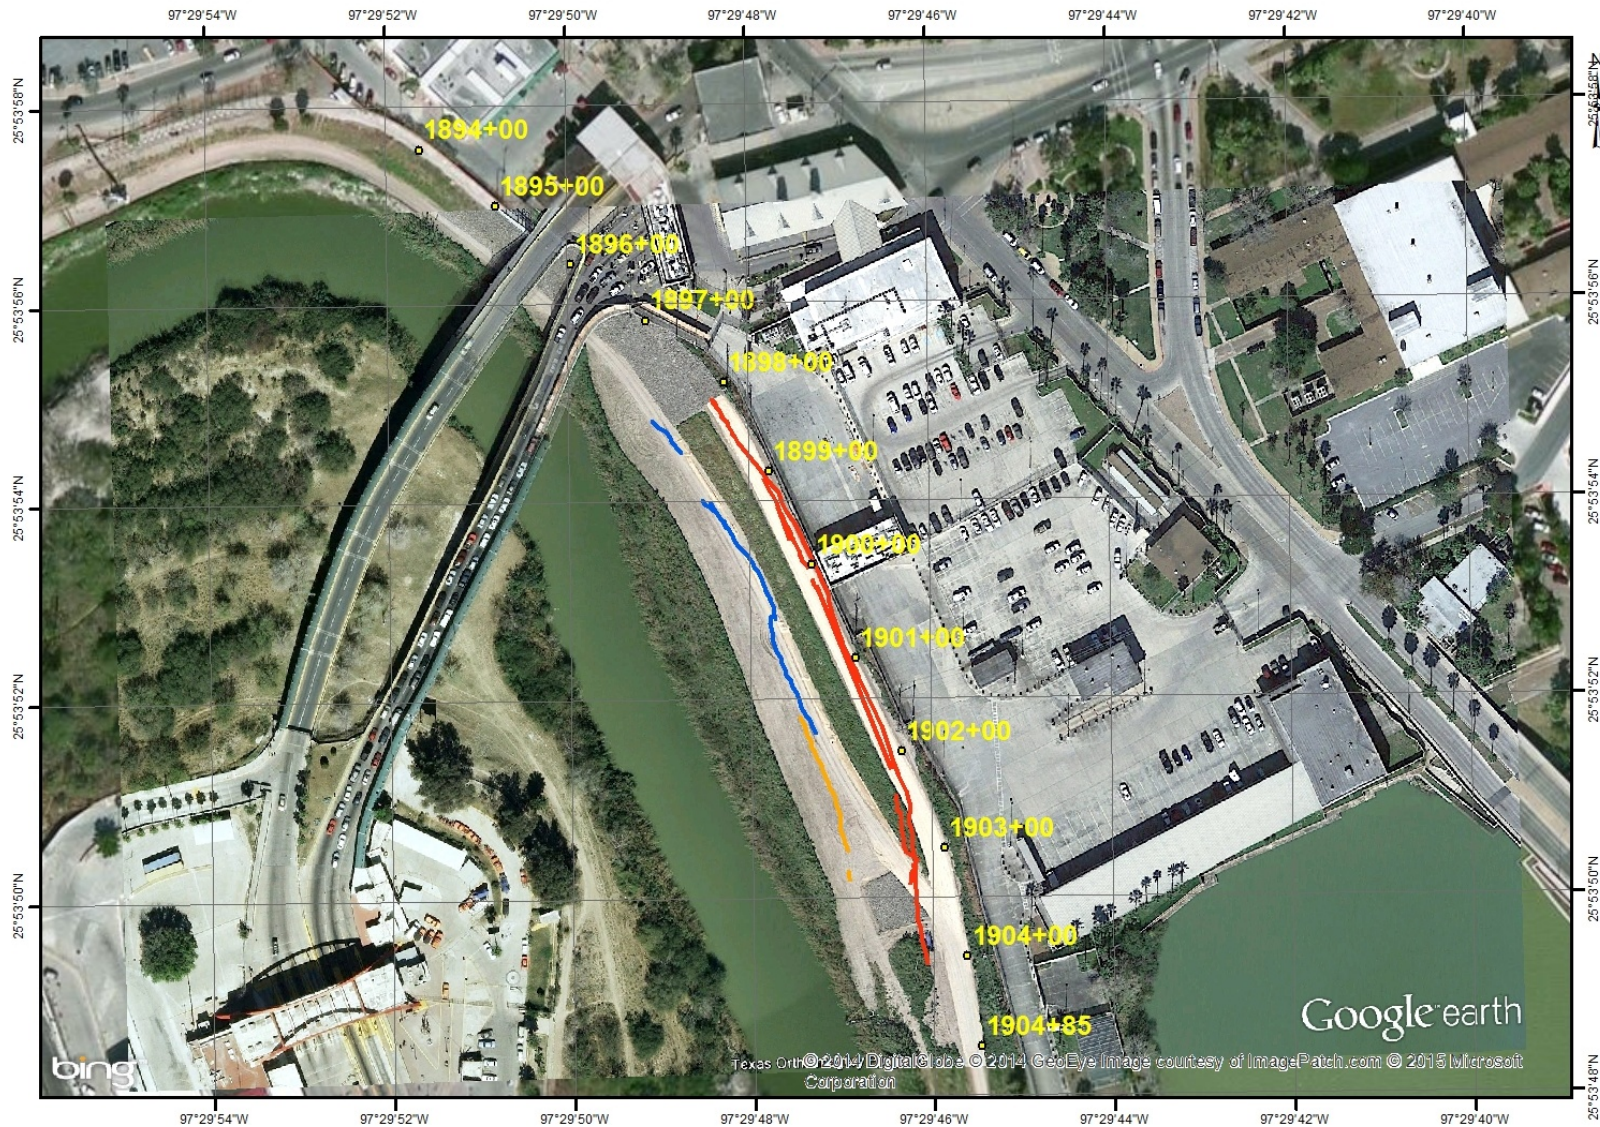
Figure 4.1. Location of major crack sets in the study reach denoted by color and levee stationing in yellow (merged Bing and Google images).

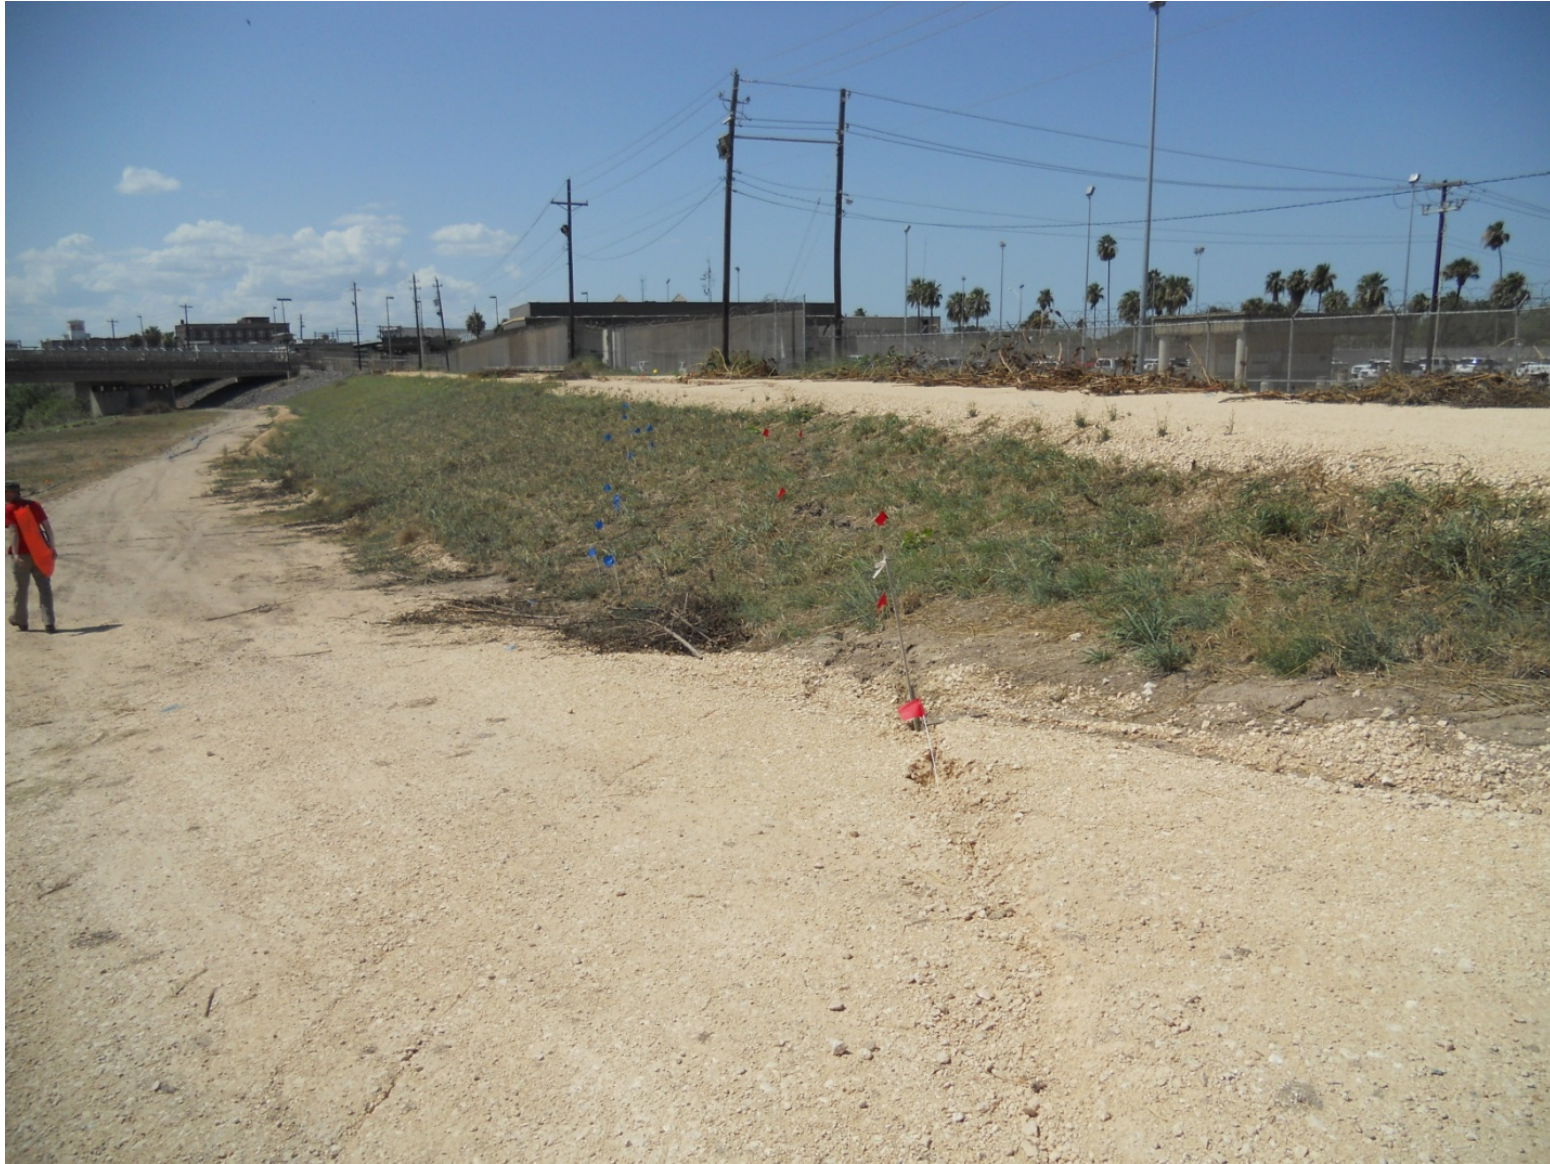
Figure 4.2. Two prominent cracks through the levee embankment at downstream end of study area that merge with cracks at the levee crest (see also Figures 1.2 to 1.4).

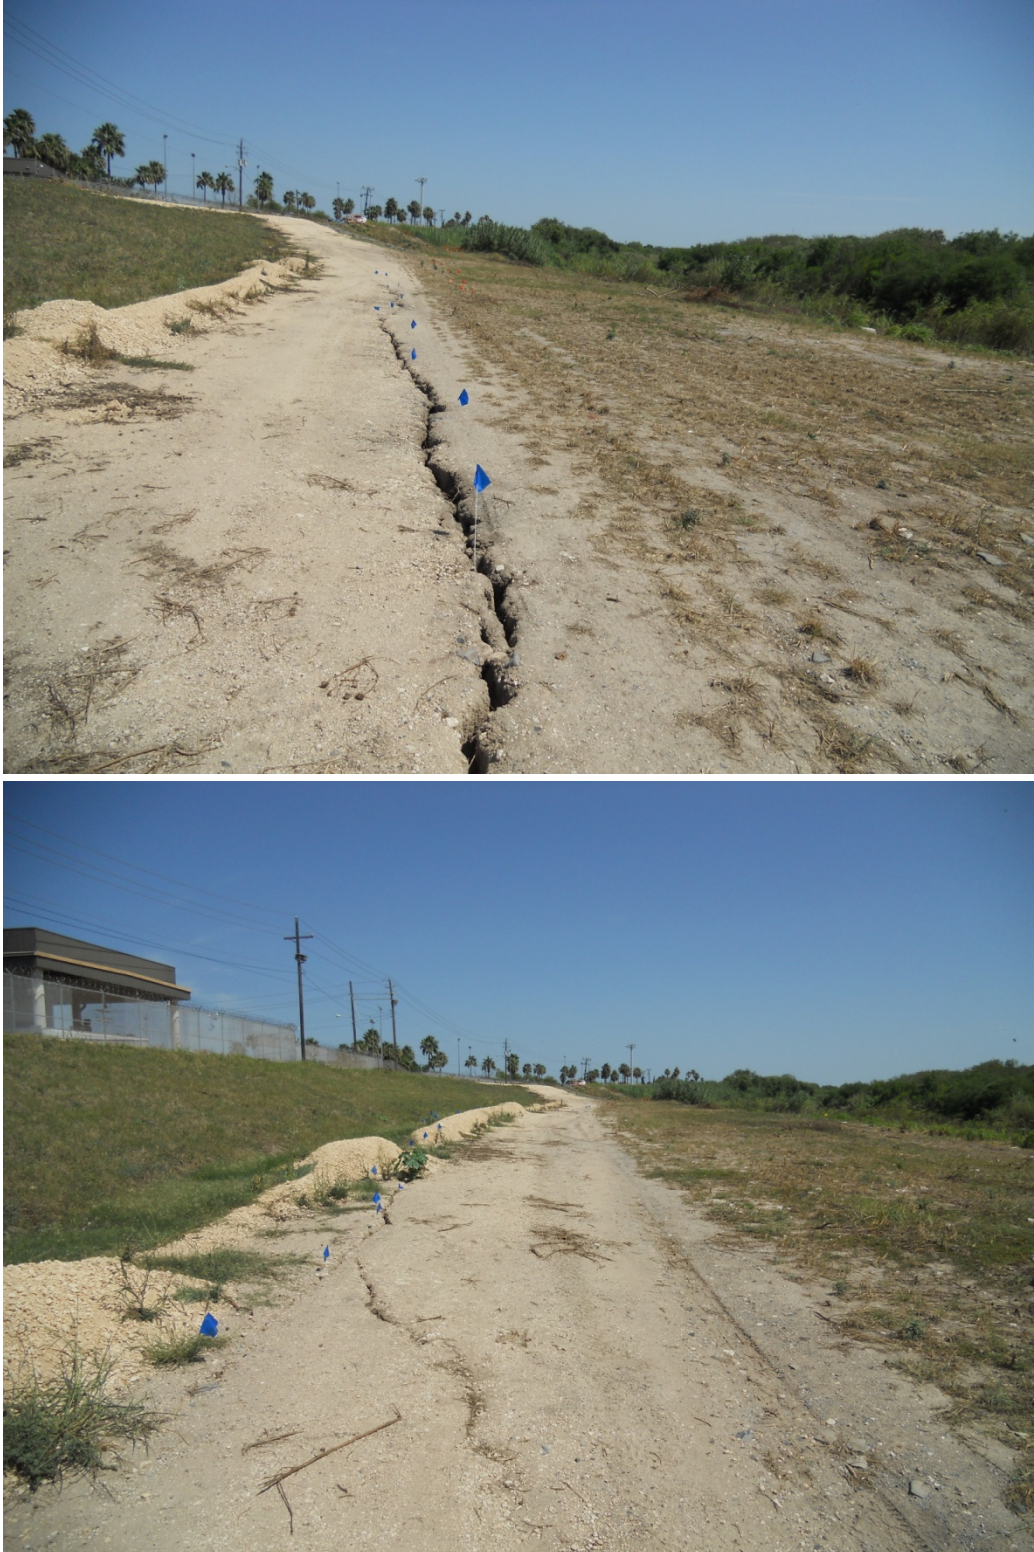
Figure 4.3. View of crack set at levee toe looking downstream. Crack extends through the gravel ridge in middle part of the lower photo and to the levee access road in top photo (see Figure 4.1 for location of crack).

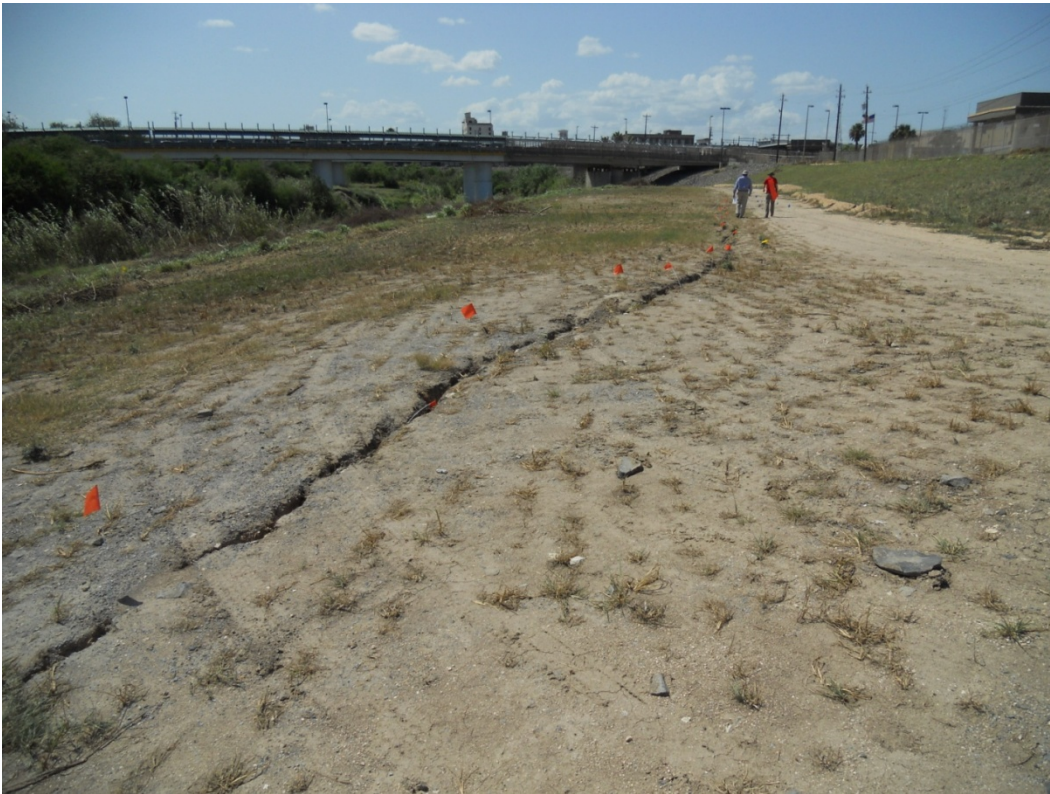
Figure 4.4. Longitudinal crack along the downstream end of the riverbank (see Figure 4.1 for location).

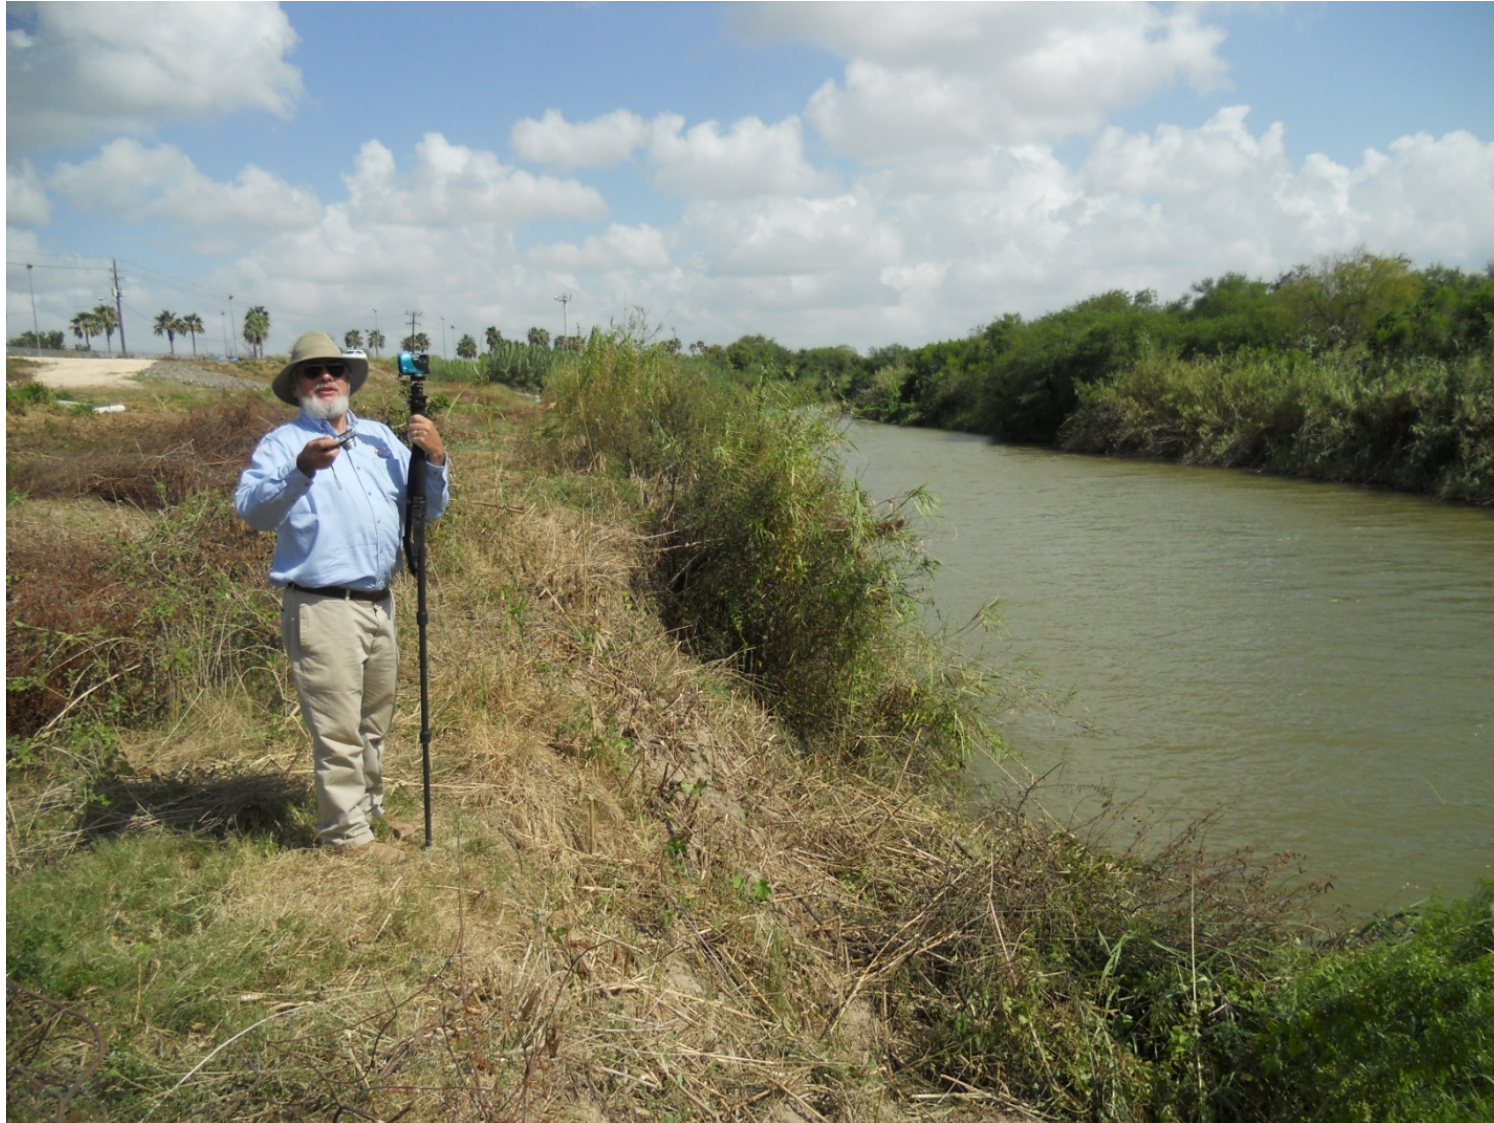
**Figure 4.17. Active bank slumping occurring along riverbank adjacent to person in photograph. Photograph is in the middle of the study reach. Photograph was taken in Jul 2014 after the brush was cleared from the bank to permit close inspection.**

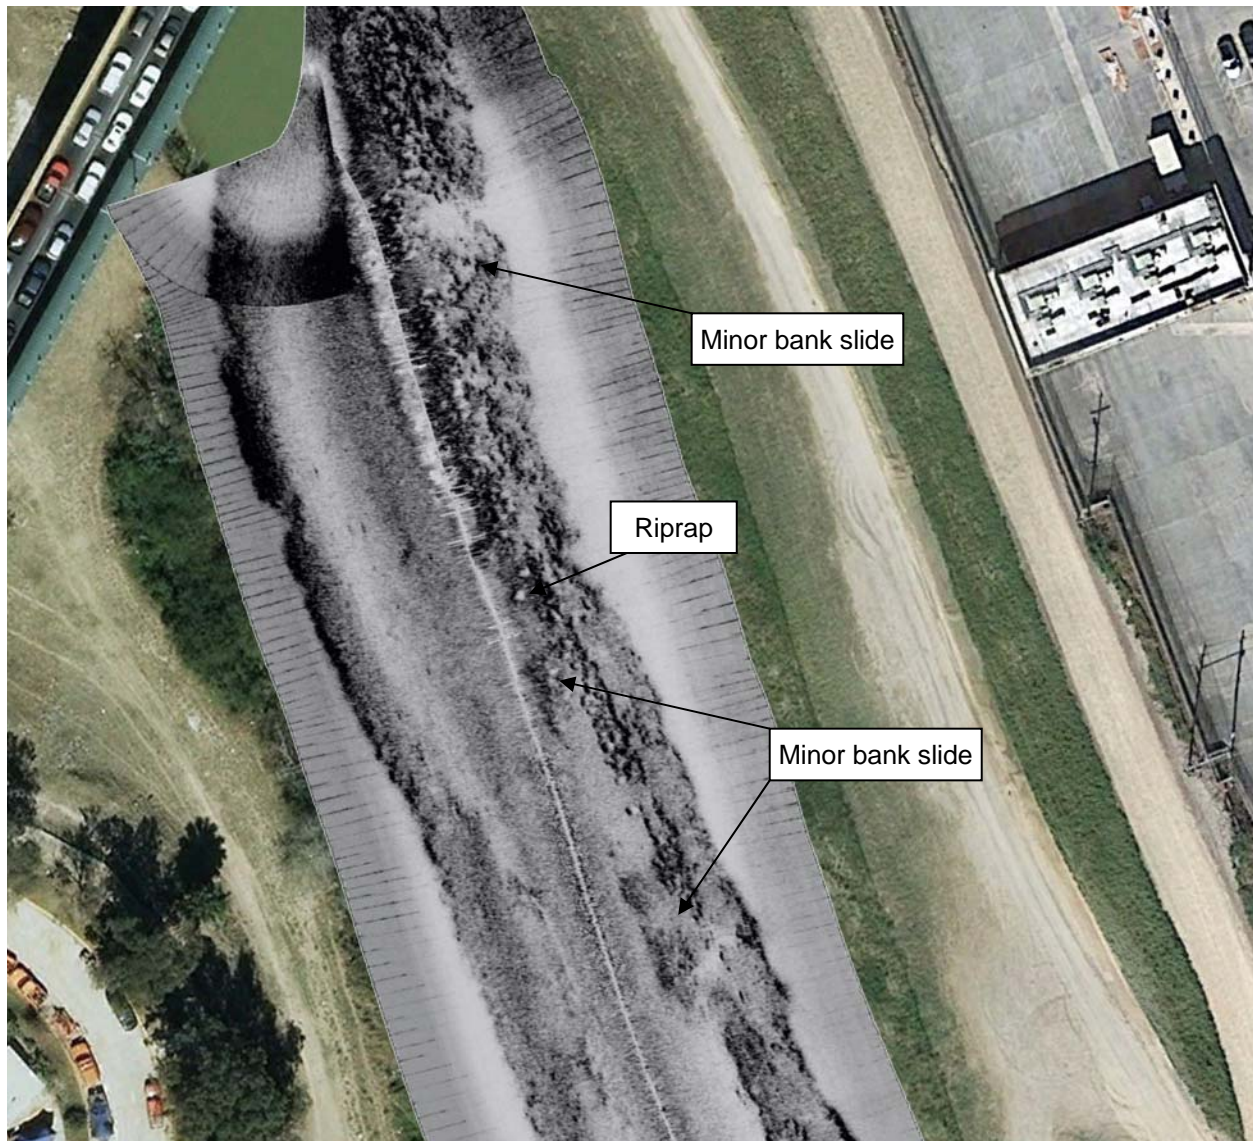
Figure 4.19. Close-up view of the side scan sonar data overlain on 2014 Google image. Note the presence of rip-rap and small bank slumps/slides on U.S side. White line corresponds to center of boat track moving toward the bridge.

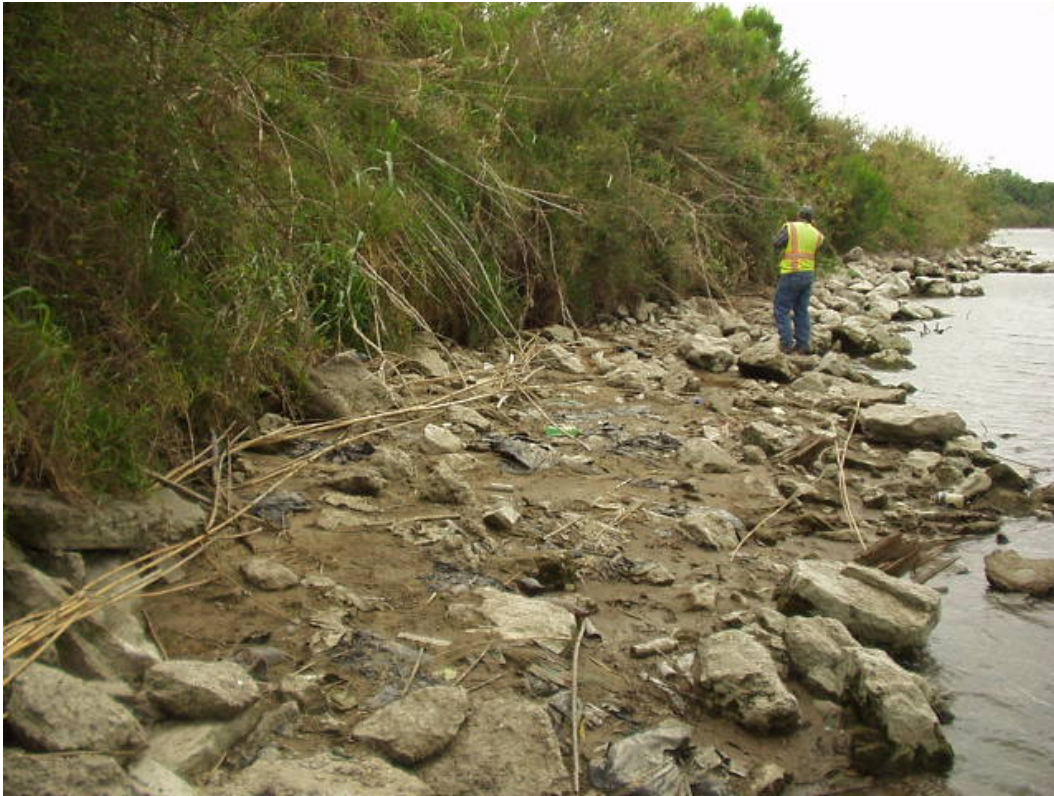
Figure 4.20. View of the exposed riverbank and channel bottom during the low water event on 12 Apr 2014 (photograph courtesy of Ramon Navarro, Engineering Services Division, USIBWC).

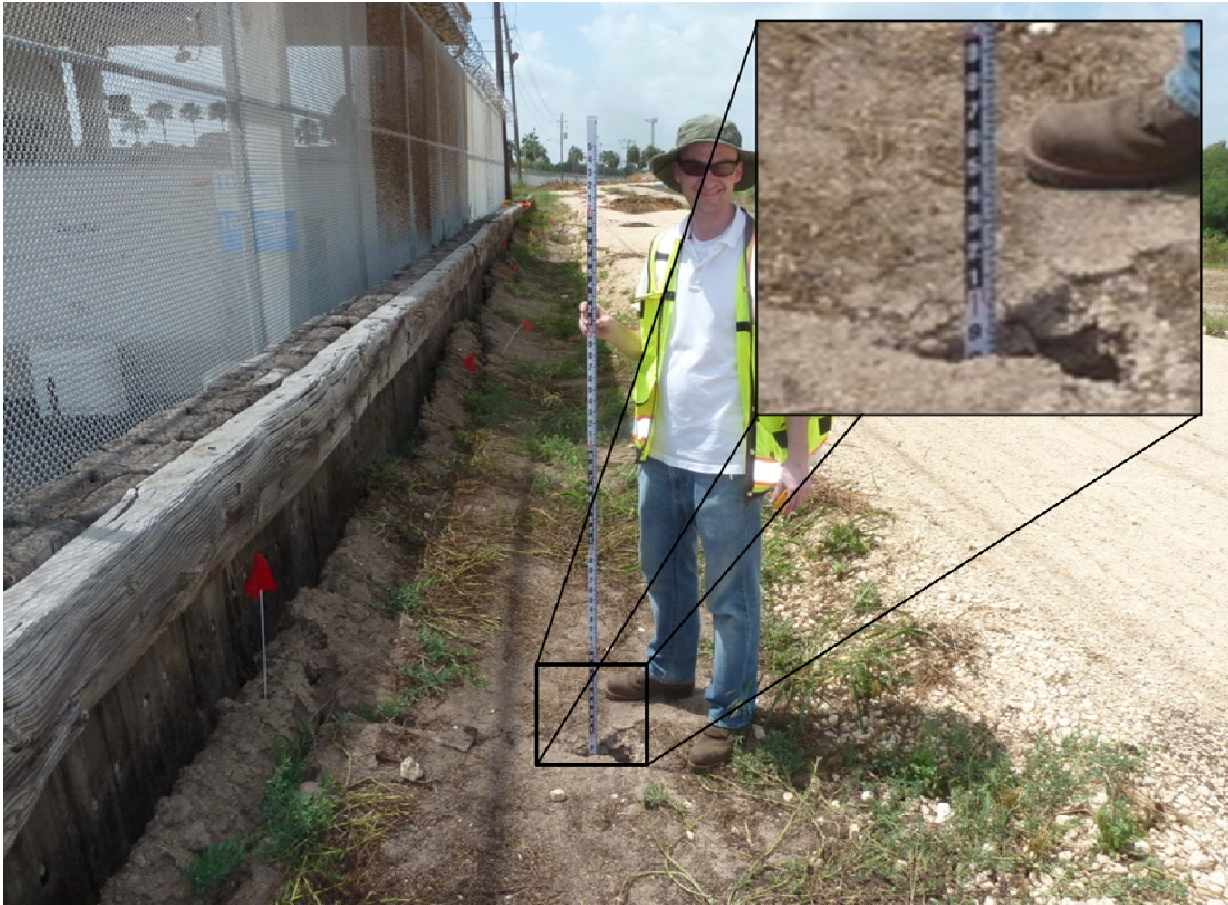
Figure 6.20. Depth of levee cracking, July 2014.
