International Boundary and Water Commission  
United States and Mexico

Report of Transboundary Bypass Flows into the Tijuana  
River

Minute 320 Binational Technical Team

Final Report

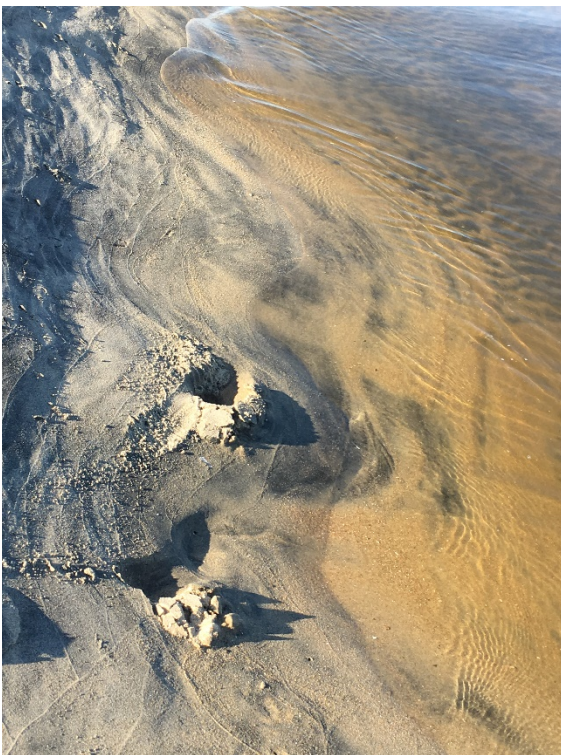
*Figure 3 Tijuana River at confluence with Pacific Ocean, dark material present -March 8, 2017*

There was the presence of black organic material in the sands. USIBWC interviewed personnel at the Tijuana River National Estuarine Research Reserve and at Border Field State Park, located near the river's mouth. Those personnel noted that the odor of wastewater is consistent when there are flows in

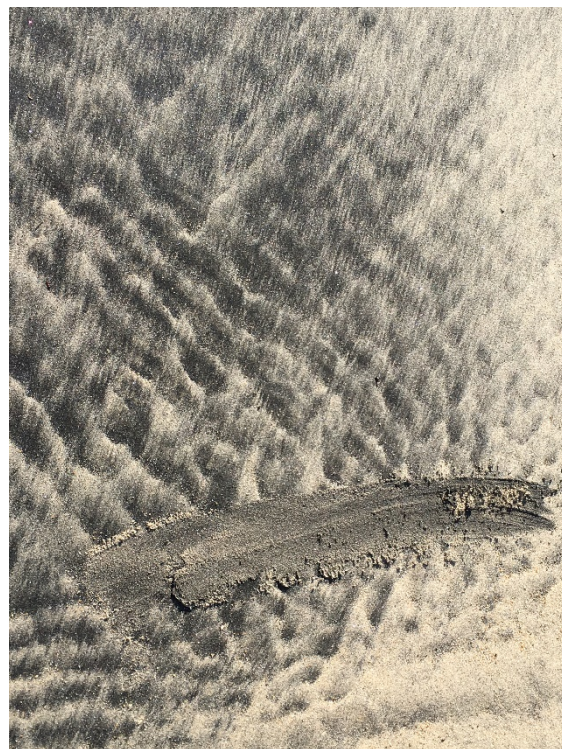
*Figure 4 Close up of sand material – March 8, 2017*

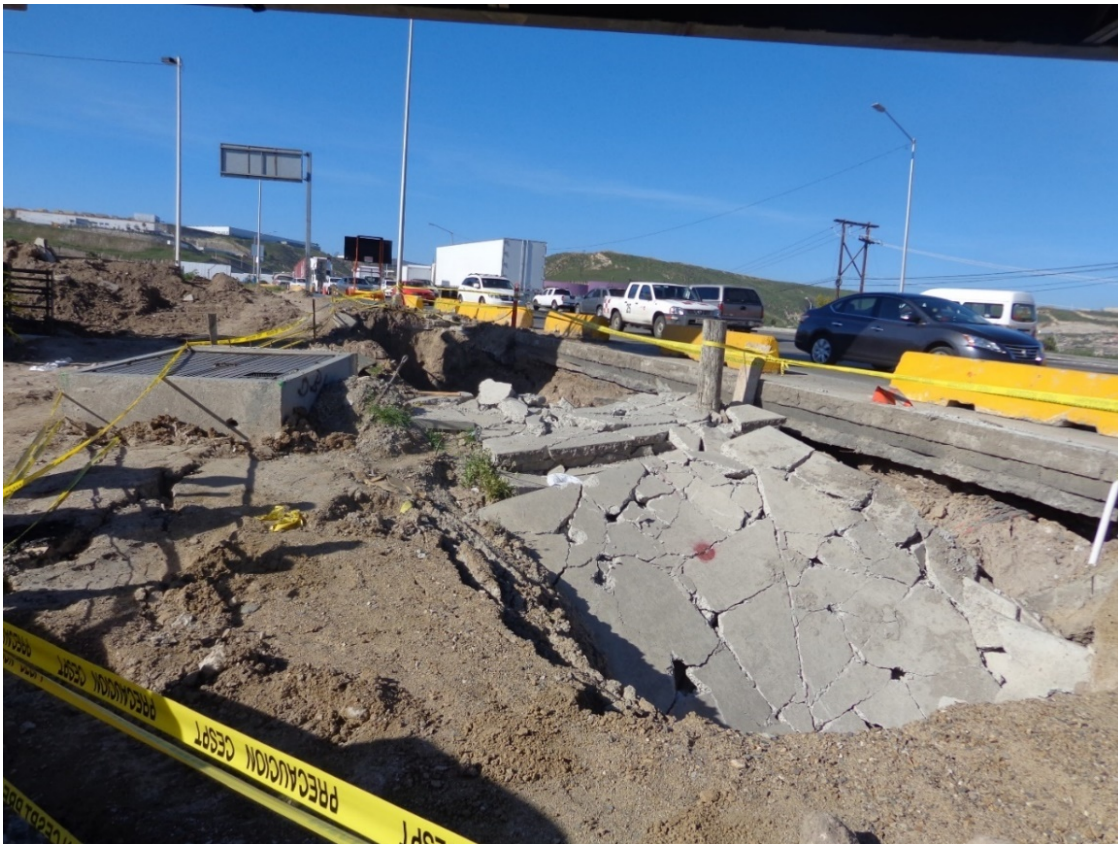
Many of the meeting participants went to the site of where the sinkhole had formed due to the collector break. The site was covered and the bus stop that had fallen in to the sinkhole had been replaced. CESPT showed everyone where the break had occurred and where the bypass had sent water to the *Poniente* collector which runs along the north side of the Rio Alamar. CESPT noted that at that location there is a 40-inch line and a 42-inch line connecting to the junction box that sends the combined flow down a 60-inch line. The area downstream of the junction box has also collapsed and this 60-inch line will need to be repaired in the upcoming dry season. Below is a photo of that area.

*Figure 10 Additional damage along roadway due to collector collapse downstream of junction box- Blvd Lazaro Cardenas, Colonia Los Pirules, Tijuana, B.C. - March 9, 2017*

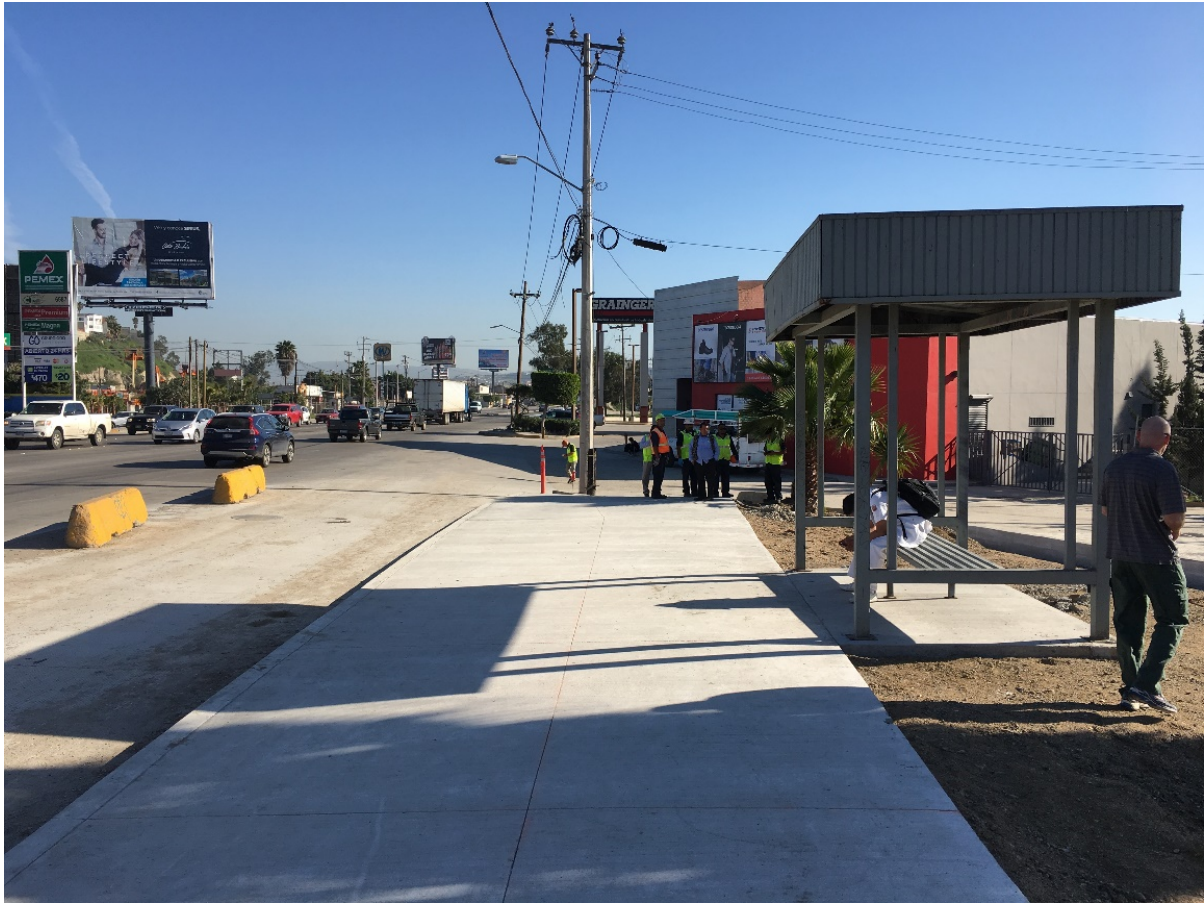
*Figure 11 Final repairs to road and bus stop and location of Insurgentes/Oriente collector repair- - Blvd Lazaro Cardenas, Colonia Los Pirules, Tijuana, B.C. - March 9, 2017*

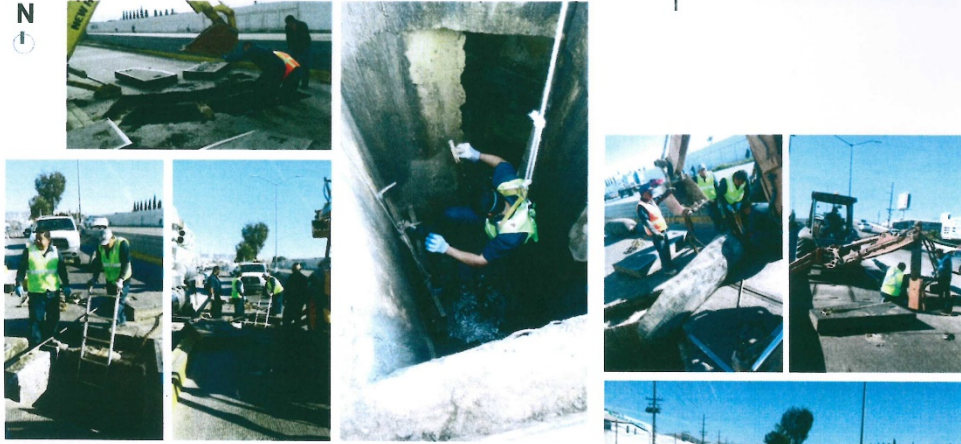
**DESVIOS AL COLECTOR PONIENTE**

EL DIA 02 DE ENERO DEL 2017, SE TRABAJO EN LA INSTALACION DE UN TAPON INFLABLE DE 24"-48" DE DIAMETRO EN LA CAJA DERIVADORA DEL COLECTOR PONIENTE UBICADA SOBRE EL BOULEVARD FEDERICO BENITEZ ESQUINA CON EL BOULEVARD LAZARO CARDENAS, DE LA COL. LA MESA, EL CUAL SE REALIZO CON EL OBJETO DE ELIMINAR EL 100% DE LAS APORTACIONES CONDUCCIDAS A TRAVES DEL COLECTOR PONIENTE HACIA EL COLECTOR ORIENTE. LO ANTERIOR COMO MEDIDA PREVENTIVA Y PARA EVITAR DERRAMES DE AGUAS NEGRAS HACIA LA CANALIZACION DEL RIO TIJUANA, ORIGINADAS POR EL APARENTE COLAPSO DE UN TRAMO DEL COLECTOR ORIENTE DE 60 PULGADAS DE DIAMETRO.
