**USIBWC Habitat Restoration Sites and Groundwater Monitoring Wells**

**MONITORING NOTES AND PHOTOGRAPHS**

**SUMMER 2023**

**U.S. Section International Boundary and Water Commission**

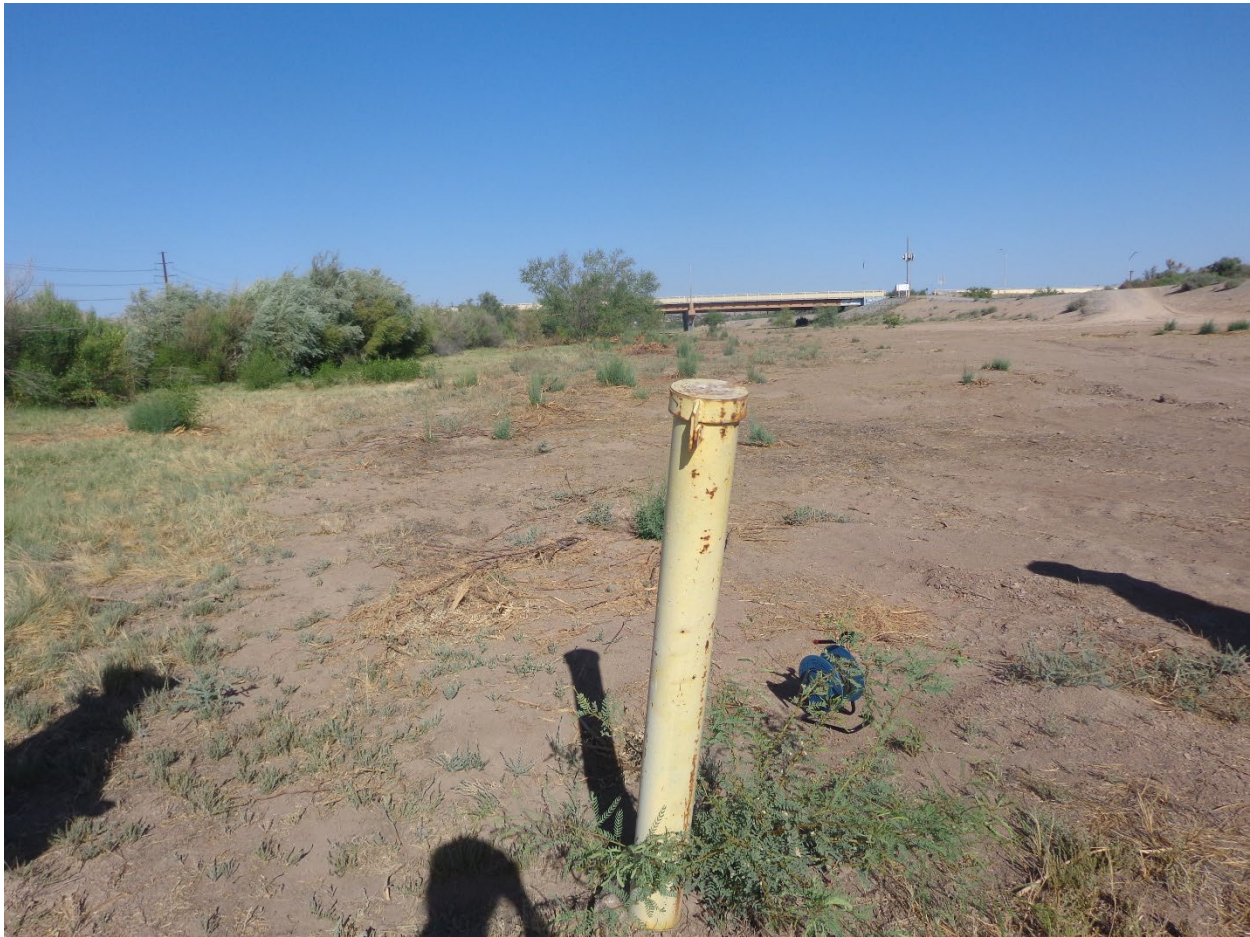
Mark, Sebastian and Jennifer visited the Anapra Restoration Site on July 7, 2023 to collect well water level readings. Around 9:15 am, we located well AB-MW-1 downstream of Sunland Park Drive. The yellow steel casing stuck up about 3-4ft out of the ground, but it was not upright. It seemed that something had knocked it over slightly, and because of this the well was obstructed and we were unable to obtain a water level reading; the probe hit a sediment patch near the ground surface with no audible water or readings. Getting to the first well was easy, but the second well had more vegetation. In both areas, vegetation was along river and seems to be doing fine. Some mulching visible in the area.

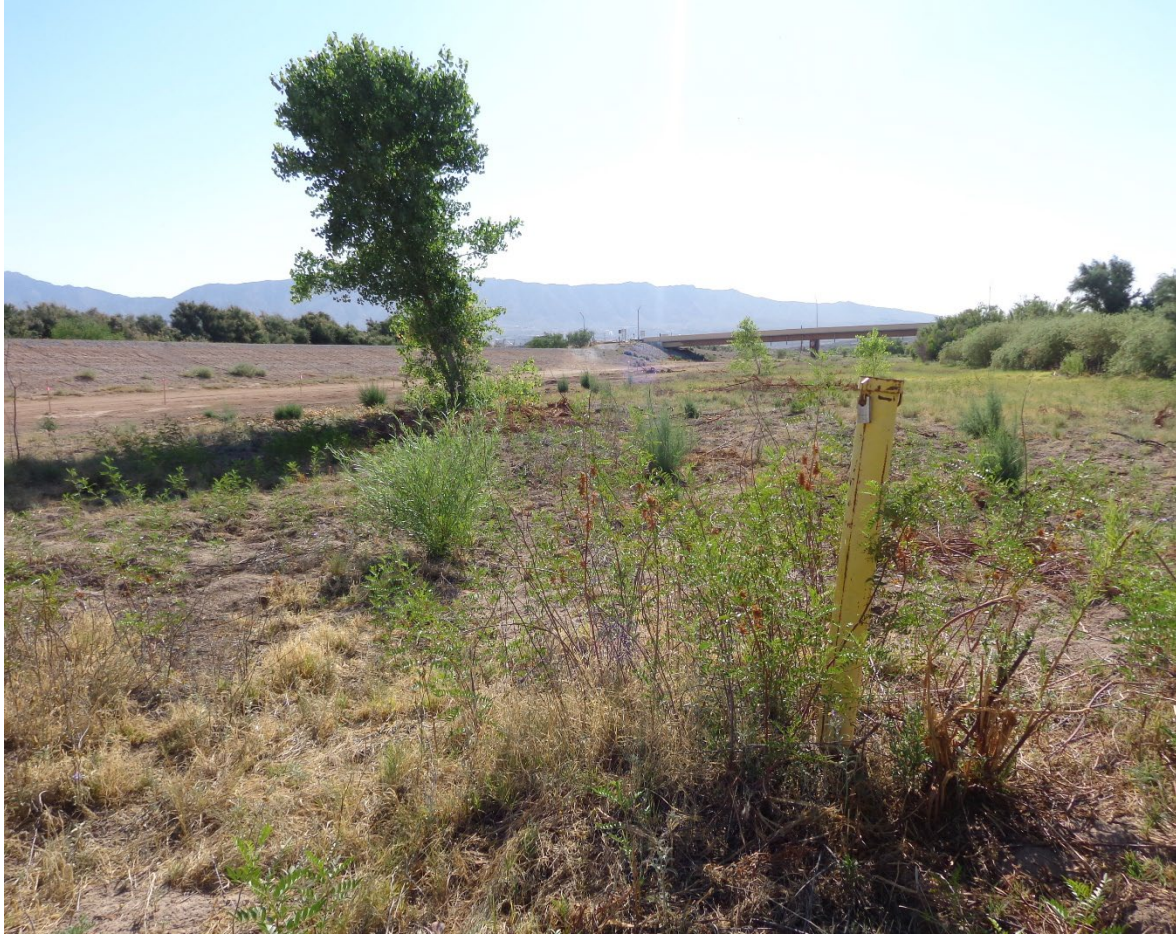
The second well, AB-MW-2, also had structural damage and had no water level reading; willows and brush surround the dry well. Not much vegetation in the area aside from the riverbank having a 100% coverage of Coyote Willows. There are sporadic young tree plantings that are surviving.

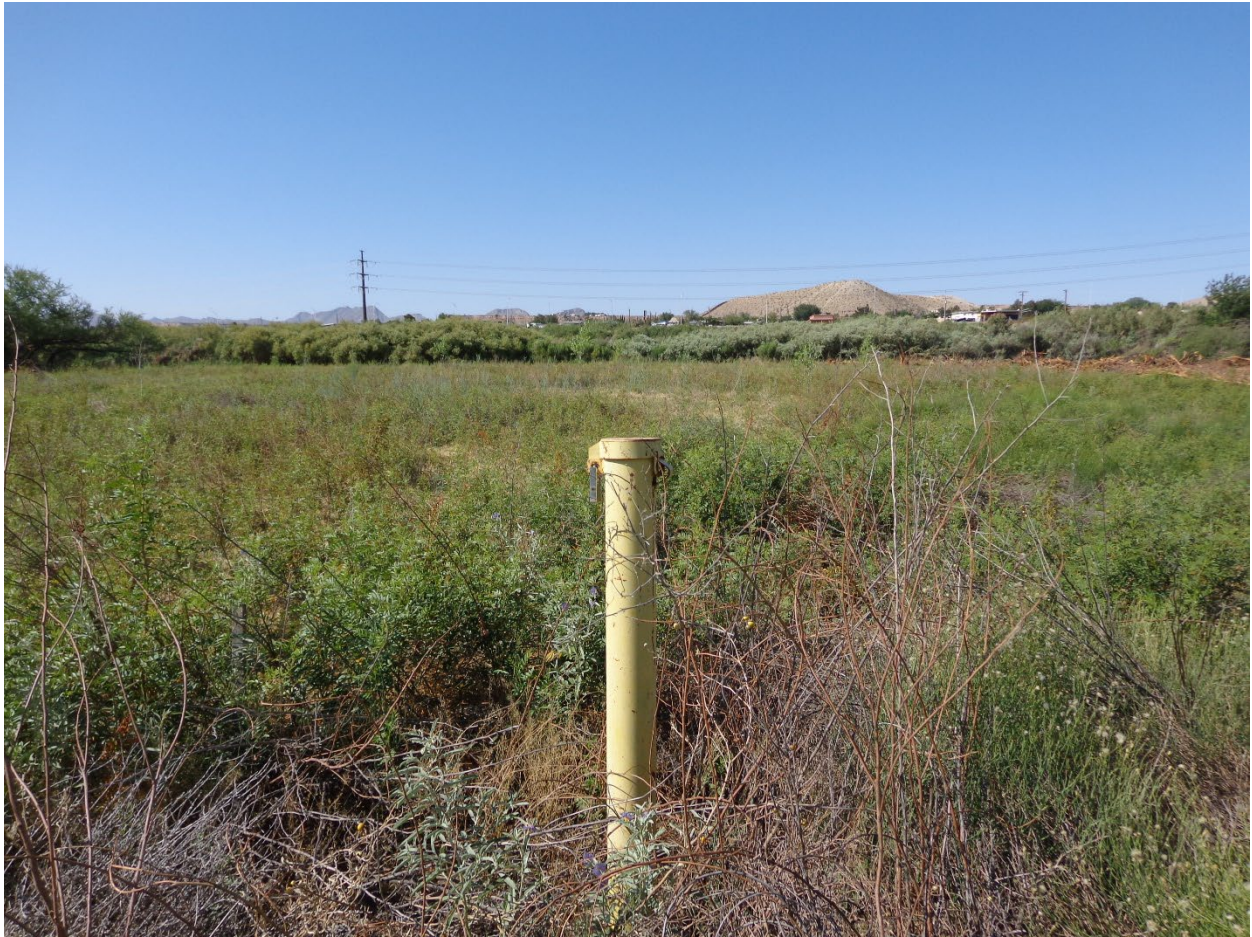
We visited the Sunland Park Restoration Site on July 7, 2023, starting at the southernmost part of the area near SP-MW-3, which had a lot of native brush around it. We started will monitoring well 3 and moved up to 1. These wells did give us readings and we took these readings from 9:32-10:05. There was significant amount of vegetation surrounding the sites but nothing to note aside from that, almost overgrown. Lots of green grass, no trees in sight.

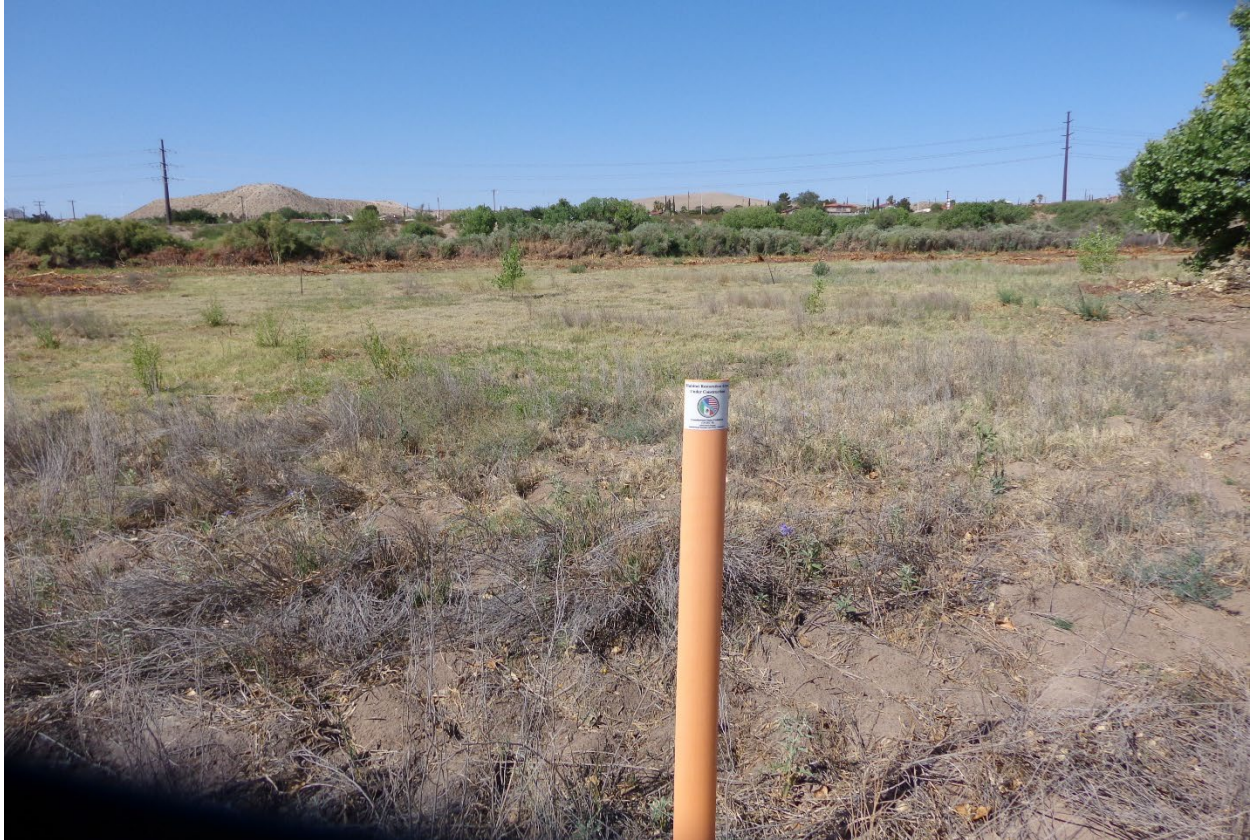
The restoration site tells a very different story, however. This has very few cottonwoods and there is a massive wood pile in the distance. We did not observe any wildlife species in the area.

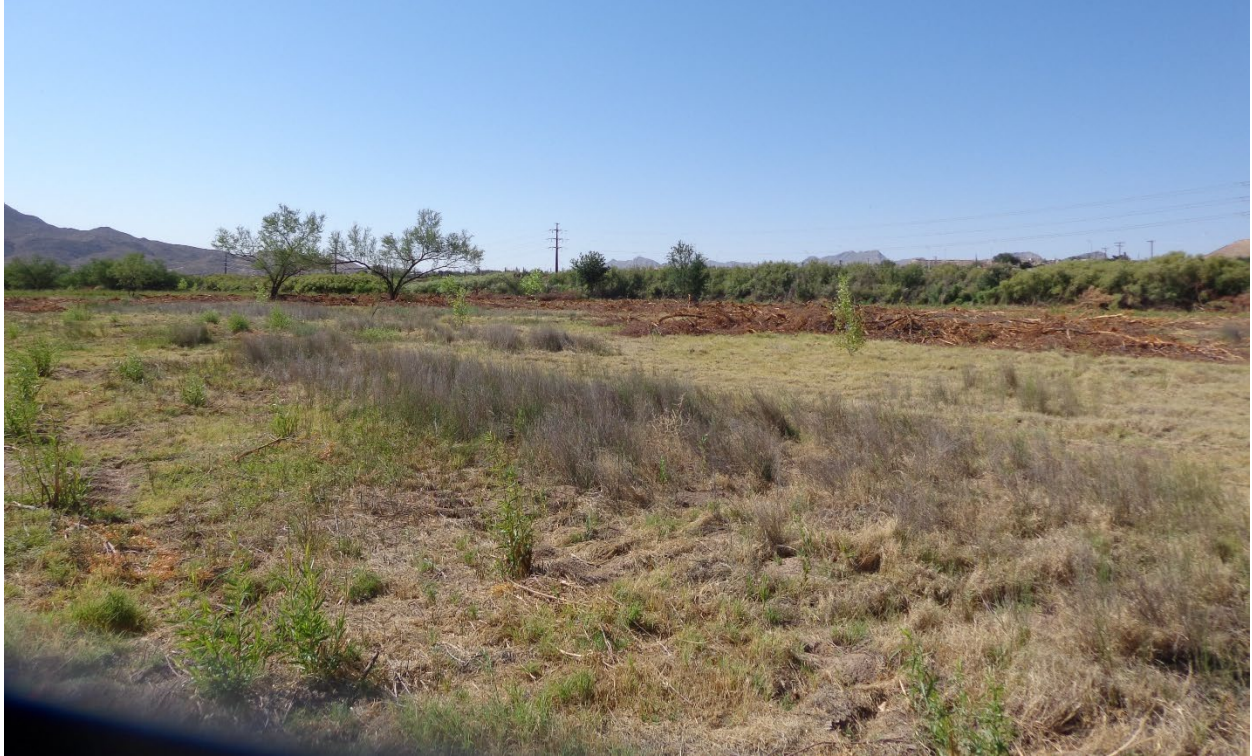
The wood pile seems to never stop as we went along the restoration site. Survival rate of cotton woods is low.

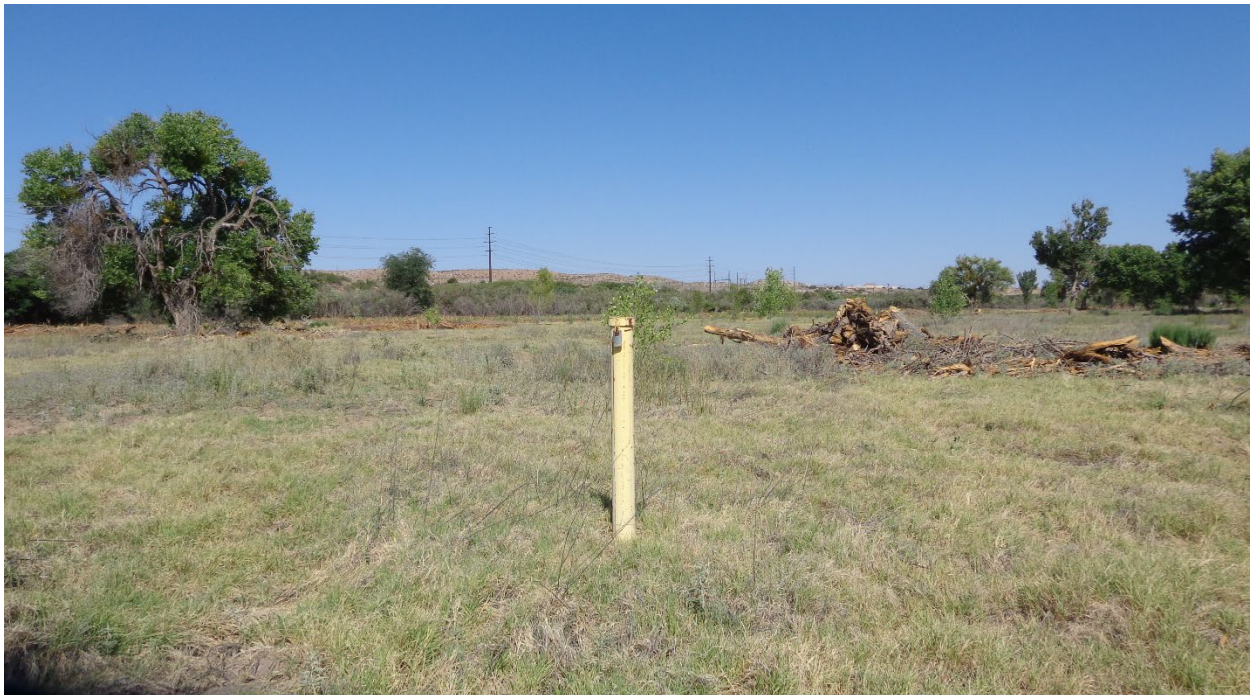
View from well SP-MW-2, tree on the left and wood and bark debris on the right. Some of these trees seem to be dying and a cause of this could mistletoe or some sort of fungal infection.

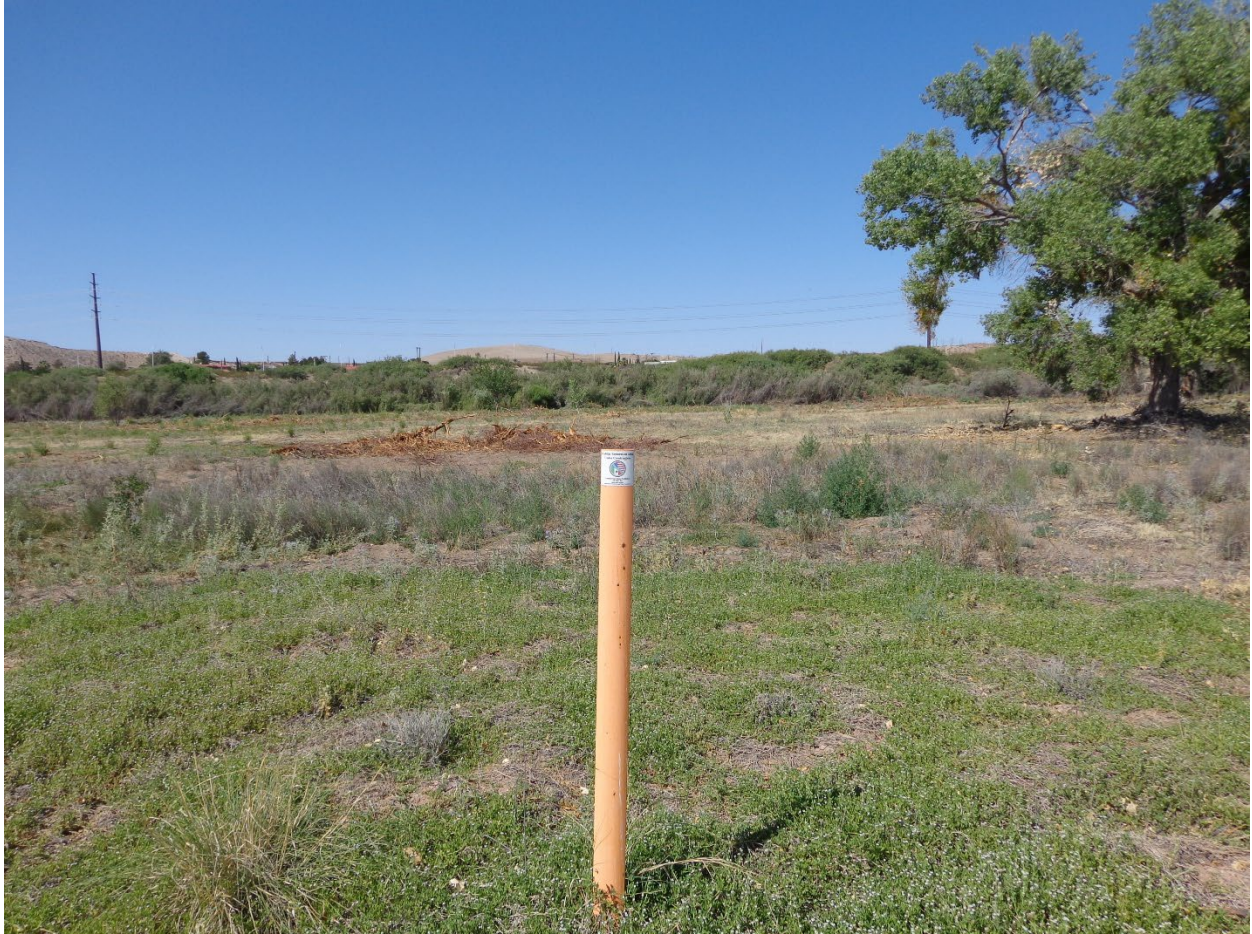
Another wood pile (background) next to a big cottonwood tree on the right of the image.

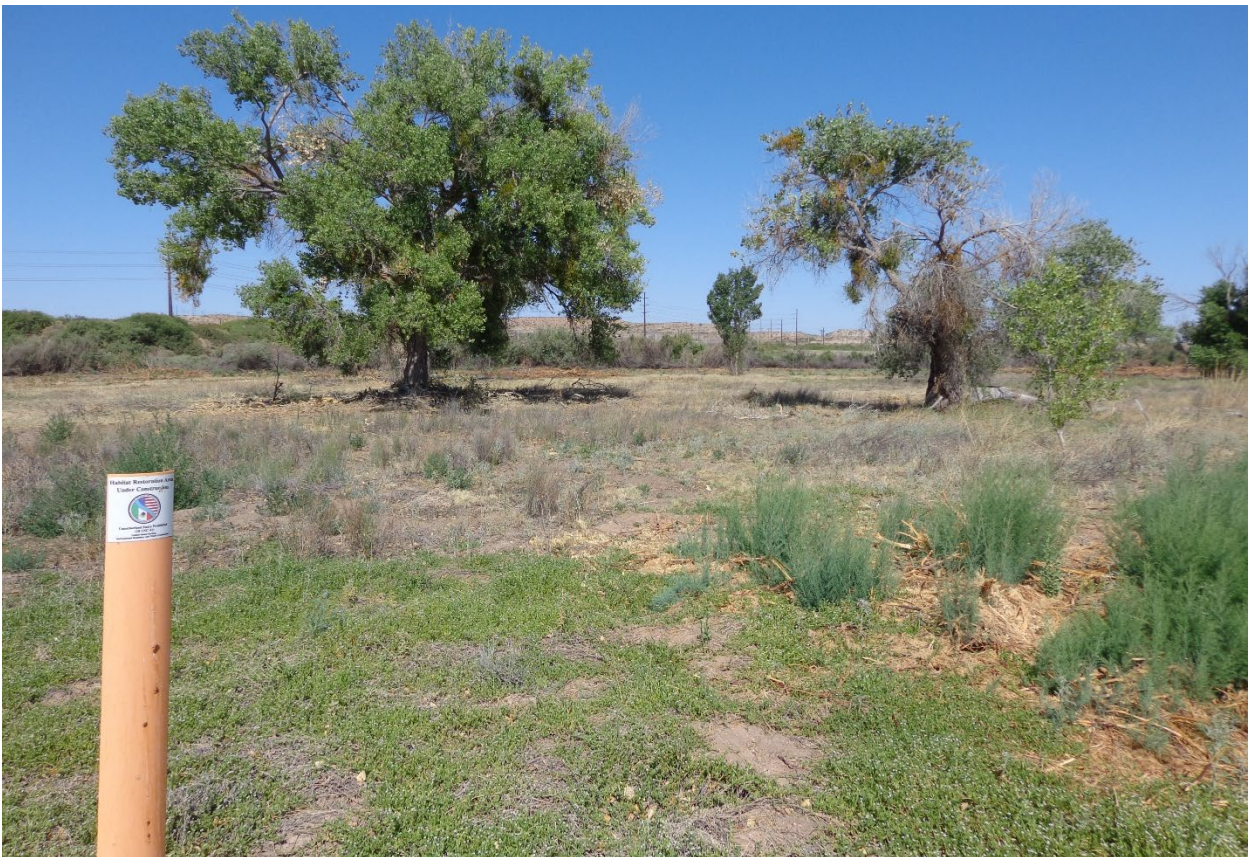
Right side of the restoration site. The trees seem to be decaying or dying off due to mistletoe or some fungal infection. No notable wildlife species in the area.

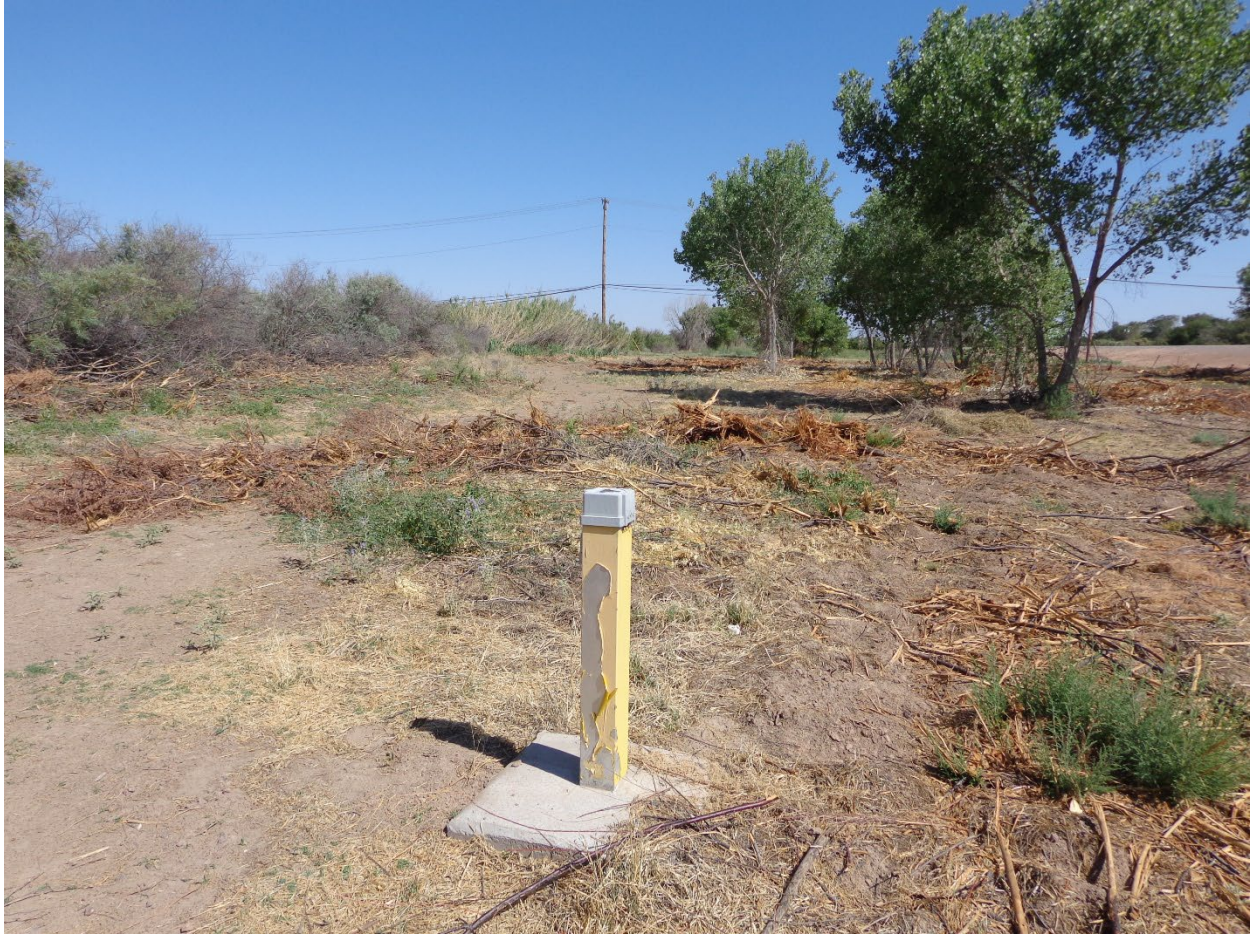
The Monitoring Well SP-MW-1 was relatively clear of vegetation except for a row of cotton woods around 20 meters from the well; vegetation on this side of the river was dry/decaying and the area was mostly clear of any vegetation. A bunch of wood shavings everywhere.

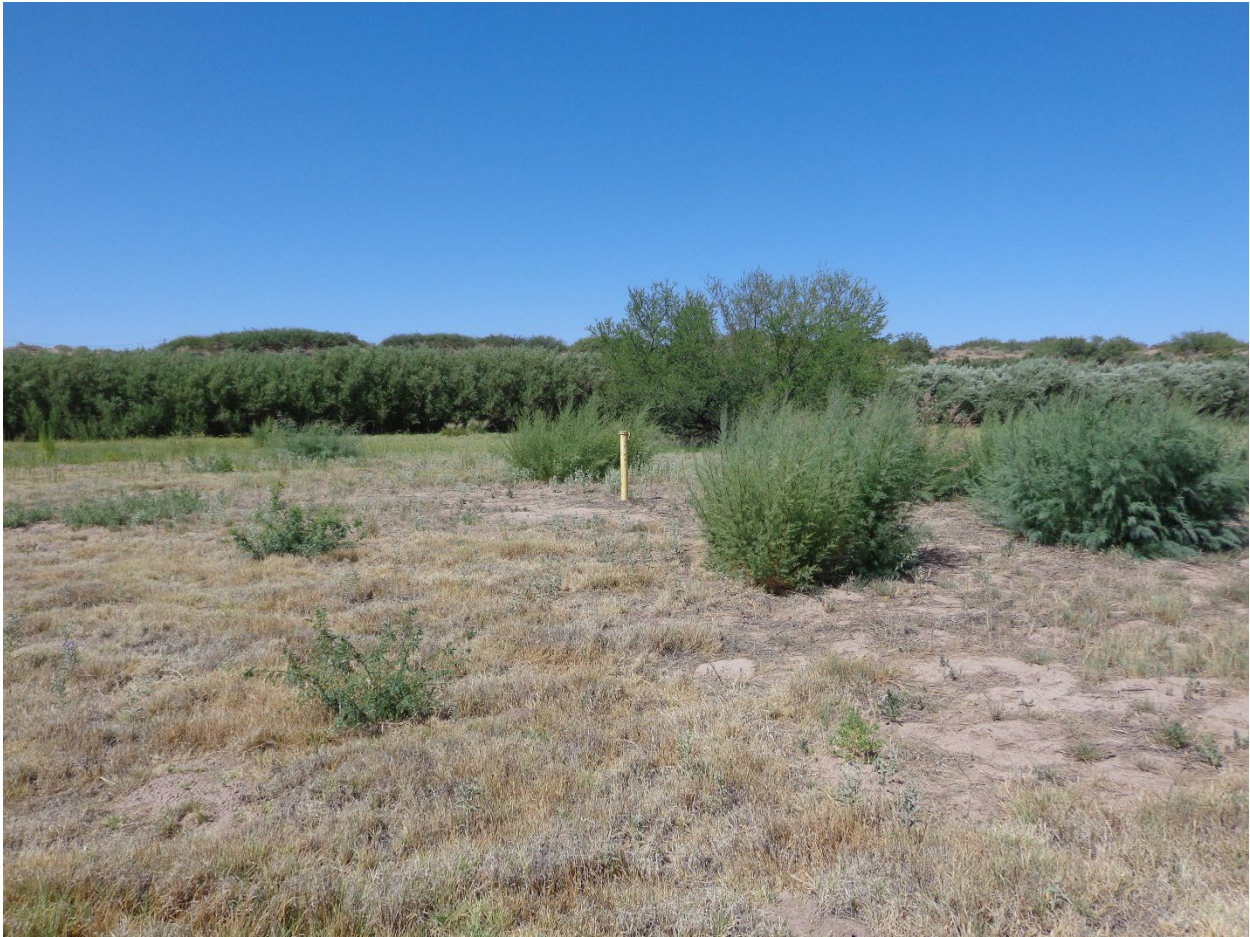
We visited Country Club East on July 7, 2023. A few sporadic salt cedar shrubs here at monitoring well CCE-MW-3 around 10:30 am. The well lock was rusty, but we were able to open it and get a reading. We found monitoring well #2 and #3 from 10:30-11:15; there was some sporadic salt cedar and mesquite. Along the riverbank there is good coverage of Coyote willows.

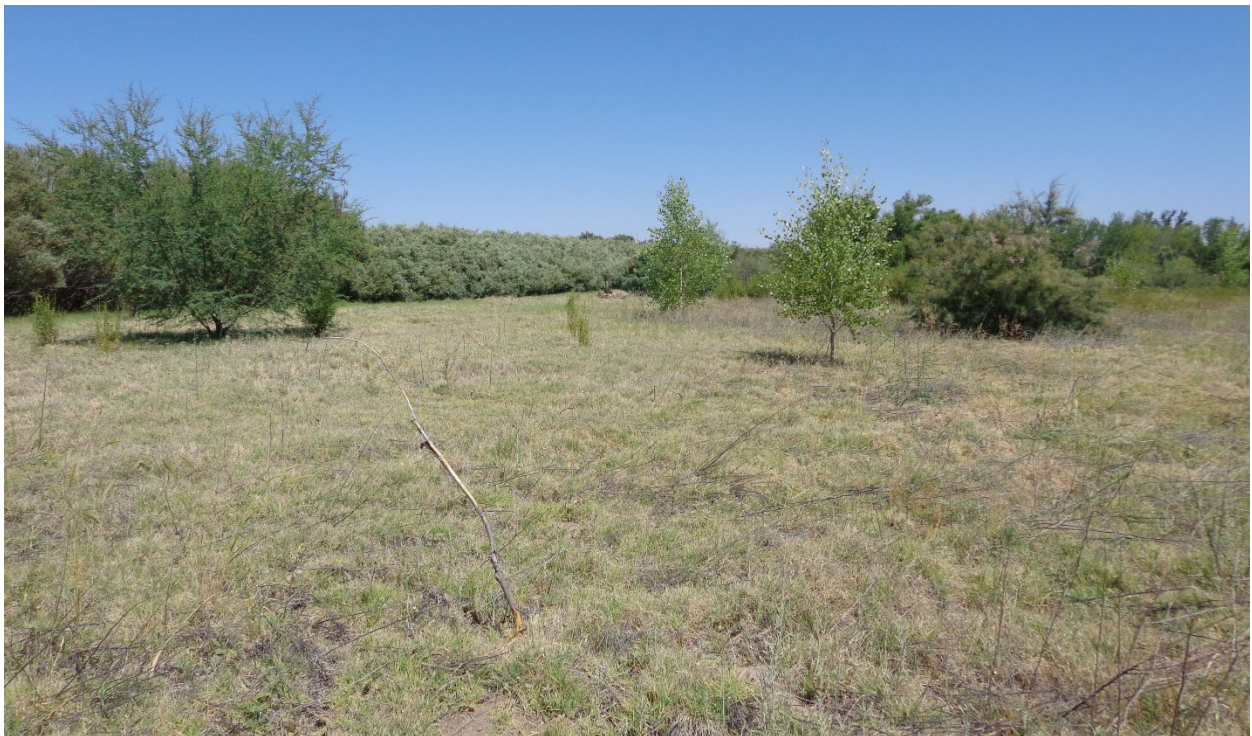
Overlooking downstream you can see some mature mesquite, sporadic salt cedar, and Cottonwood plantings. In the foreground is a pole that did not survive.

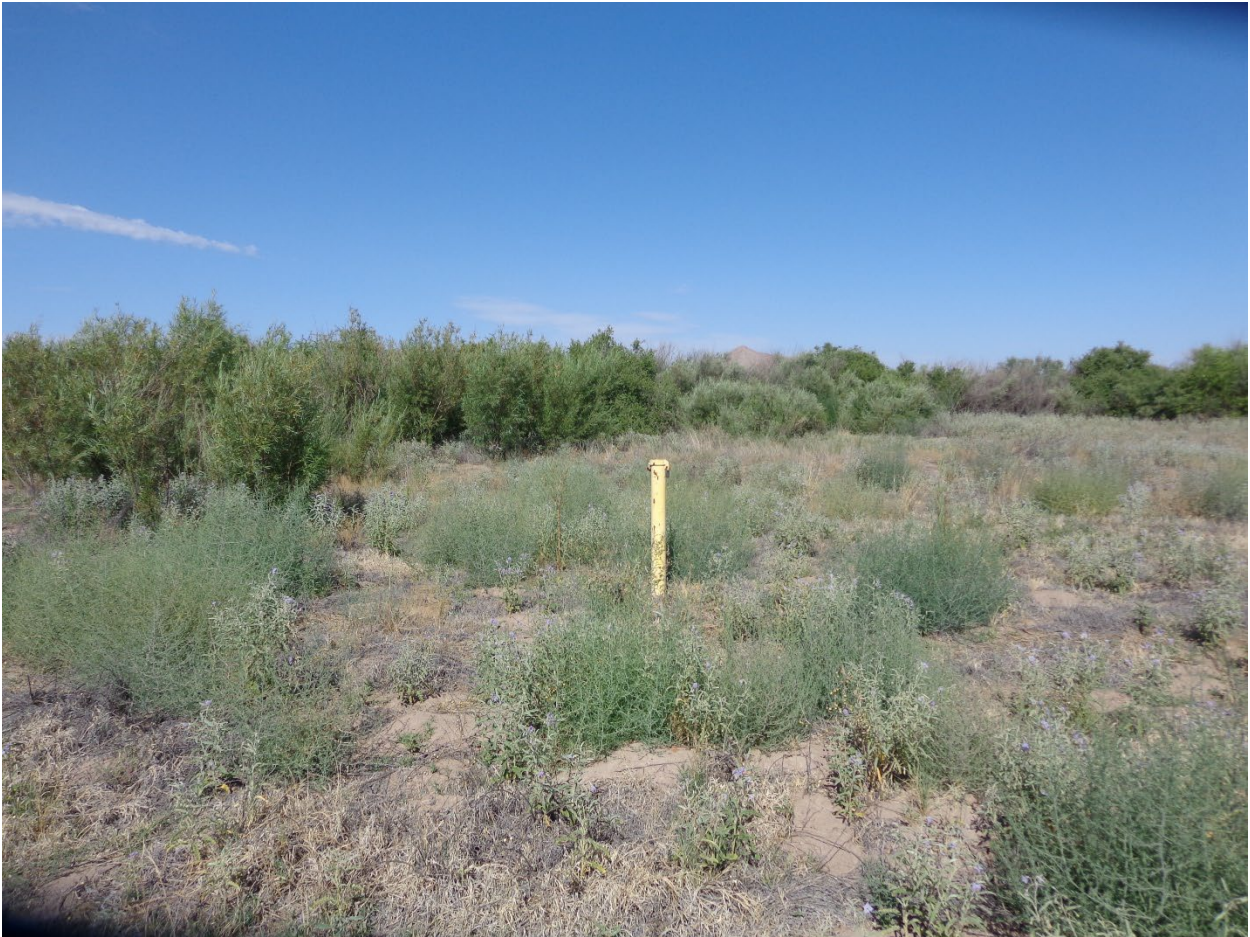
On July 11, 2023, from 10:16-10:38, we visited Leasburg Extension Lateral Wasteway #8 to monitor al four wells. LEL-MW-3 pictured above is at the southern end of the site and is outside of the irrigated area. The well was stuck so we were not able to measure water level. All these wells had some brush that we had to push away so that we could access the wells.

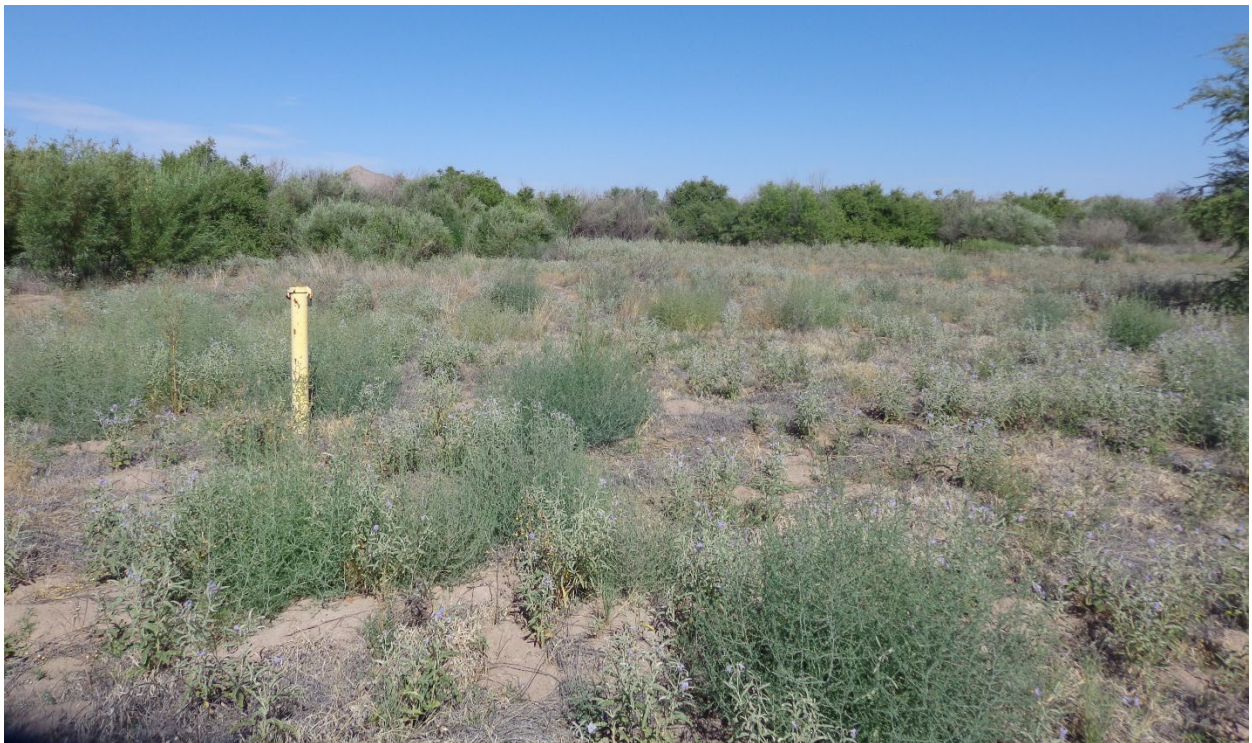
There are some willows in the distance from LEL-MW-3. This was the monitoring well that we could not measure. We then decided to come back at a later date to see if we could break open the lock or force it open.

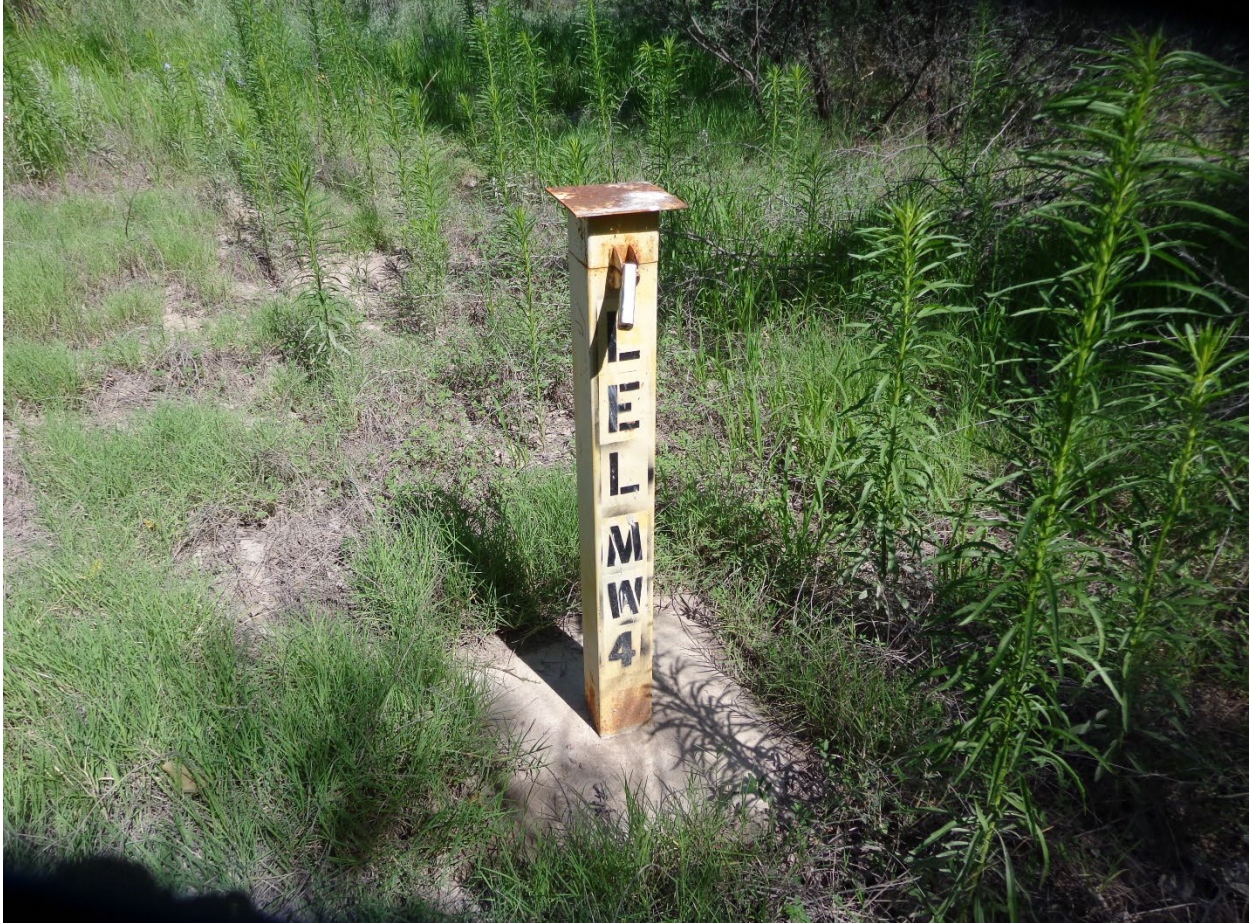
This is the monitoring well that had the sonde in it, we took some time, but we extracted the data and now it is a plotted graph on the HOBOWare field laptop. Area was full of vegetation. At LEL-MW-4, we collected the Sonde data using the HOBOWare Shuttle device.

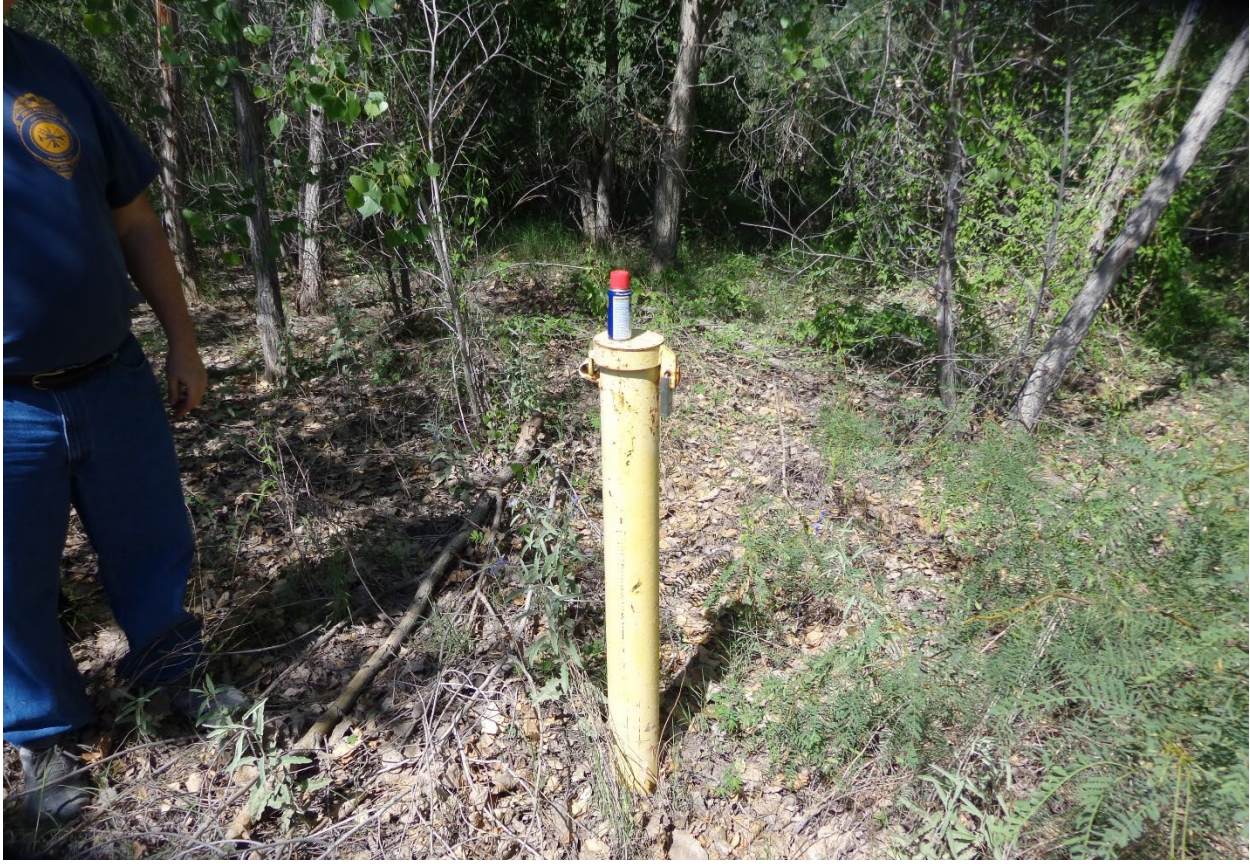
This was LEL-MW-1 another hard well to locate only because of the foliage in the area. This well is also within the irrigated area. The lock was hard to open but we used the WD-40 to get it lubricated and opened it up to collect a water level reading.

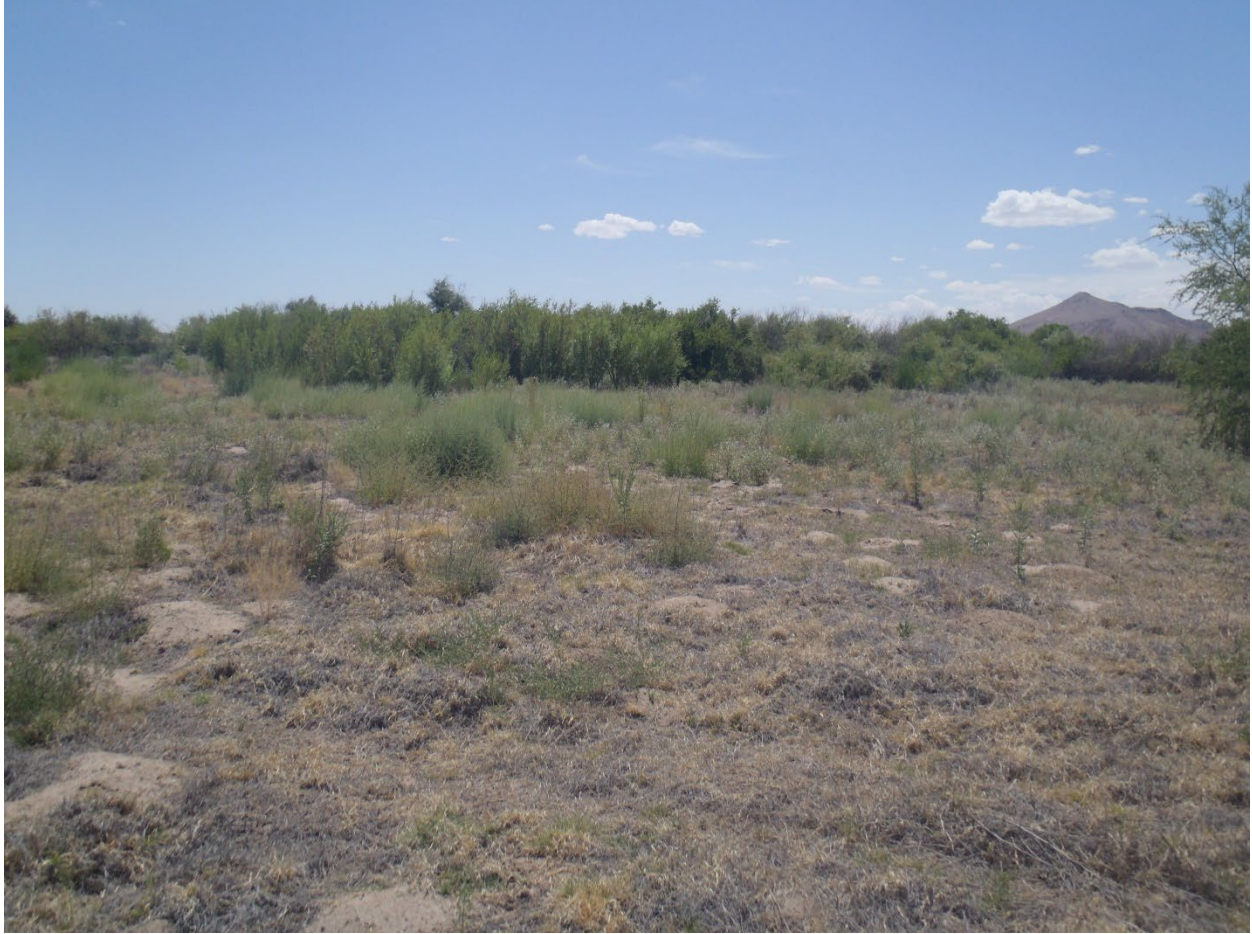
We revisited LEL-MW-3 on 7/18/23 after going to Rincon Siphon. Very hard to see but this is the well with the lock that was stuck. We were able to open the lock and got a water level reading.

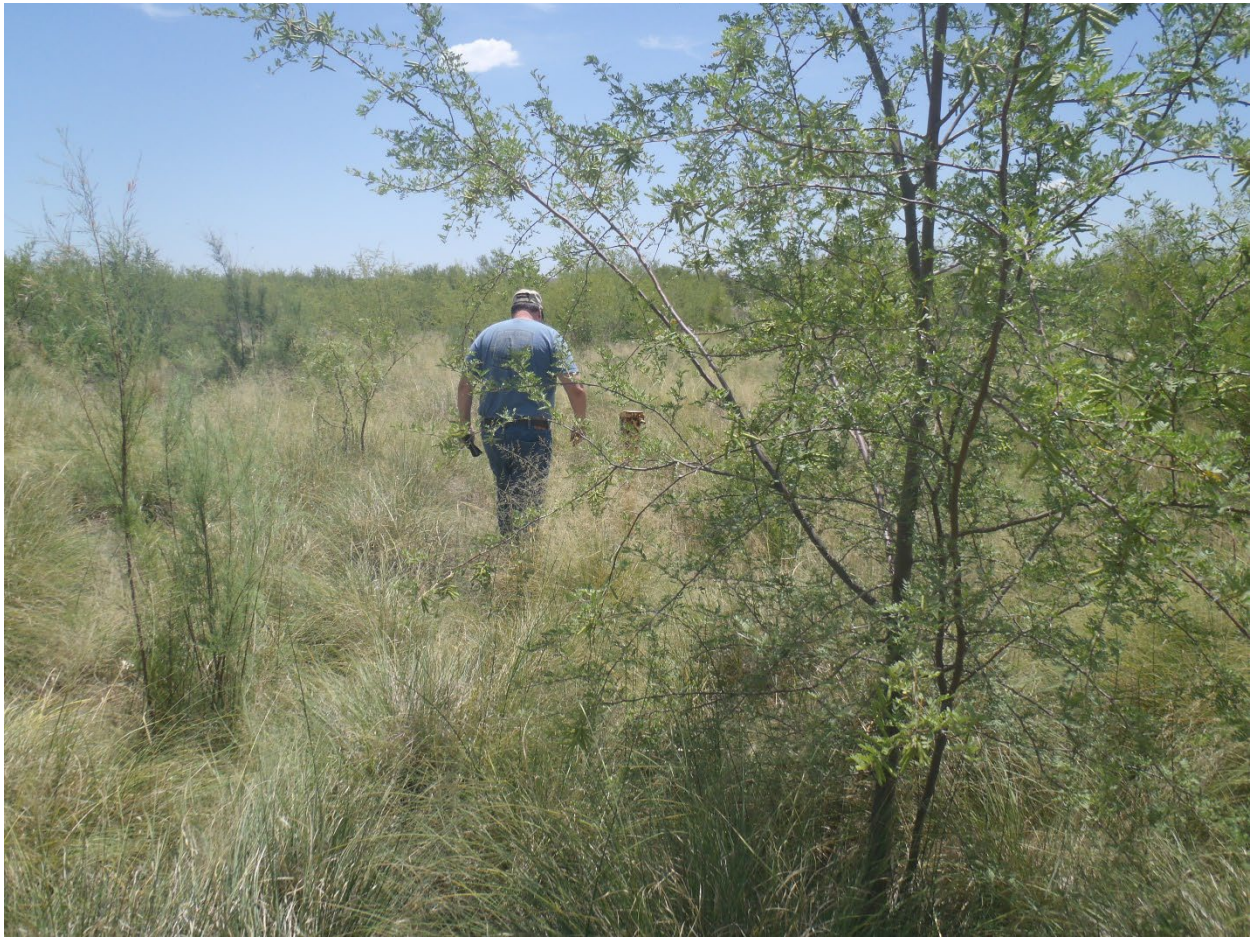
Pictured above is RS-MW-4 at Rincon Siphon Restoration Site, Parcel D. This is a big open area near the river. We had a high reading close to 4 ft, meaning the groundwater is only about a foot and a half below the ground surface. This site has recovered from previous brush fires, and native grasses have returned in abundance.

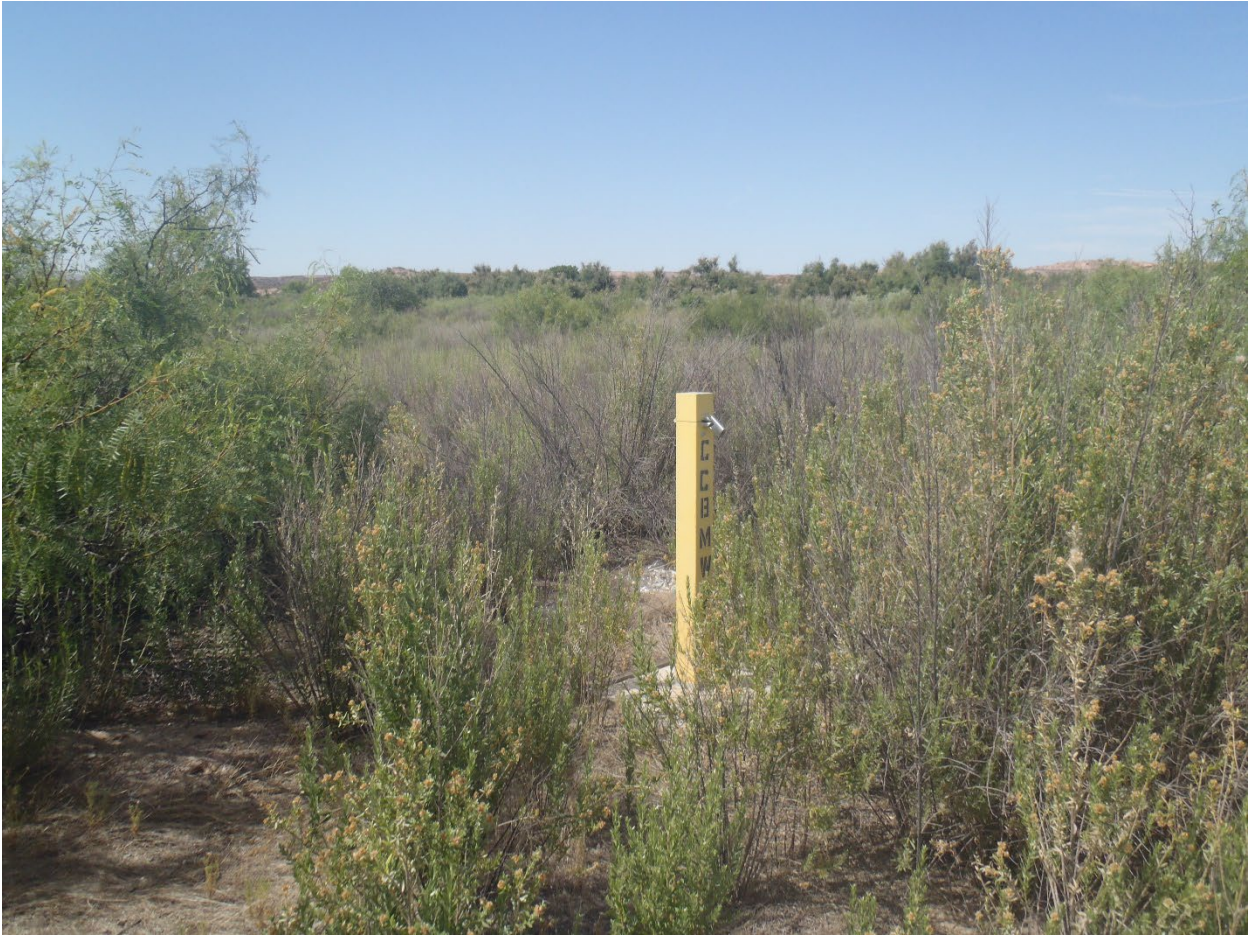
This is monitoring well #2 for Crow Canyon B, which is alongside the road and surrounded by vegetation. There was also some notable trash near the road leading up to the well.

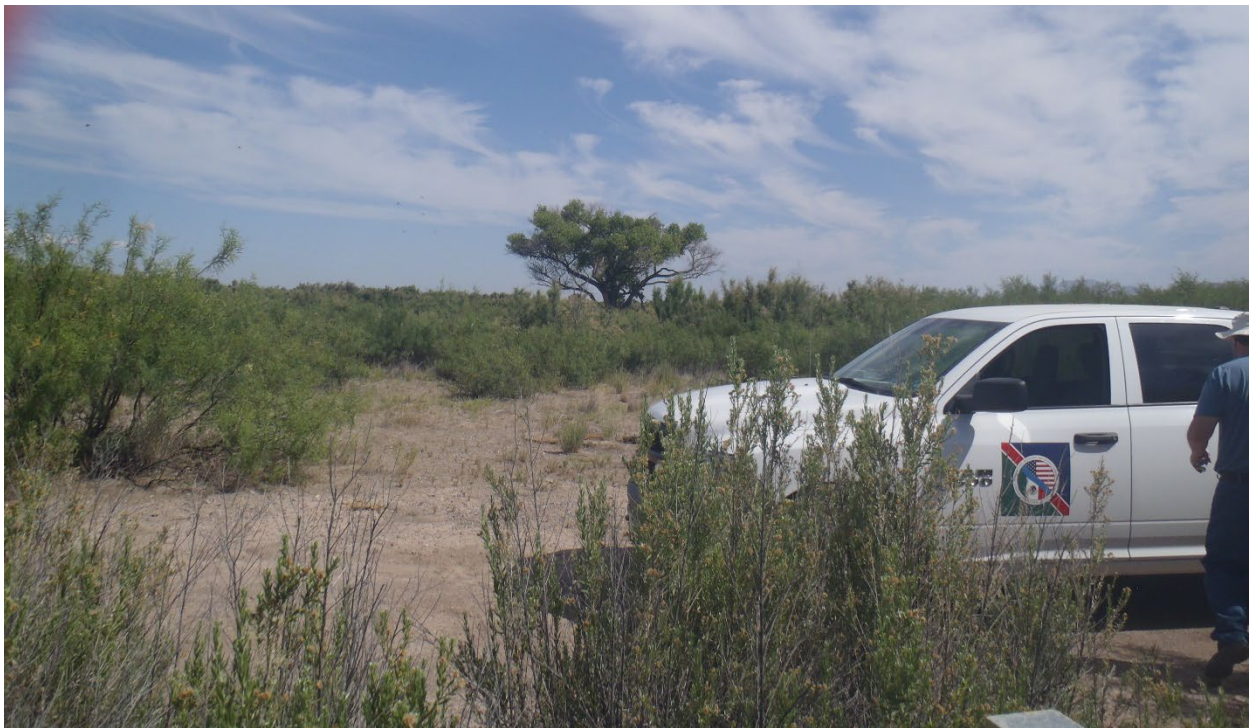
A struggling cottonwood tree in the distance.

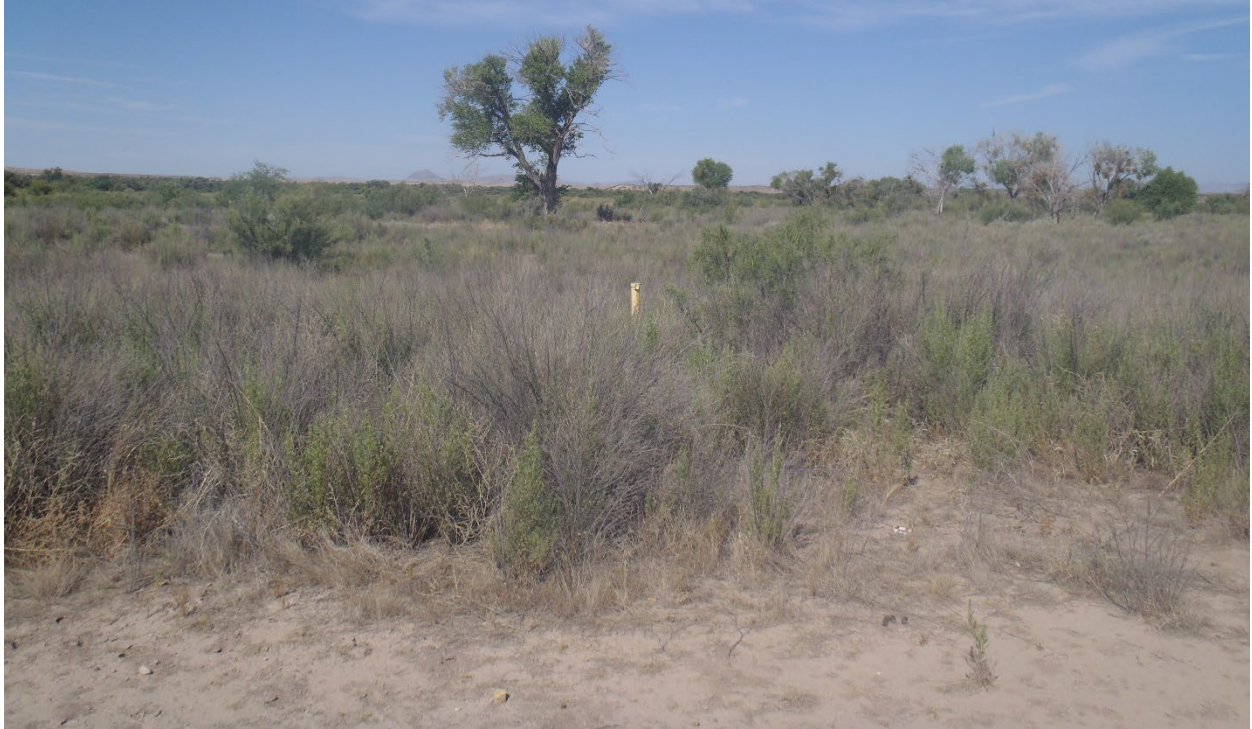
Well #2 was surrounded by tall brush barely visible from the picture. In the back you can see a dying cottonwood and on the right of this pictures you can see more dying old cottonwood trees.
