**USIBWC Habitat Restoration Sites and Groundwater Monitoring Wells**

**MONITORING NOTES AND PHOTOGRAPHS**

**SUMMER 2023**

**U.S. Section International Boundary and Water Commission**

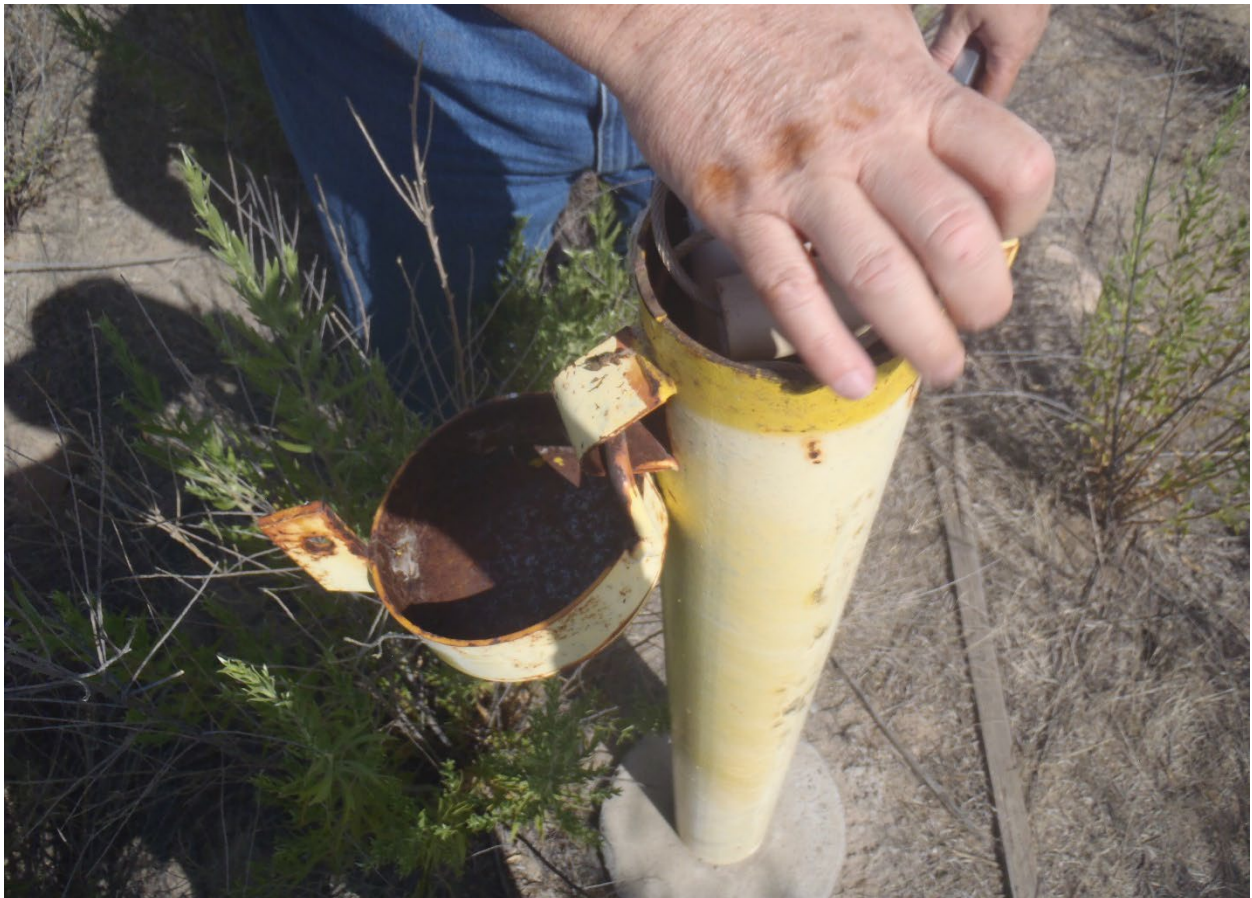
Struggling to pull the sonde out. We decided to leave it and move on to the next well.

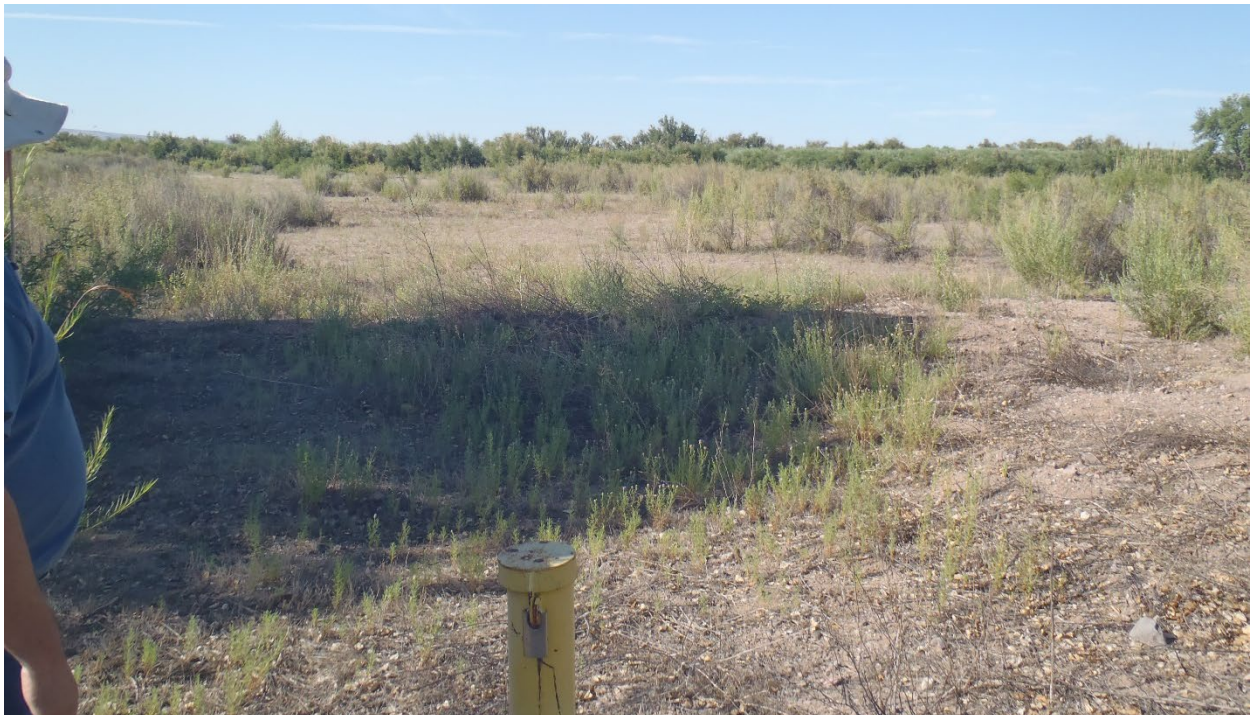
YE-MW-1 view looking towards the south, good vegetation near the riverbank, but scarce in the floodplain outside of the irrigated area of the old river meander.
