UNITED STATES AND MEXICO SIGN AGREEMENT TO PRESERVE STRUCTURAL SAFETY OF AMISTAD DAM

CONSTRUCTION OF A COMPOSITE CUTOFF WALL TO REDUCE THE RISK OF FAILURE AT AMISTAD INTERNATIONAL DAM

**JOINT REPORT OF THE PRINCIPAL ENGINEERS ON THE IMPLEMENTATION OF
CORRECTIVE MEASURES TO REDUCE THE RISK OF FAILURE AT AMISTAD DAM THROUGH THE
CONSTRUCTION OF A COMPOSITE CUTOFF WALL**

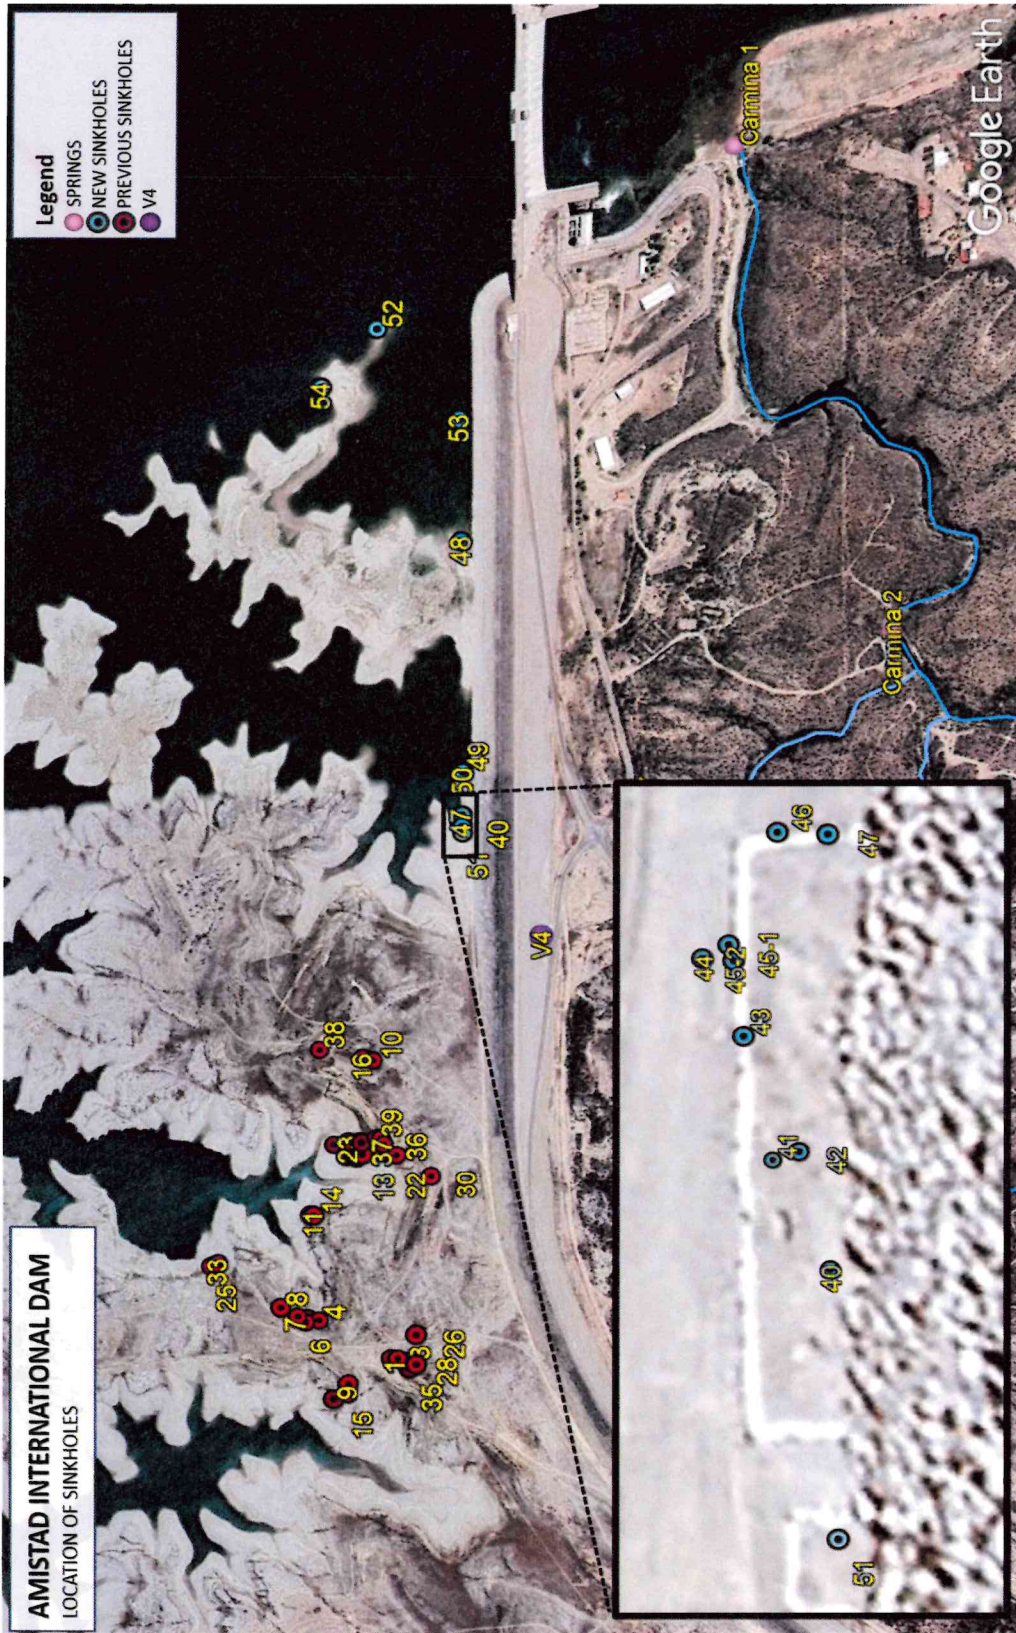
Figure 2: Amistad Dam Sinkholes and Springs

Extensive subsurface flow (springs) has been reported downstream of Amistad Dam since initial reservoir impoundment in 1968. In general, most of this seepage is traveling through the foundation of karstic limestone in the Georgetown formation beneath the subgrade of the embankment section. Most of the springs at Amistad International Dam occur at considerable distances downstream of the dam (328+ feet/100+ m). However, it is worth noting that there is one area on the Mexico side downstream of the earthen embankment where groundwater surfaces as springs at the toe of the dam. This area is identified as V4 and is located between dam Stations km 6+350 and 6+460 (reference Figure 2 of Exhibit I for the location of V4 spring).

From 1994 to date, 55 sinkholes have formed between Stations km 5+450 and 7+100, with water losses of up to 1 cubic meter per second (cms). Water seepage passes under the embankment through fractures and faults that connect to karstic zones in the Georgetown Limestone and emerge downstream as seepage or springs.

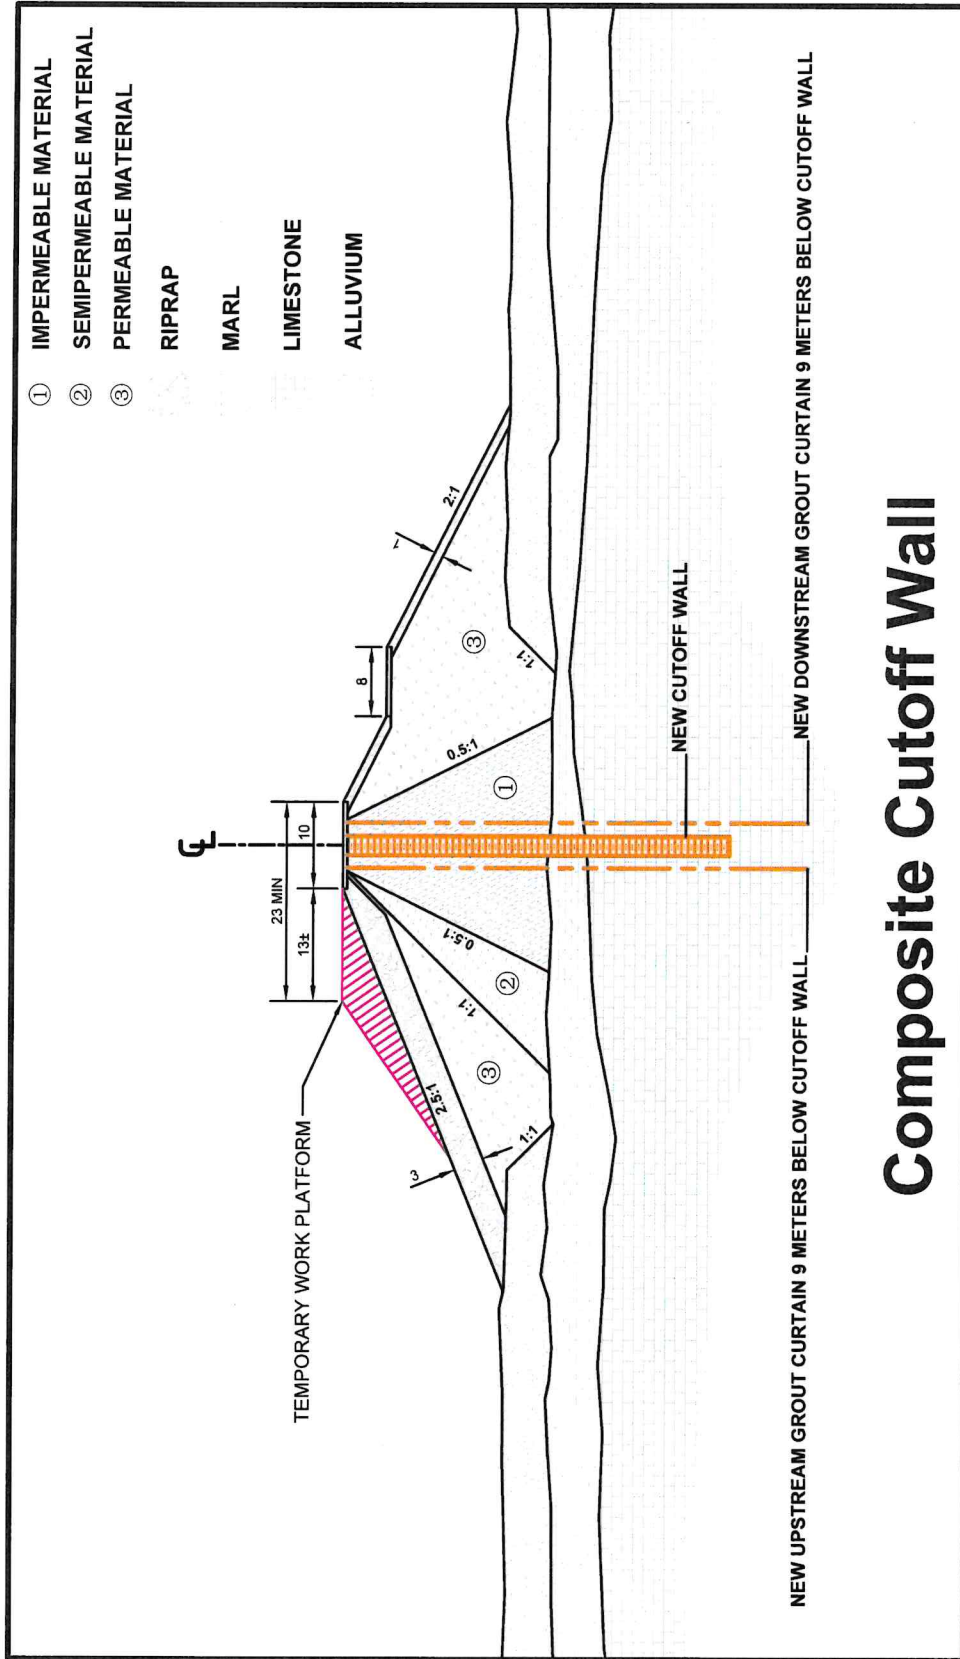
Figure 5: Composite Cutoff Wall Project Concept

Each grout curtain consists of a line of boreholes parallel to the dam, drilled from the crest and backfilled with pressurized cement grout mix. The purpose of the grout curtains is to fill fissures, fractures, seepage pathways, and cavities in the karstic bedrock; to obtain additional information to define in greater detail the concrete cutoff wall depth and extent; and to permit the construction of the cutoff wall by blocking water flow and thus preventing the risk of collapse of the wall during excavation.

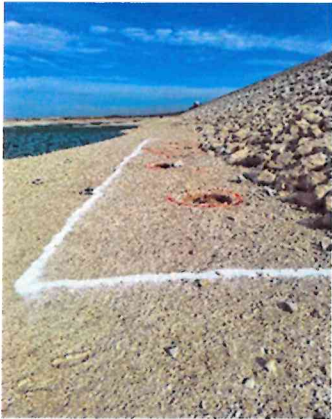
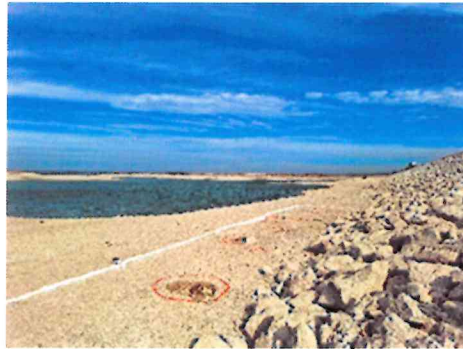
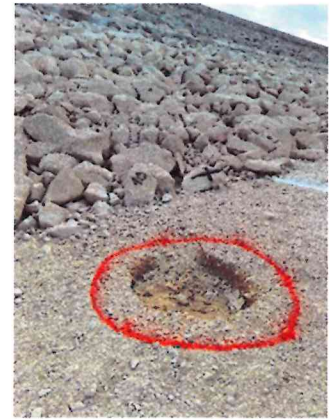
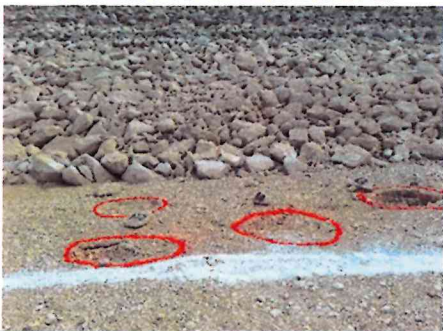
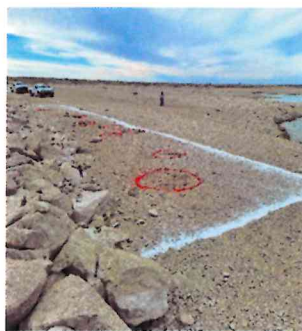
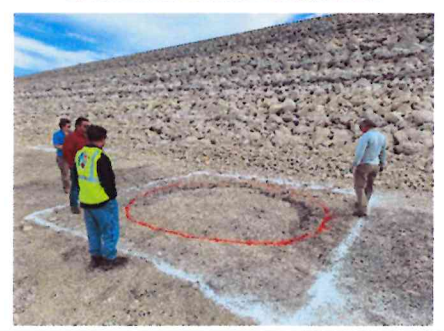
January 30, 2024 The sinkholes identified with consecutive numbers from #40 to #48 were detected in an area at the toe of the upstream slope between km 5+770 and 6+230.

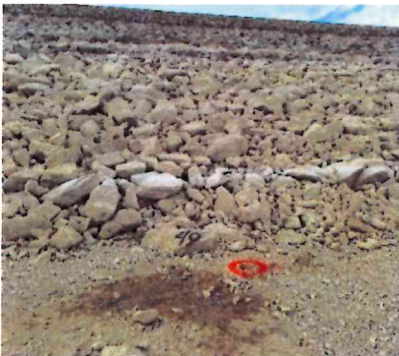
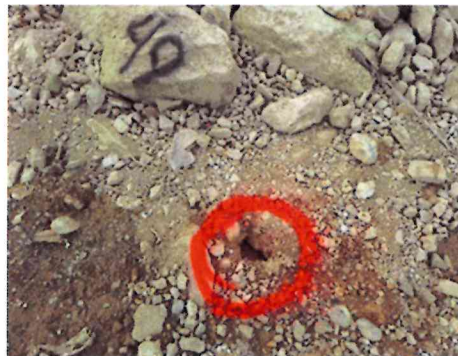
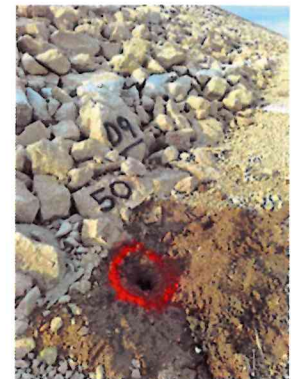
February 07, 2024 The sinkholes identified as #49 and #50 are observed at the toe of the upstream slope of the embankment.

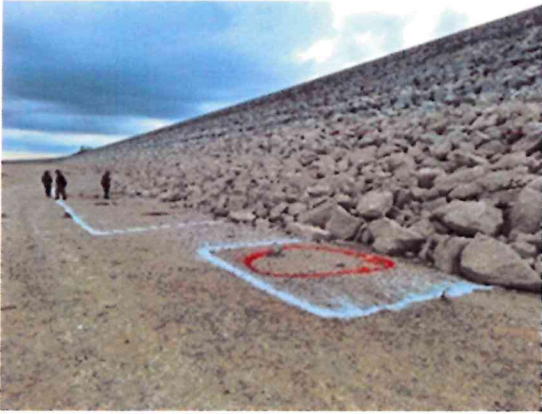
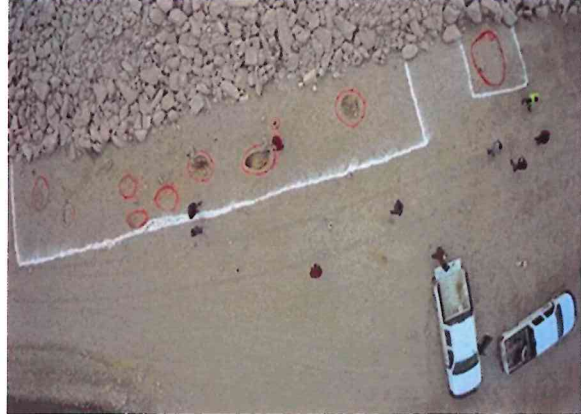
February 08, 2024 A new sinkhole was detected and labeled #51 based on the next consecutive number.

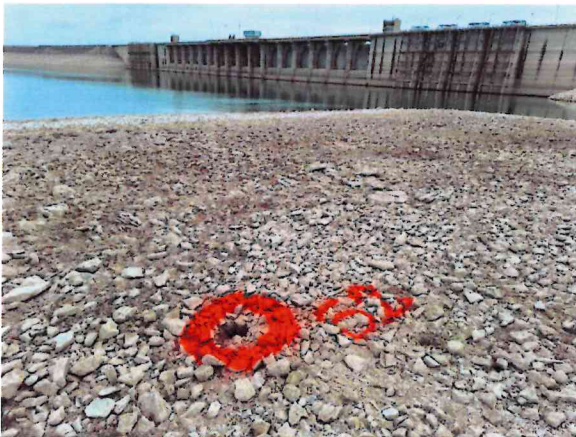
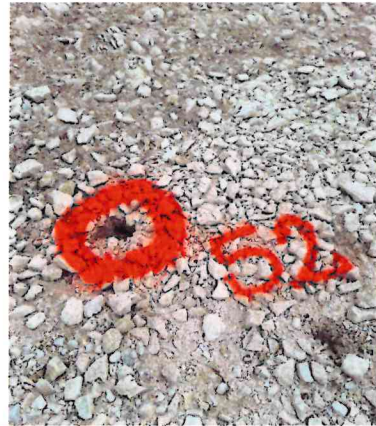
February 16, 2024 Sinkhole #52, located at Station km 5+373, 211 m away from the embankment.

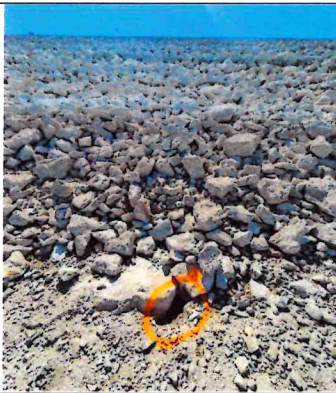
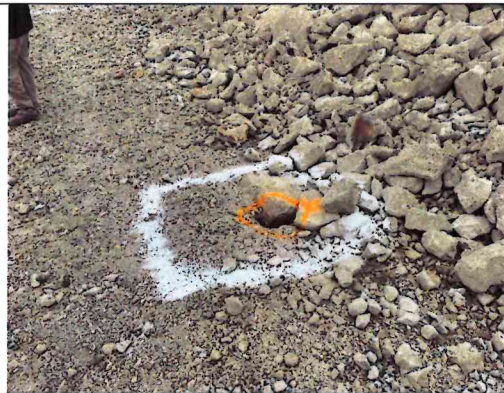
February 21, 2024 Sinkhole #53 is identified at the toe of the upstream slope at Station km 5+560.

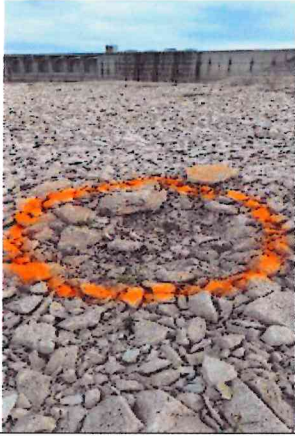
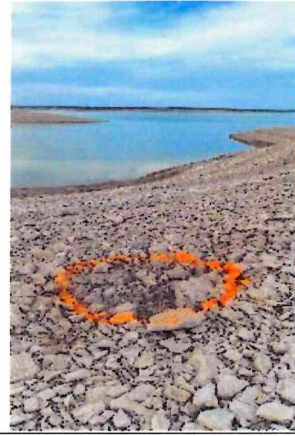
February 26, 2024 Sinkhole #54 located at Station km 5+450 was observed 320 m away from the toe of the upstream slope.
