MINUTE NO. 332

CONSTRUCTION OF A COMPOSITE CUTOFF WALL TO REDUCE THE RISK OF FAILURE AT AMISTAD INTERNATIONAL DAM

**JOINT REPORT OF THE PRINCIPAL ENGINEERS ON THE IMPLEMENTATION OF
CORRECTIVE MEASURES TO REDUCE THE RISK OF FAILURE AT AMISTAD DAM THROUGH THE
CONSTRUCTION OF A COMPOSITE CUTOFF WALL**

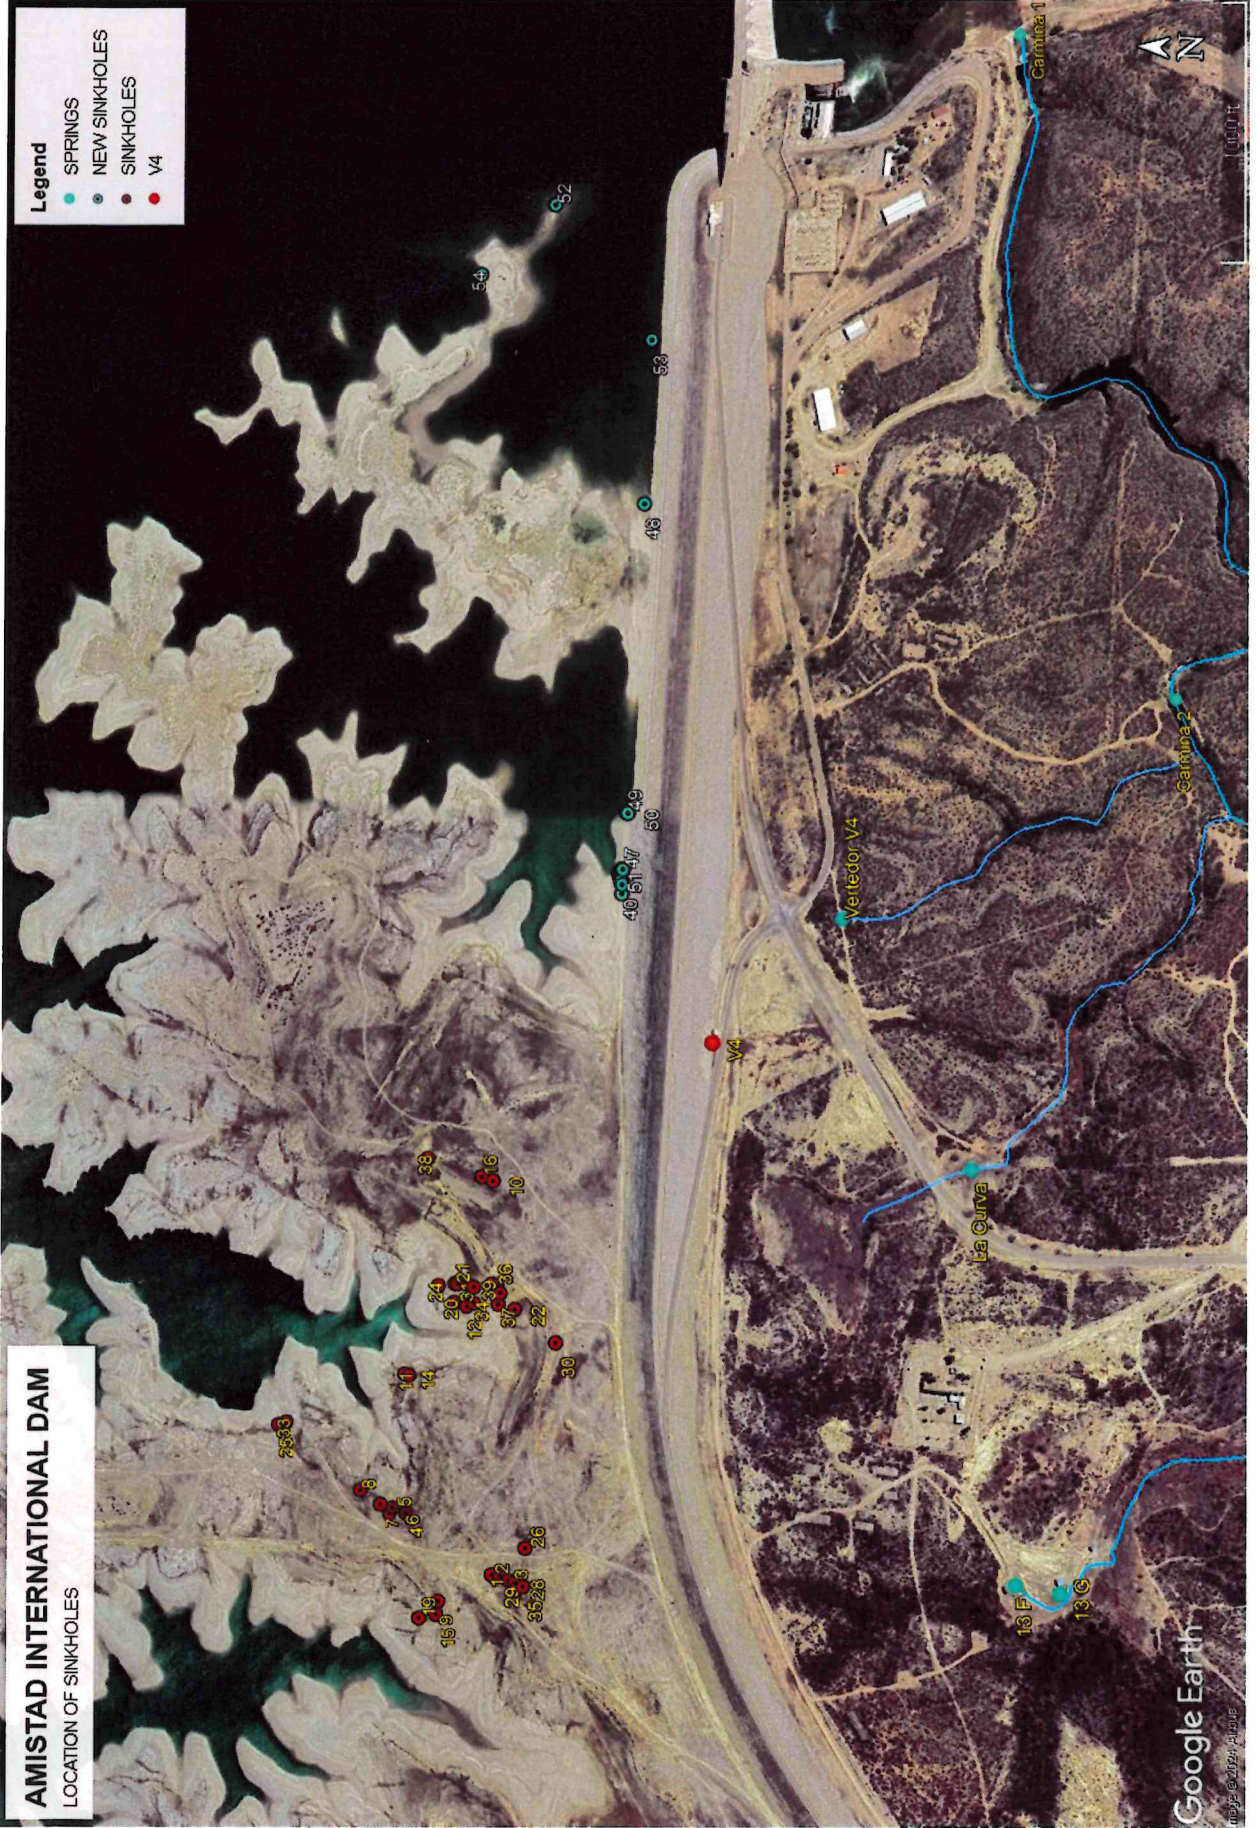
EXHIBIT II.A. Location of sinkholes

To date, 16 new sinkholes have been found, in addition to the 39 that had previously been recorded through 2023. Between Stations kilometer (km) 5+450 and 6+265, there are 14 sinkholes near the toe of the embankment slope and two more in the area of the dam reservoir at 221 m and 320 m from the toe of the upstream slope of the embankment.

Considering the above and analyzing the recommendations of IBWC's Technical Advisors, it is proposed to extend the length of the Composite Cutoff Wall project and add approximately 607 m (from Station km 6+000 to the east) to the original 2-kilometer length that was recommended at the meeting of the Commission and its Technical Advisors on October 5 and 6, 2022. Therefore, the total length of the project will be approximately 2.6 km starting at Station km 5+393 (beginning of the clay-cored rockfill section) and ending at Station km 8+000.

Beginning the Composite Cutoff Wall project at the new Station km 5+398 will provide for the rehabilitation to include the area of the embankment where the new sinkholes were found. This reinforces the structural and functional safety of the Amistad Dam embankment.

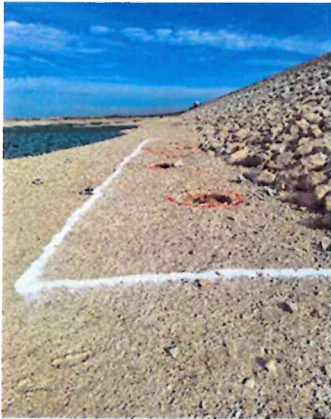
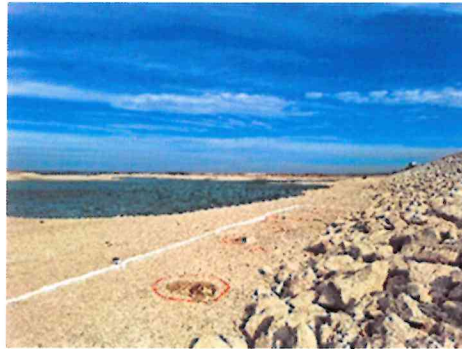
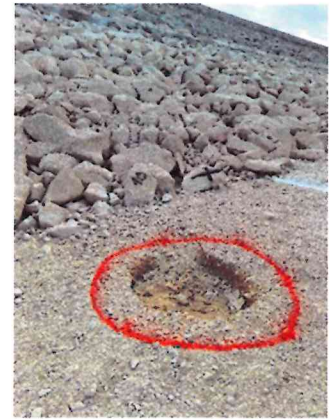
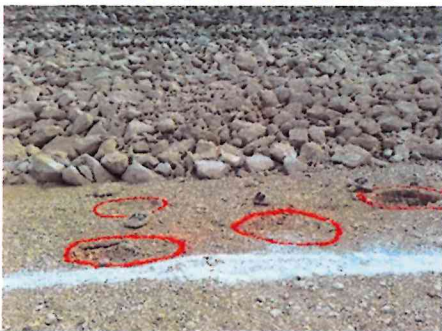
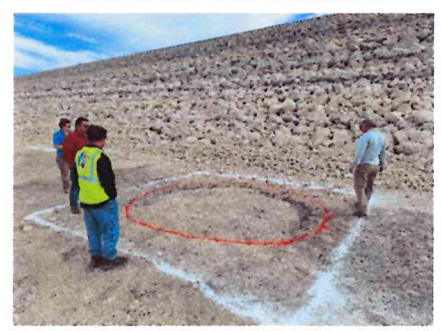
January 30, 2024 The sinkholes identified with consecutive numbers from #40 to #48 were detected in an area at the toe of the upstream slope between km 5+770 and 6+230.

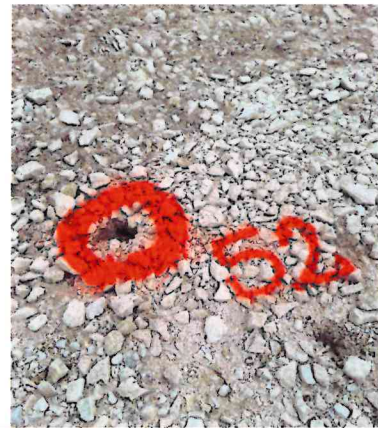
February 16, 2024 Sinkhole #52, located at Station km 5+373, 211 m away from the embankment.

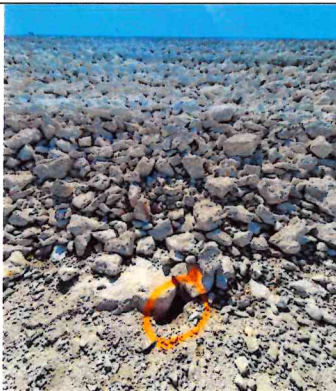
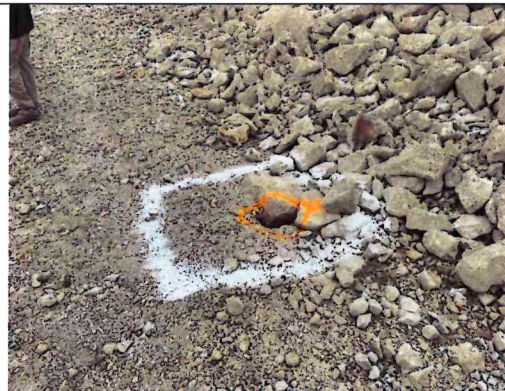
February 21, 2024 Sinkhole #53 is identified at the toe of the upstream slope at Station km 5+560.

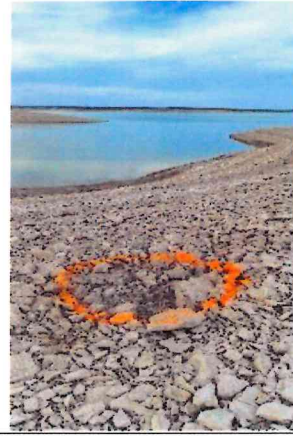
February 26, 2024 Sinkhole #54 located at Station km 5+450 was observed 320 m away from the toe of the upstream slope.
