Riparian Habitat Restoration at Three Sites in New Mexico and Texas: Country Club East, Sunland Park, and Anapra Bridge Restoration Sites

Final Restoration Report

Version: October 2017 to January 2020

Prepared by: ***IDEALS-AGEISS, LLC***

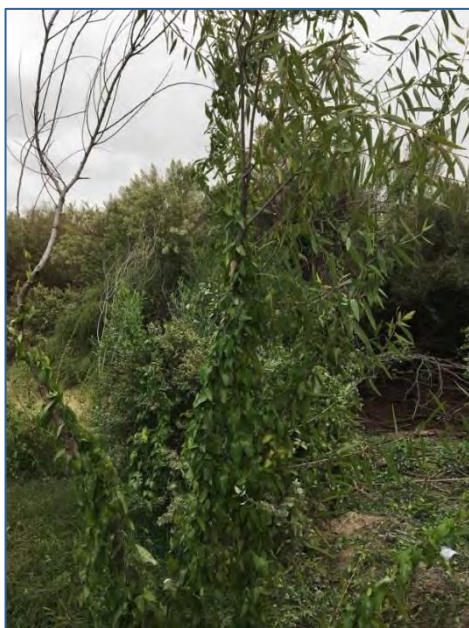
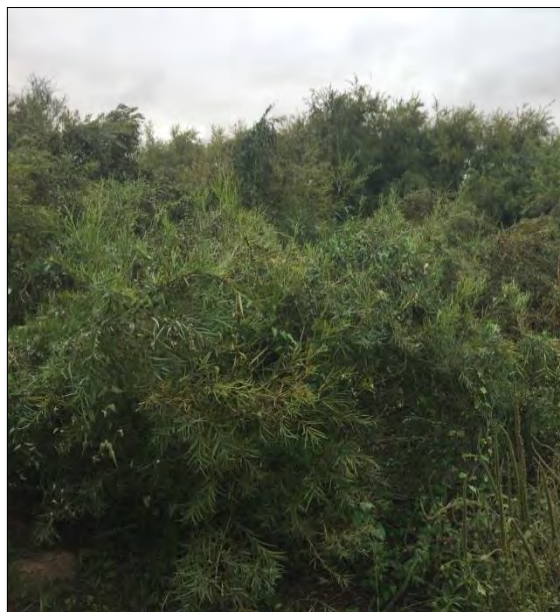
During the October 2018 monitoring, IDEALS-AGEISS biologists noted that funastrum (*Funastrum cynanchoides*), a twining milkweed species, established within the transplanted coyote willows and Goodding's willows area; the area recently exposed for the saltcedar removal. At times, only individual trees were entwined by the vine, but in some areas the vine developed into a large mat which overgrew the naturally occurring coyote willows on the bank and engulfed the planted willows. However, by October 2019 the vine was not as prevalent although some of the trees in the area had been damaged/killed by the vine.

**Examples of a Goodding's willow covered with funastrum at
Sunland Park, 17 October 2018**

At the Sunland Park restoration site, 473 of the Goodding’s willows could not be located despite having a crew of four field personnel walking transects through the site during the 2018 survey. Some of the missing trees can be attributed to the heavy infestation of the funastrum which is estimated to have

covered approximately 68-100 planted trees. In addition, Goodding’s willows in the flycatcher area were intermixed with the densely packed transplanted coyote willows and were difficult to find. Survival was 67 percent. Despite the addition of 295 Goodding’s willows in early 2019 to complete the required plantings, willow survival continued to drop (38 percent) and many poles were not located. Some of this can be attributed to the funastrum, but in addition, any poles that potentially rotted and fell over into the understory may not have been found. The impact of the funastrum and delayed 2019 irrigation release likely contributed to the mortality.

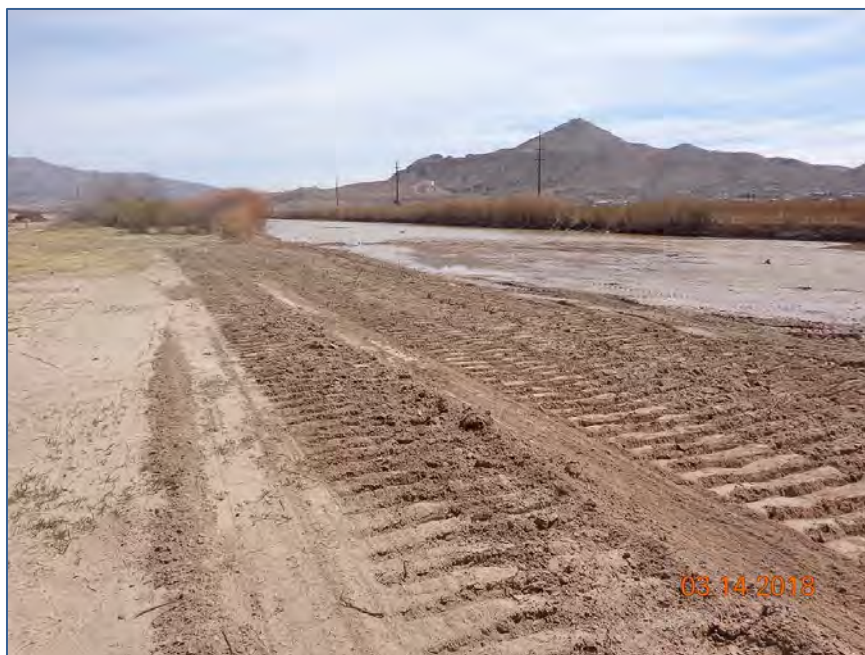
In March 2018, the USIBWC maintenance crew mowed the transplanted coyote willows at the Sunland Park Bridge at the Anapra site. Approximately 385 trees were mowed. USIBWC revised the No Mow Zones accordingly to include the east bank of the Sunland Park Bridge as a No Mow Zone. USIBWC's River Management Plan notes that 300 feet upstream and downstream of bridges are mowed; however, USIBWC has noted the Sunland Park Bridge east bank as an exception and will be mowed only 100 feet upstream and downstream of the bridge at the Anapra site. In October 2018, the north side of the bridge appeared to have been mowed again and at the south side of the bridge some willows were re-sprouting. Additionally, heavy salt patches were documented in several areas on the site during the 2018 and 2019 October monitoring.

**Coyote willows mowed at the Sunland Bridge on the
Anapra restoration site, 14 March 2018**

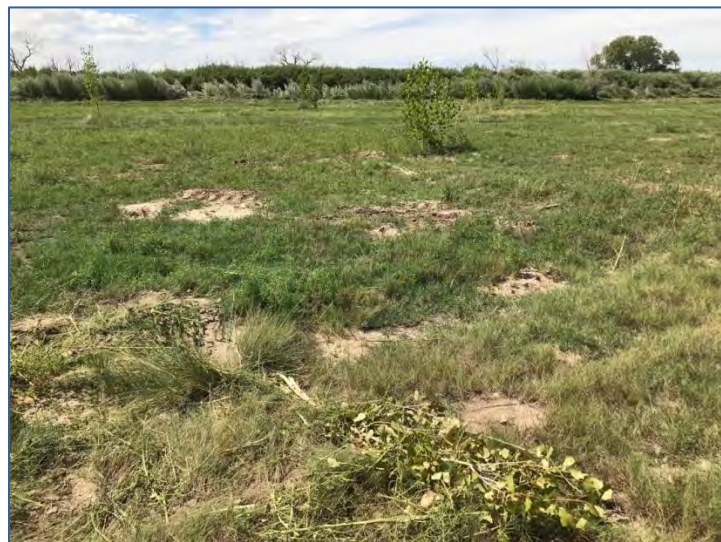
Example of cottonwood damage at Country Club East, August 2018

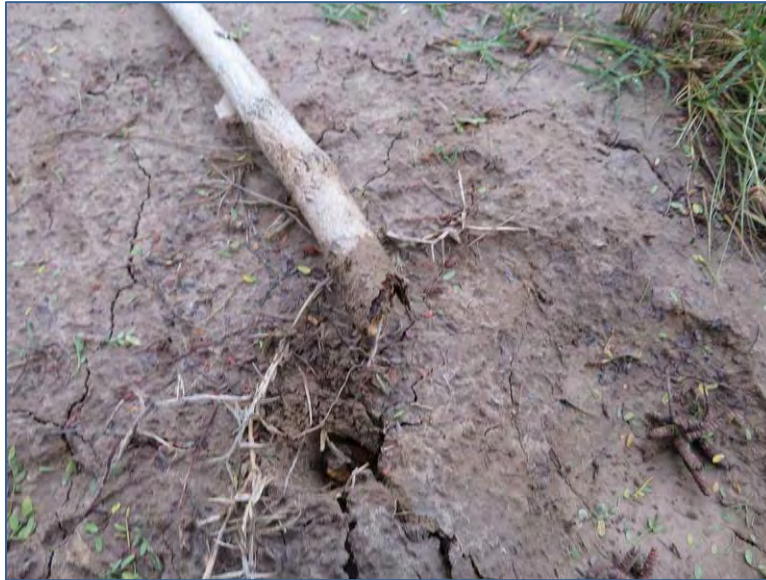
It was noted especially at the Anapra Bridge and Sunland Park restoration sites that some cottonwood poles rotted at the base of the pole. When the snap test was applied to these trees, the pole broke at ground level and the stem and the root system appeared to be rotted. These sites were not inundated with water to create prolonged exposure of submerged poles.

**Example of cottonwood that rotted at the base at
Anapra Bridge, 17 October 2018**

Given the high salt content at Anapra Bridge and the root-rot that occurred in the cottonwoods, IDEALS-AGEISS recommends that in the future the USIBWC consider focusing on species such as four-wing saltbush, bachharis, or mesquite to provide the species diversity at the site if additional plantings are implemented.

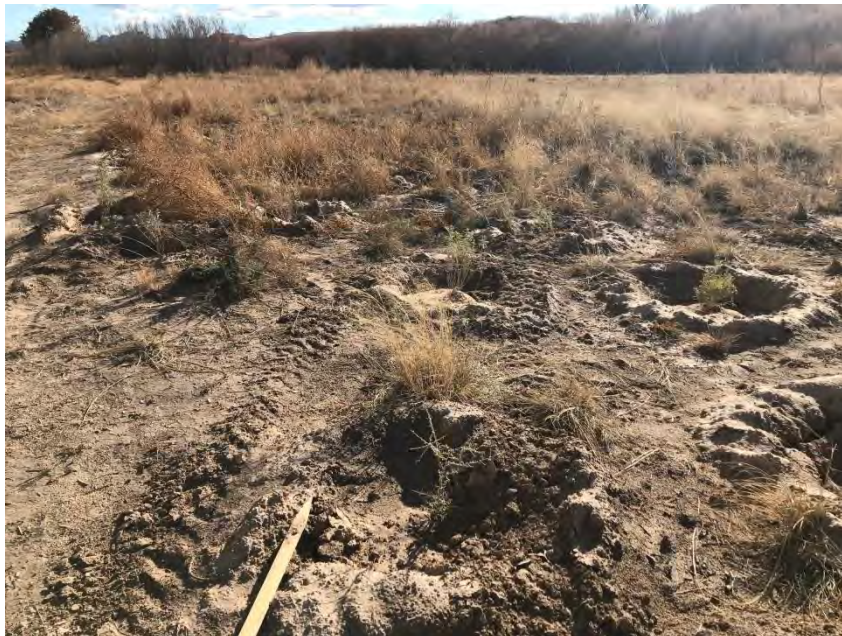
No recent evidence of herbivory was observed at any of the sites, although a dead (shot) beaver (*Castor canadensis*) was located at the Sunland Park site in November 2018. The IDEALS-AGEISS team biologists did observe other instances which had the potential to impact restoration efforts. Pocket gopher activity was observed at the Sunland Park site and was evident at the Anapra Bridge site during the 2018 season. This species has the potential to undermine root structure of planted poles. However, during the 2019 season the species was not documented on the sites as the ground cover increased. Plantings at both Anapra Bridge and the Country Club East restoration sites incurred damage from maintenance crews and other recreationists. Approximately 20 cottonwood poles on the north end of Country Club East restoration site were destroyed by USIBWC maintenance crews mowing the floodplain on 29 August 2018. Additional damaged trees and shrubs were noted at the Country Club East site during the October 2018 monitoring from recreationists.

Evidence of recreational damage to the Country Club East shrub plantings, December 28, 2018.

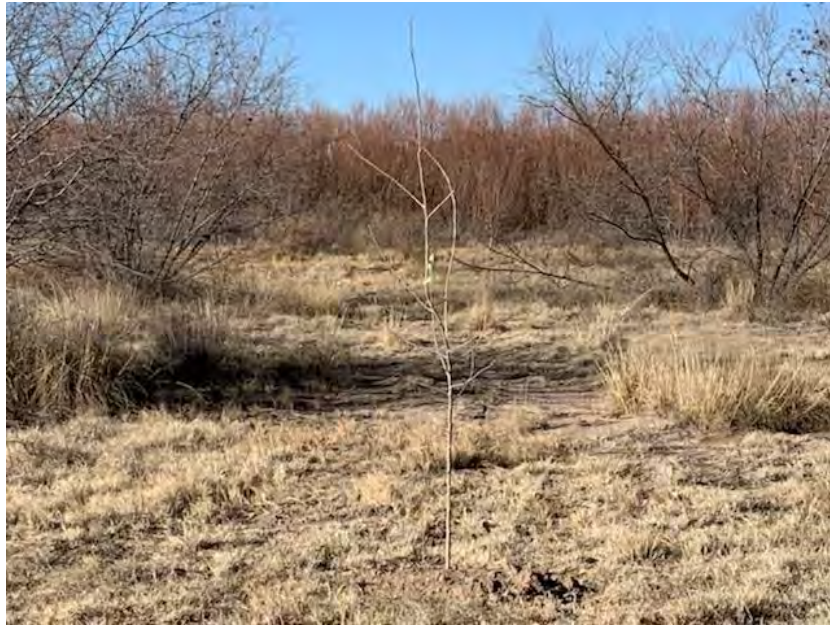
The Country Club site incurs heavy recreational use. IDEALS-AGEISS field crews noticed that once the water in the river stopped flowing, that motor cross and four-wheeler activity significantly increased. The grass was extremely high and dense during the monitoring and some cottonwood re-sprouting may have gone unnoticed. It was noted in November 2018 during long stem shrub planting that some re-sprouting was occurring from the ground with no pole evident in the areas. The re-spouts were approximately 6 inches high and would not have been very visible during the October monitoring due to the height and density of the grass. There is no way to determine if the missing trees were damaged (they were mostly missing along the edges of the site) or if they were actual mortalities. IDEALS-AGEISS recorded 78 dead and 57 destroyed cottonwoods at this site during the 2018 monitoring. We were unable to locate 260 trees but assume based on our findings and the known activity in the area that a portion of these trees is likely destroyed and gone. IDEALS-AGEISS recommended replacing the known 78 dead cottonwoods and an additional 151 cottonwoods based on the known ratio of dead versus damaged (58 percent of the

Country Club East replanting of cottonwoods, 13 January 2020.

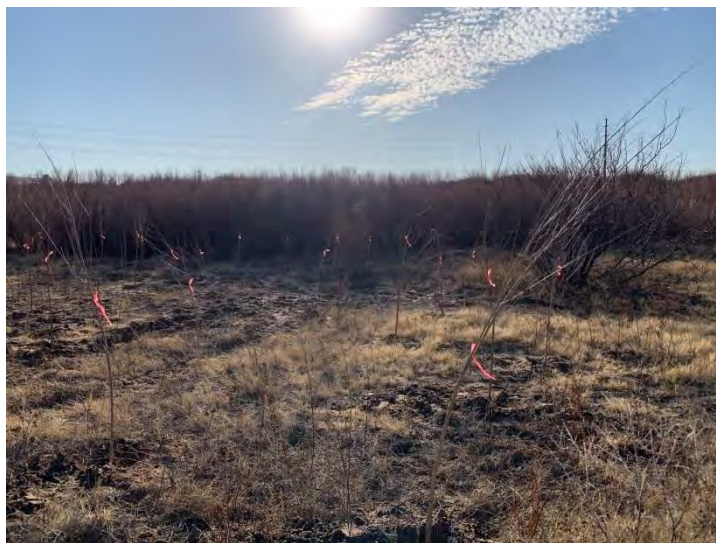
In addition to the 273 dead Goodding's willows at the Sunland Park site, 473 trees were unaccounted for. Some areas north of the SP-3 well along the levee toe road were devoid of Goodding's willow plantings. It is unknown if this is from trees dying or potential incursions into the site that may have damaged the trees. In addition, a large area containing Goodding's willows was inundated with funastrum and the densely populated flycatcher areas made locating trees difficult. An estimated 68 to 100 trees were potentially affected by this twining vine. At the Sunland Park site, IDEALS-AGEISS overplanted the coyote willows by 145 plants. IDEALS-AGEISS recommended that the 273 documented dead Goodding's willows be replaced in the flycatcher habitat. Of the missing 473 Goodding's willows, IDEALS-AGEISS recommended replacing 80 additional Goodding's willows based on documented October mortality rate of 17 percent (17 percent of 473). It is likely that some of the willows under the funastrum are still viable; and that trees were missed in the flycatcher area because they were tucked away in existing vegetation and blended in with the transplants. The 145 additional coyote willows are a supplement to the flycatcher habitat and the potential loss of the Goodding's willows. IDEALS-AGEISS recommended the Sunland Park replacement of the 188 cottonwoods be composed of half cottonwoods (94) and half Goodding's willows (94) to further augment the flycatcher habitat (Table 3-10). Cottonwoods were replanted from 7-9 January 2020. Goodding's willows were re-planted on the site during 23-24 December 2019 and were concentrated in the middle to northern end of the site closer to the river than the levee road at Sunland Park (Figure 3-8).

Replanting efforts for Goodding's willow at the Sunland Park Restoration site, 7 January 2020.

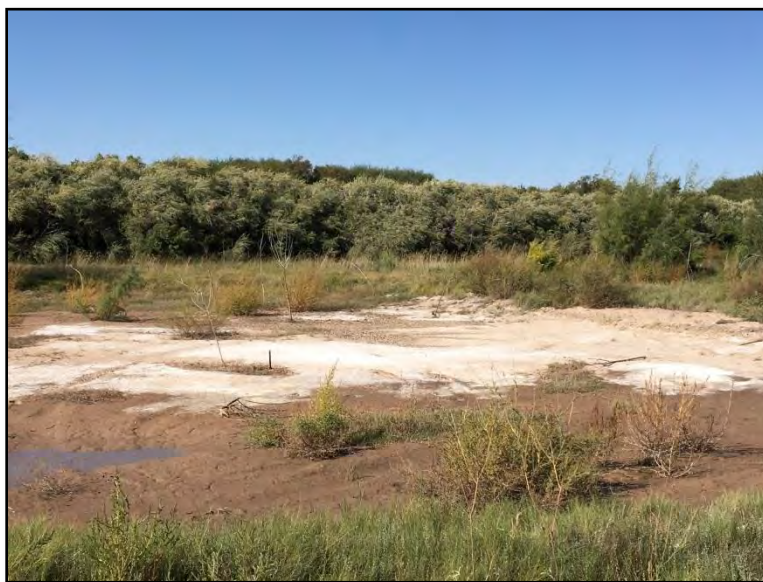
remain on the site for longer periods. While the water at high flow during the study was at the river bank top, conditions were never present to allow water to flow into the restoration sites from the cut banks. The swales did act for rain water retention; however, salt also tended to be concentrated in the swales.

**Swale at Country Club East with some salt accumulation,
16 October 2019.**
