FINAL ENVIRONMENTAL ASSESSMENT

IMPROVEMENTS TO THE ARROYO COLORADO SOUTH LEVEE, HIDALGO AND CAMERON COUNTIES, TEXAS

**United States Section,
International Boundary and
Water Commission**

November 2010

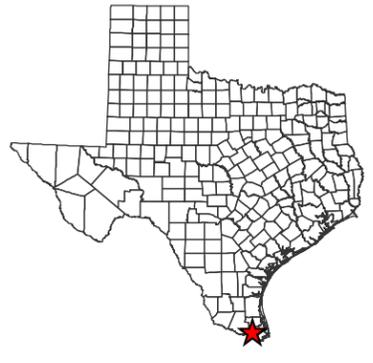
FIGURE 1.1

- ⊙ Levee Mile Markers
- South Levee Centerline

Source
 USGS Harlingen, La Feria, Mercedes, Progreso and Santa Maria Quadrangles (2002).
 Hidalgo and Cameron Counties, Texas

The Proposed Action would involve improvements to the Arroyo Colorado South Levee system (ACS) in order to address the 100-year flood protection criteria established by the Federal Emergency Management Agency (FEMA). Improvements to the ACS would include raising the levee by adding fill material to the existing levee to bring flood control to the original design specifications with a minimum of 3 feet of freeboard, the difference between the top of the levee and the designed water surface elevation. Figure 1.1 shows the layout of the upper and lower reaches of the project area, main geographical features, and levee mile markers. Appendix A provides detailed maps of the project area.

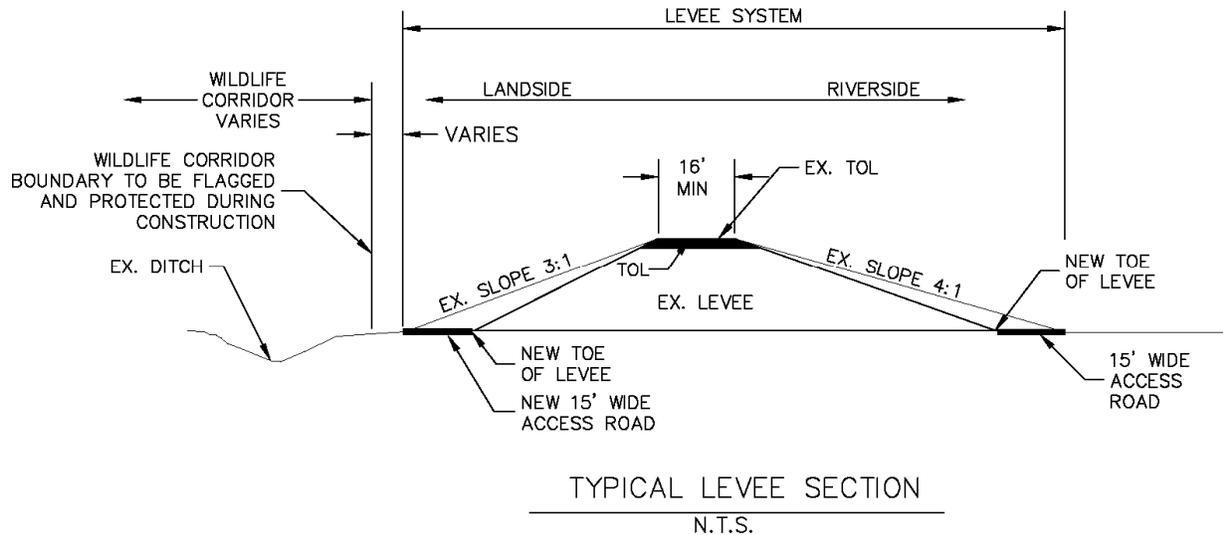
Figure 2-1: Typical Cross-section of a Levee Illustrating Footprint Expansion

Other modifications to the levee would include construction of a 15-foot wide access road on both the riverside and landside of the levee and widening of the levee crown to 16 feet where necessary. The riverside edge of the existing wildlife corridor would serve as the limits of construction for the landside of the levee, to the maximum extent practicable. A typical cross-section of a levee is shown in Figure 2.1.

Footprint expansion would occur entirely within the flood control project ROW. Structural improvements (e.g., seepage remediation) may be needed in some sections of the levee. These improvements would not contribute to footprint expansion of the current levee footprint. Structural improvements could include the following:

- Relief wells: construction of wells along the access road on the landside of the levee. Wells would be protected with a concrete vault below the access road grade and discharge water into the de facto wildlife corridor via pipe.
- Toe drain: construction of an underground drain at the landside toe of the levee to drain seepage away from the levee
- Cutoff trench: placement of impervious material into the levee foundation via trench
- Riverside impervious blankets: placement of impervious material along the riverside levee slope
- Floodwall: thin, vertical, structural barriers constructed atop an embankment levee as a supplemental extension
- Concrete rip-rap: placement of concrete grout on the riverside slope of the levee

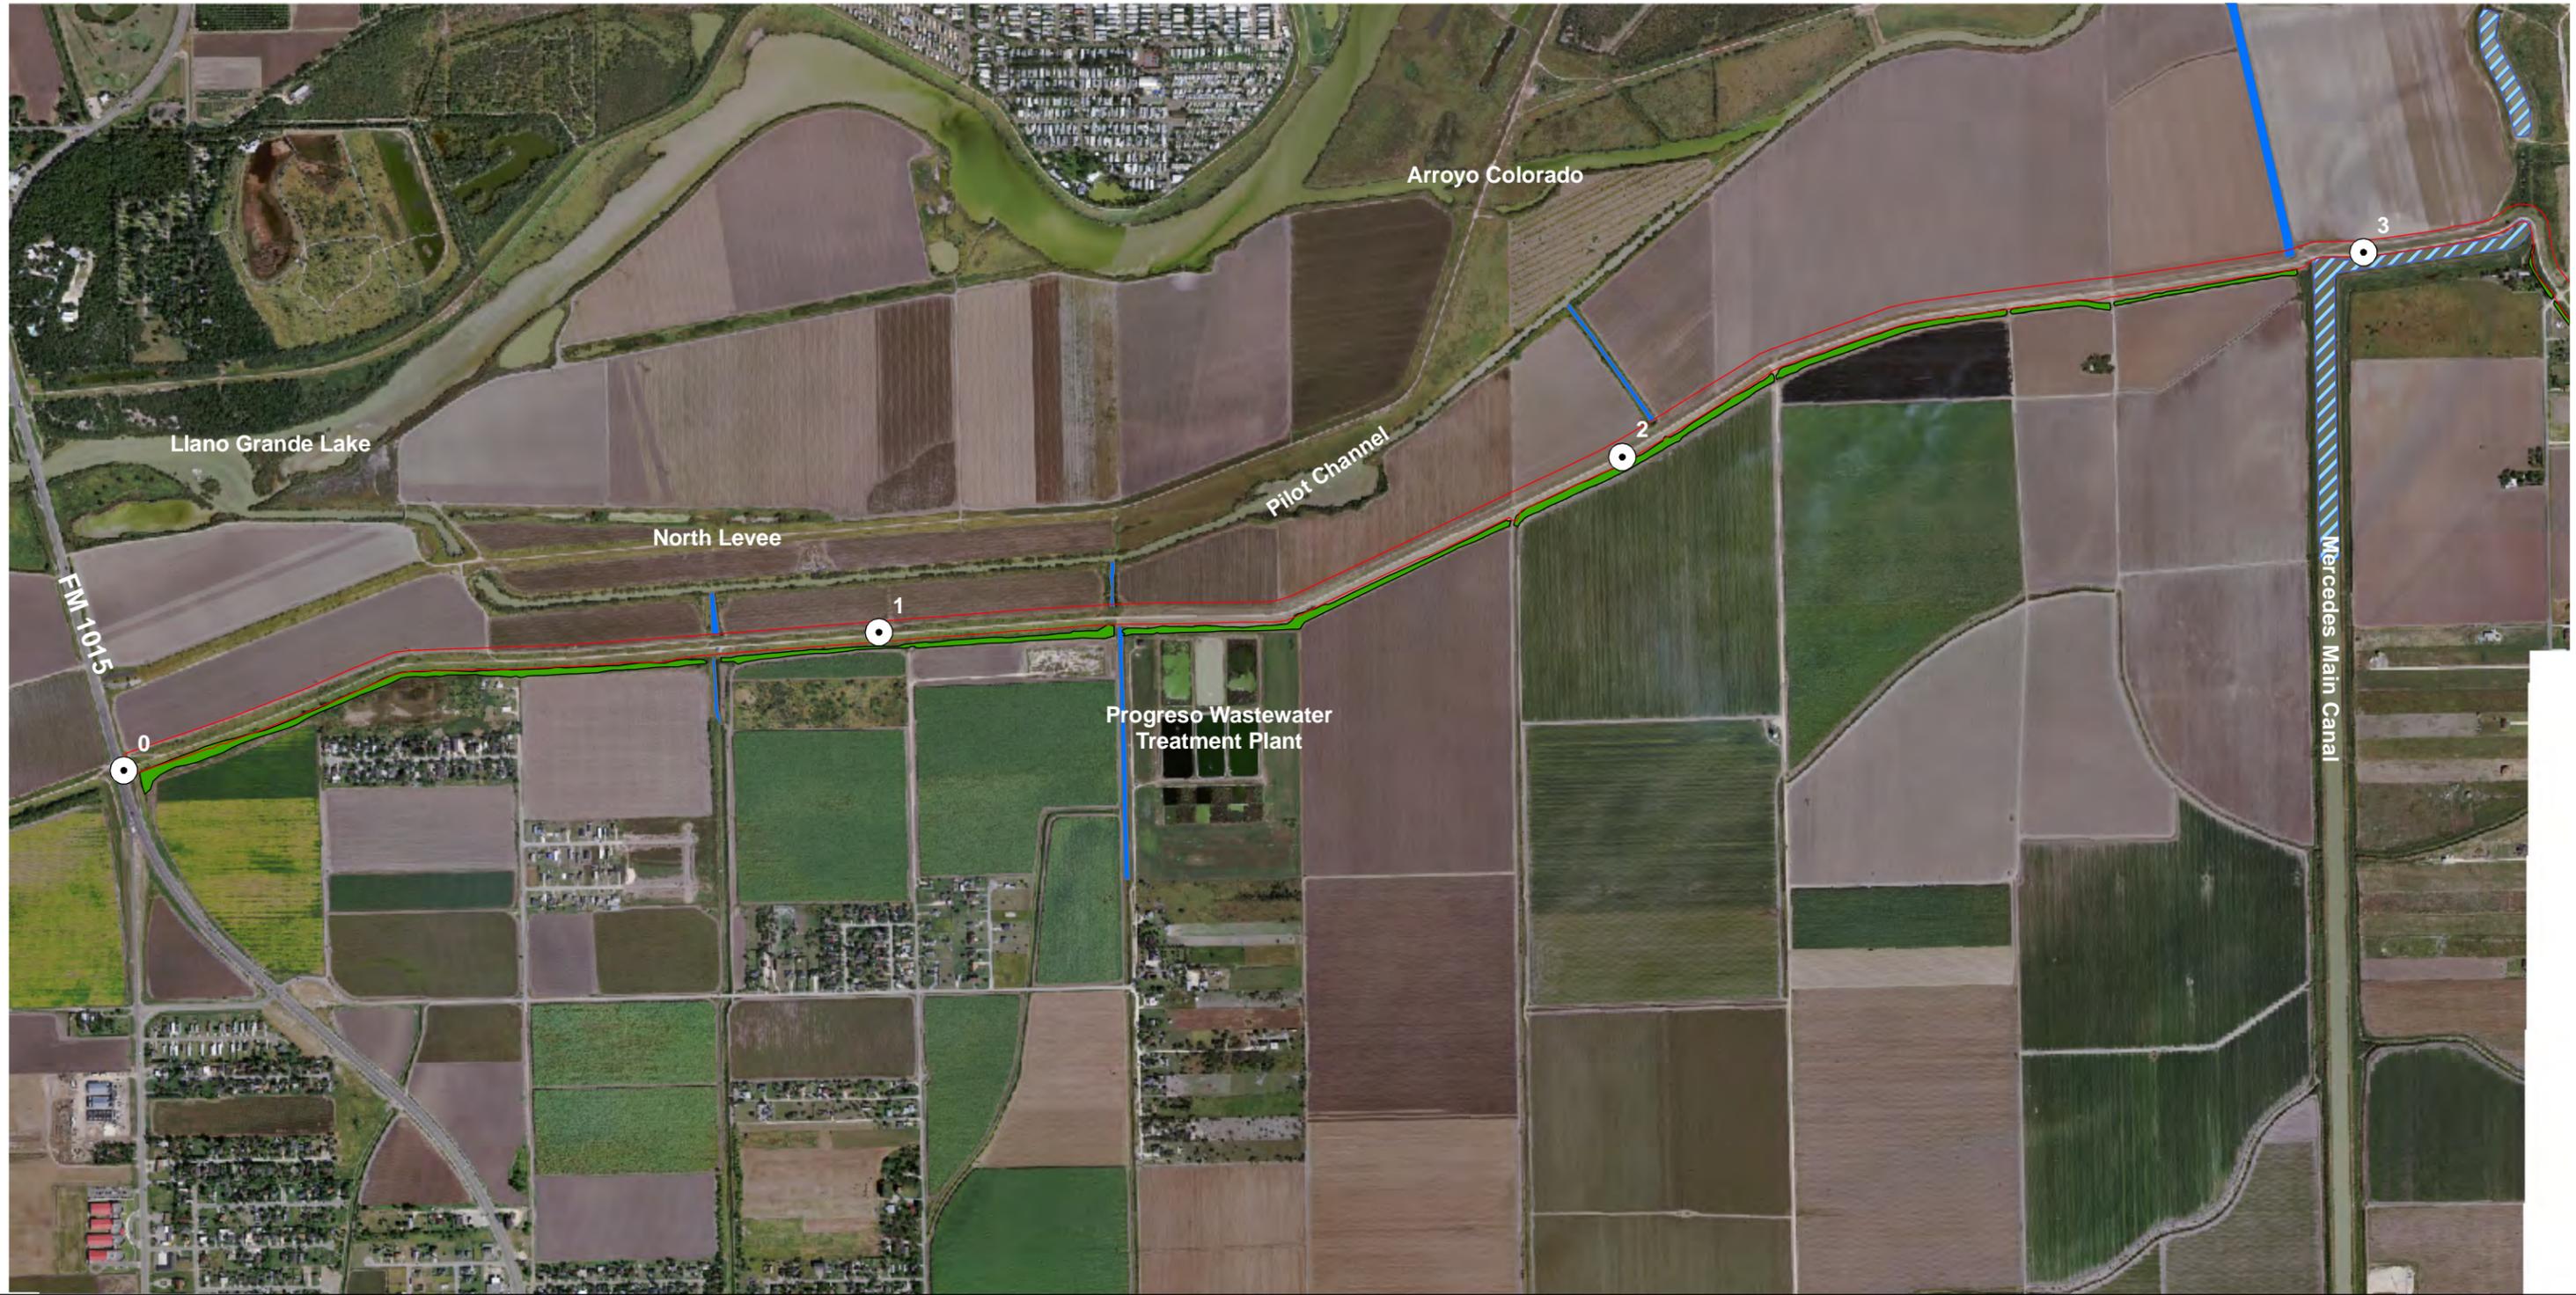
**APPENDIX A:
Detailed Maps of the Arroyo Colorado South Levee Project Area**

- Levee Mile Markers
- 100 Foot Construction Corridor
- Wildlife Corridor
- ▨ Borrow Pit
- Drainage Ditch
- ▨ Irrigation Canal
- Pond
- Stream

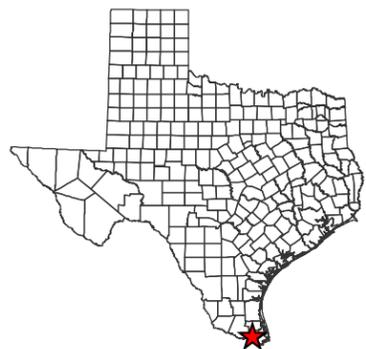
FIGURE 1
Site Location Map

Arroyo Colorado South Levee

- ◻ Mile Markers
- East End of Levee

The ACSL Project is located along the Arroyo Colorado South Levee from FM 1015 to Parker Road in Hidalgo and Cameron Counties, Texas (survey area). Where accessible, the survey area extended approximately 25 feet laterally beyond the toe of the levee on both sides for the entire 16 miles of ACSL right-of-way, which is regularly maintained by the USIBWC. A site location map is included as Figure 1.

The survey area is located along the south levee of the Arroyo Colorado and is approximately 3.5 to 8 miles north of the Rio Grande (Figure 1). The entire Project area is located within the South Laguna Madre Watershed (U.S. Environmental Protection Agency [USEPA] 2010).

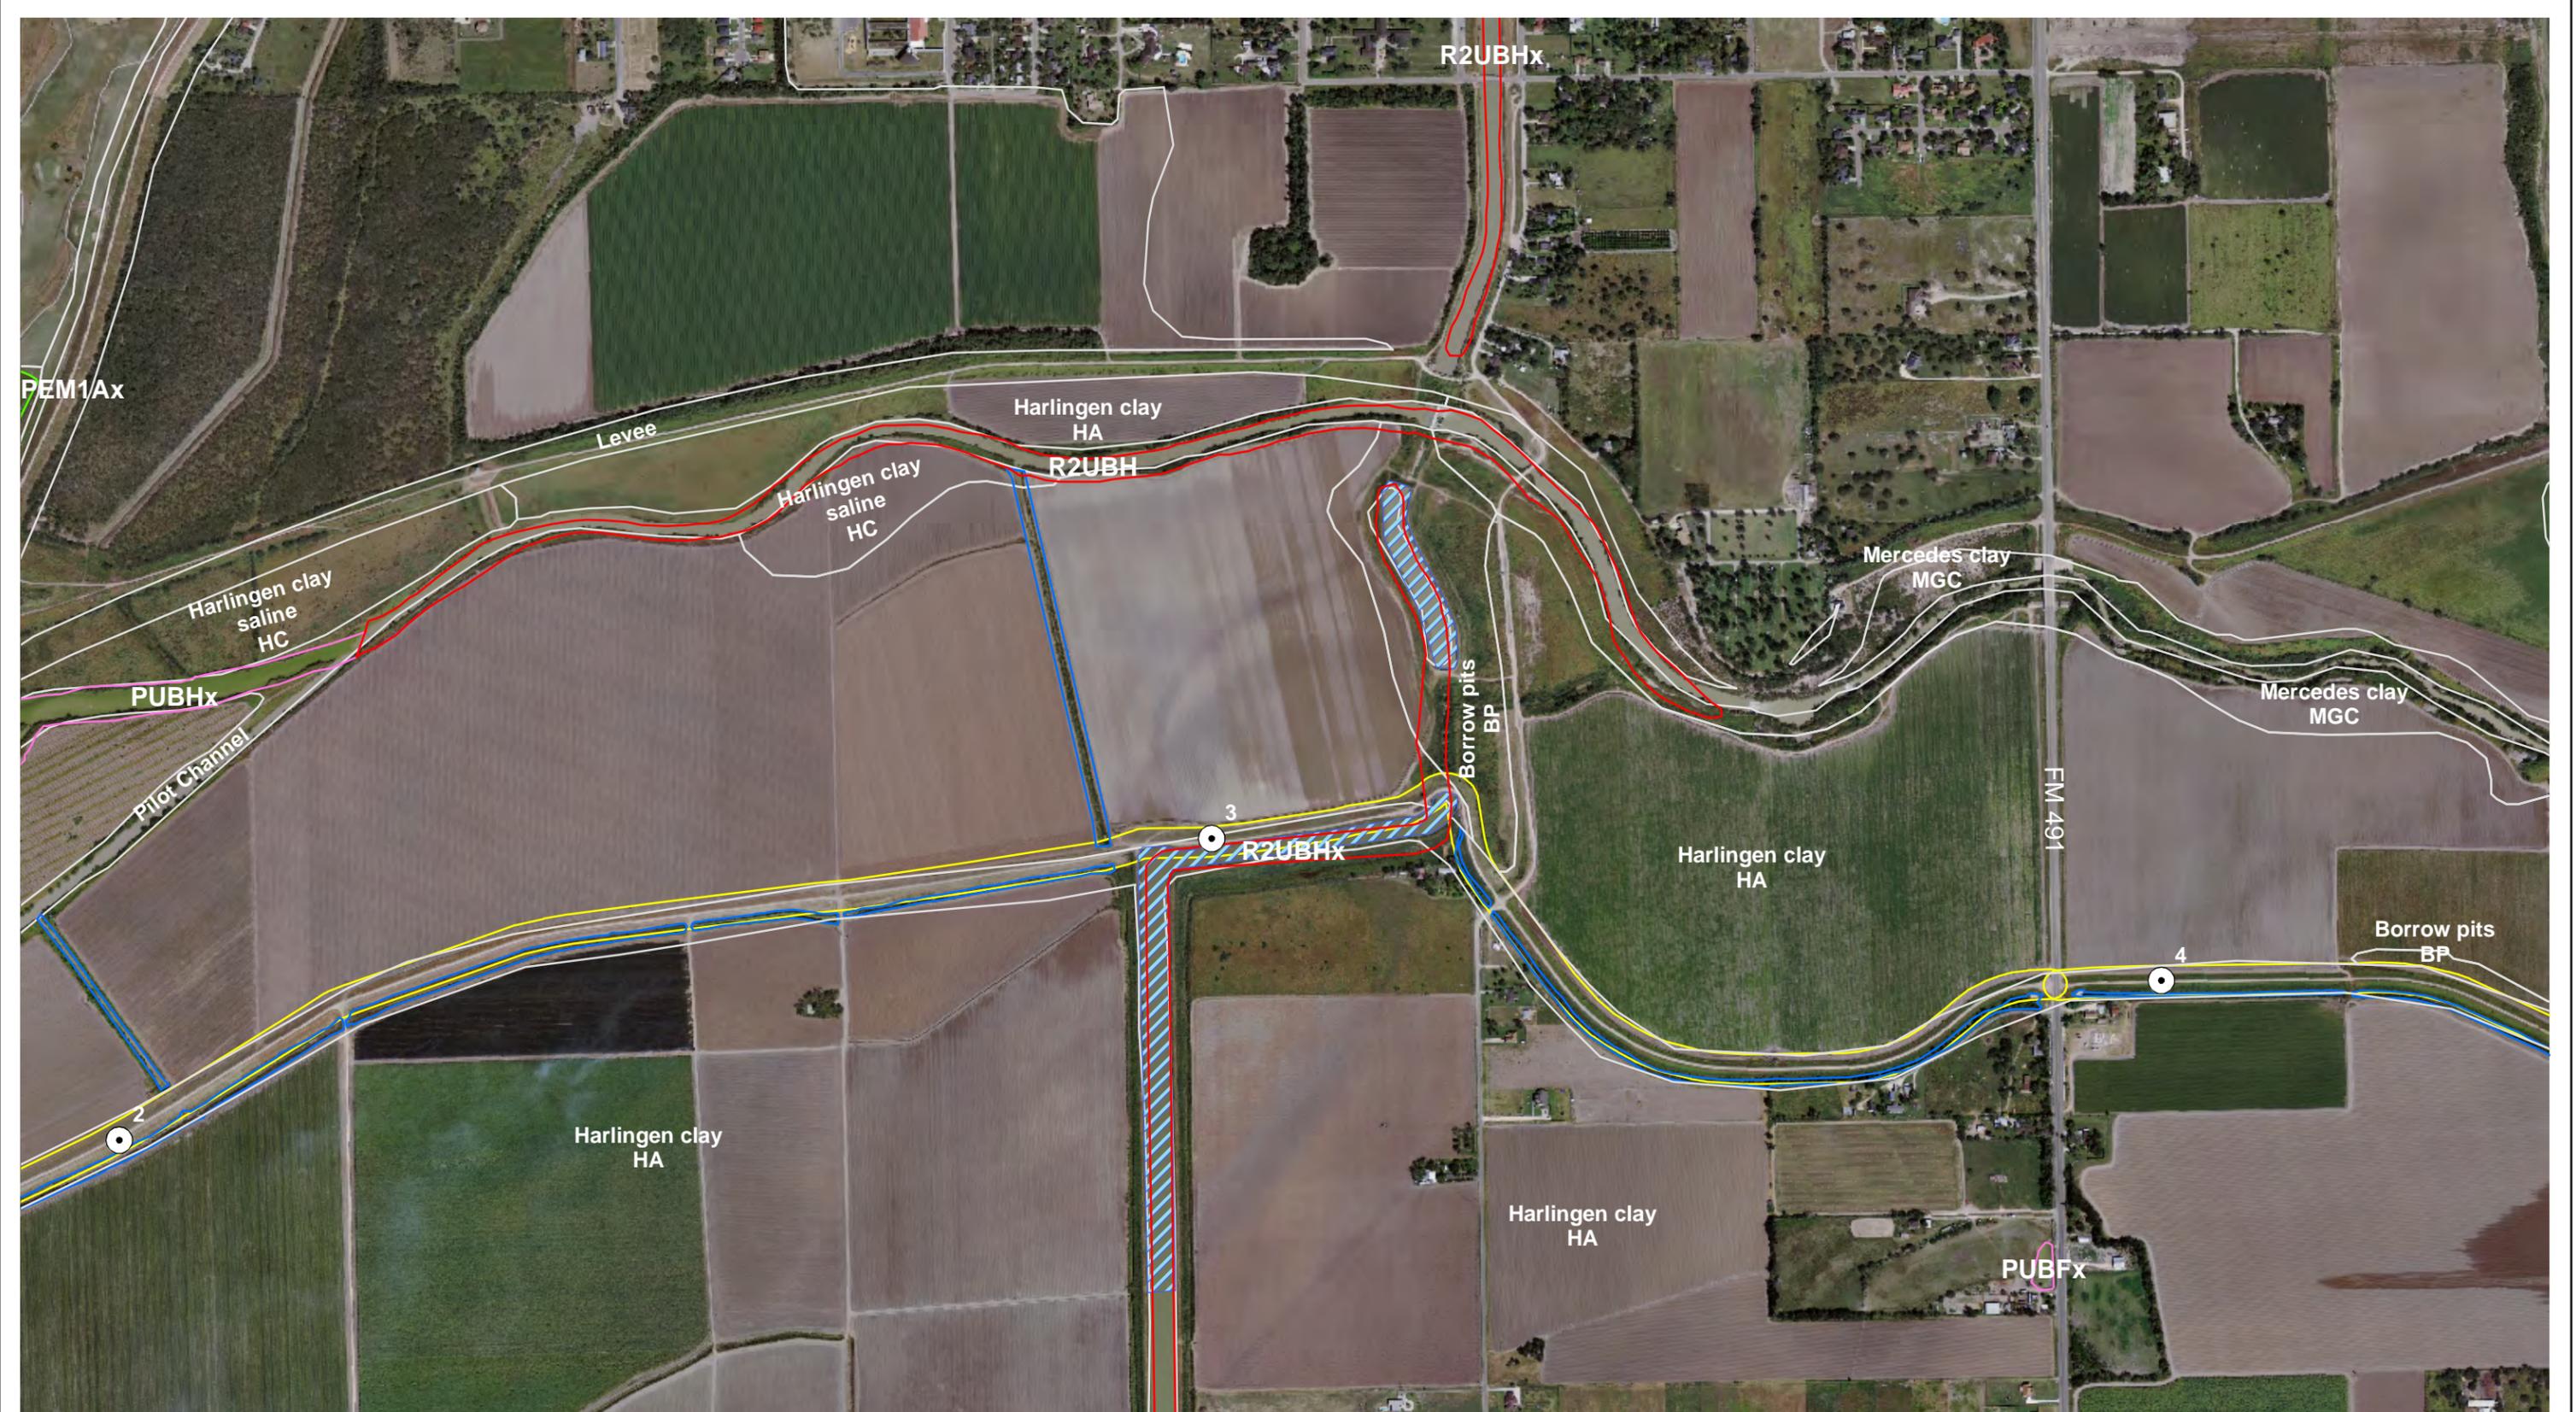
FIGURE 2
Soils Map
Sheet 1 of 7

Arroyo Colorado South Levee
International Boundary and Water Commission
United States Section

| Mile Markers | Freshwater Emergent Wetland |

Desktop analysis of potential Waters of the U.S. was conducted by reviewing topographic (Figures 1), and USFWS NWI (2010) online wetland mapper and hydric soils data from the USDA – NRCS (2010) online web soil survey data (Figures 2 through 8). This analysis provided an indication of the presence of wetlands and waterbodies, areas and soils likely to support hydrophytic vegetation, and photographic signatures of potential wetlands and waterbodies. It should be noted that the status of the wetlands presented on the NWI online mapper that were outside of the survey corridor could not be verified.

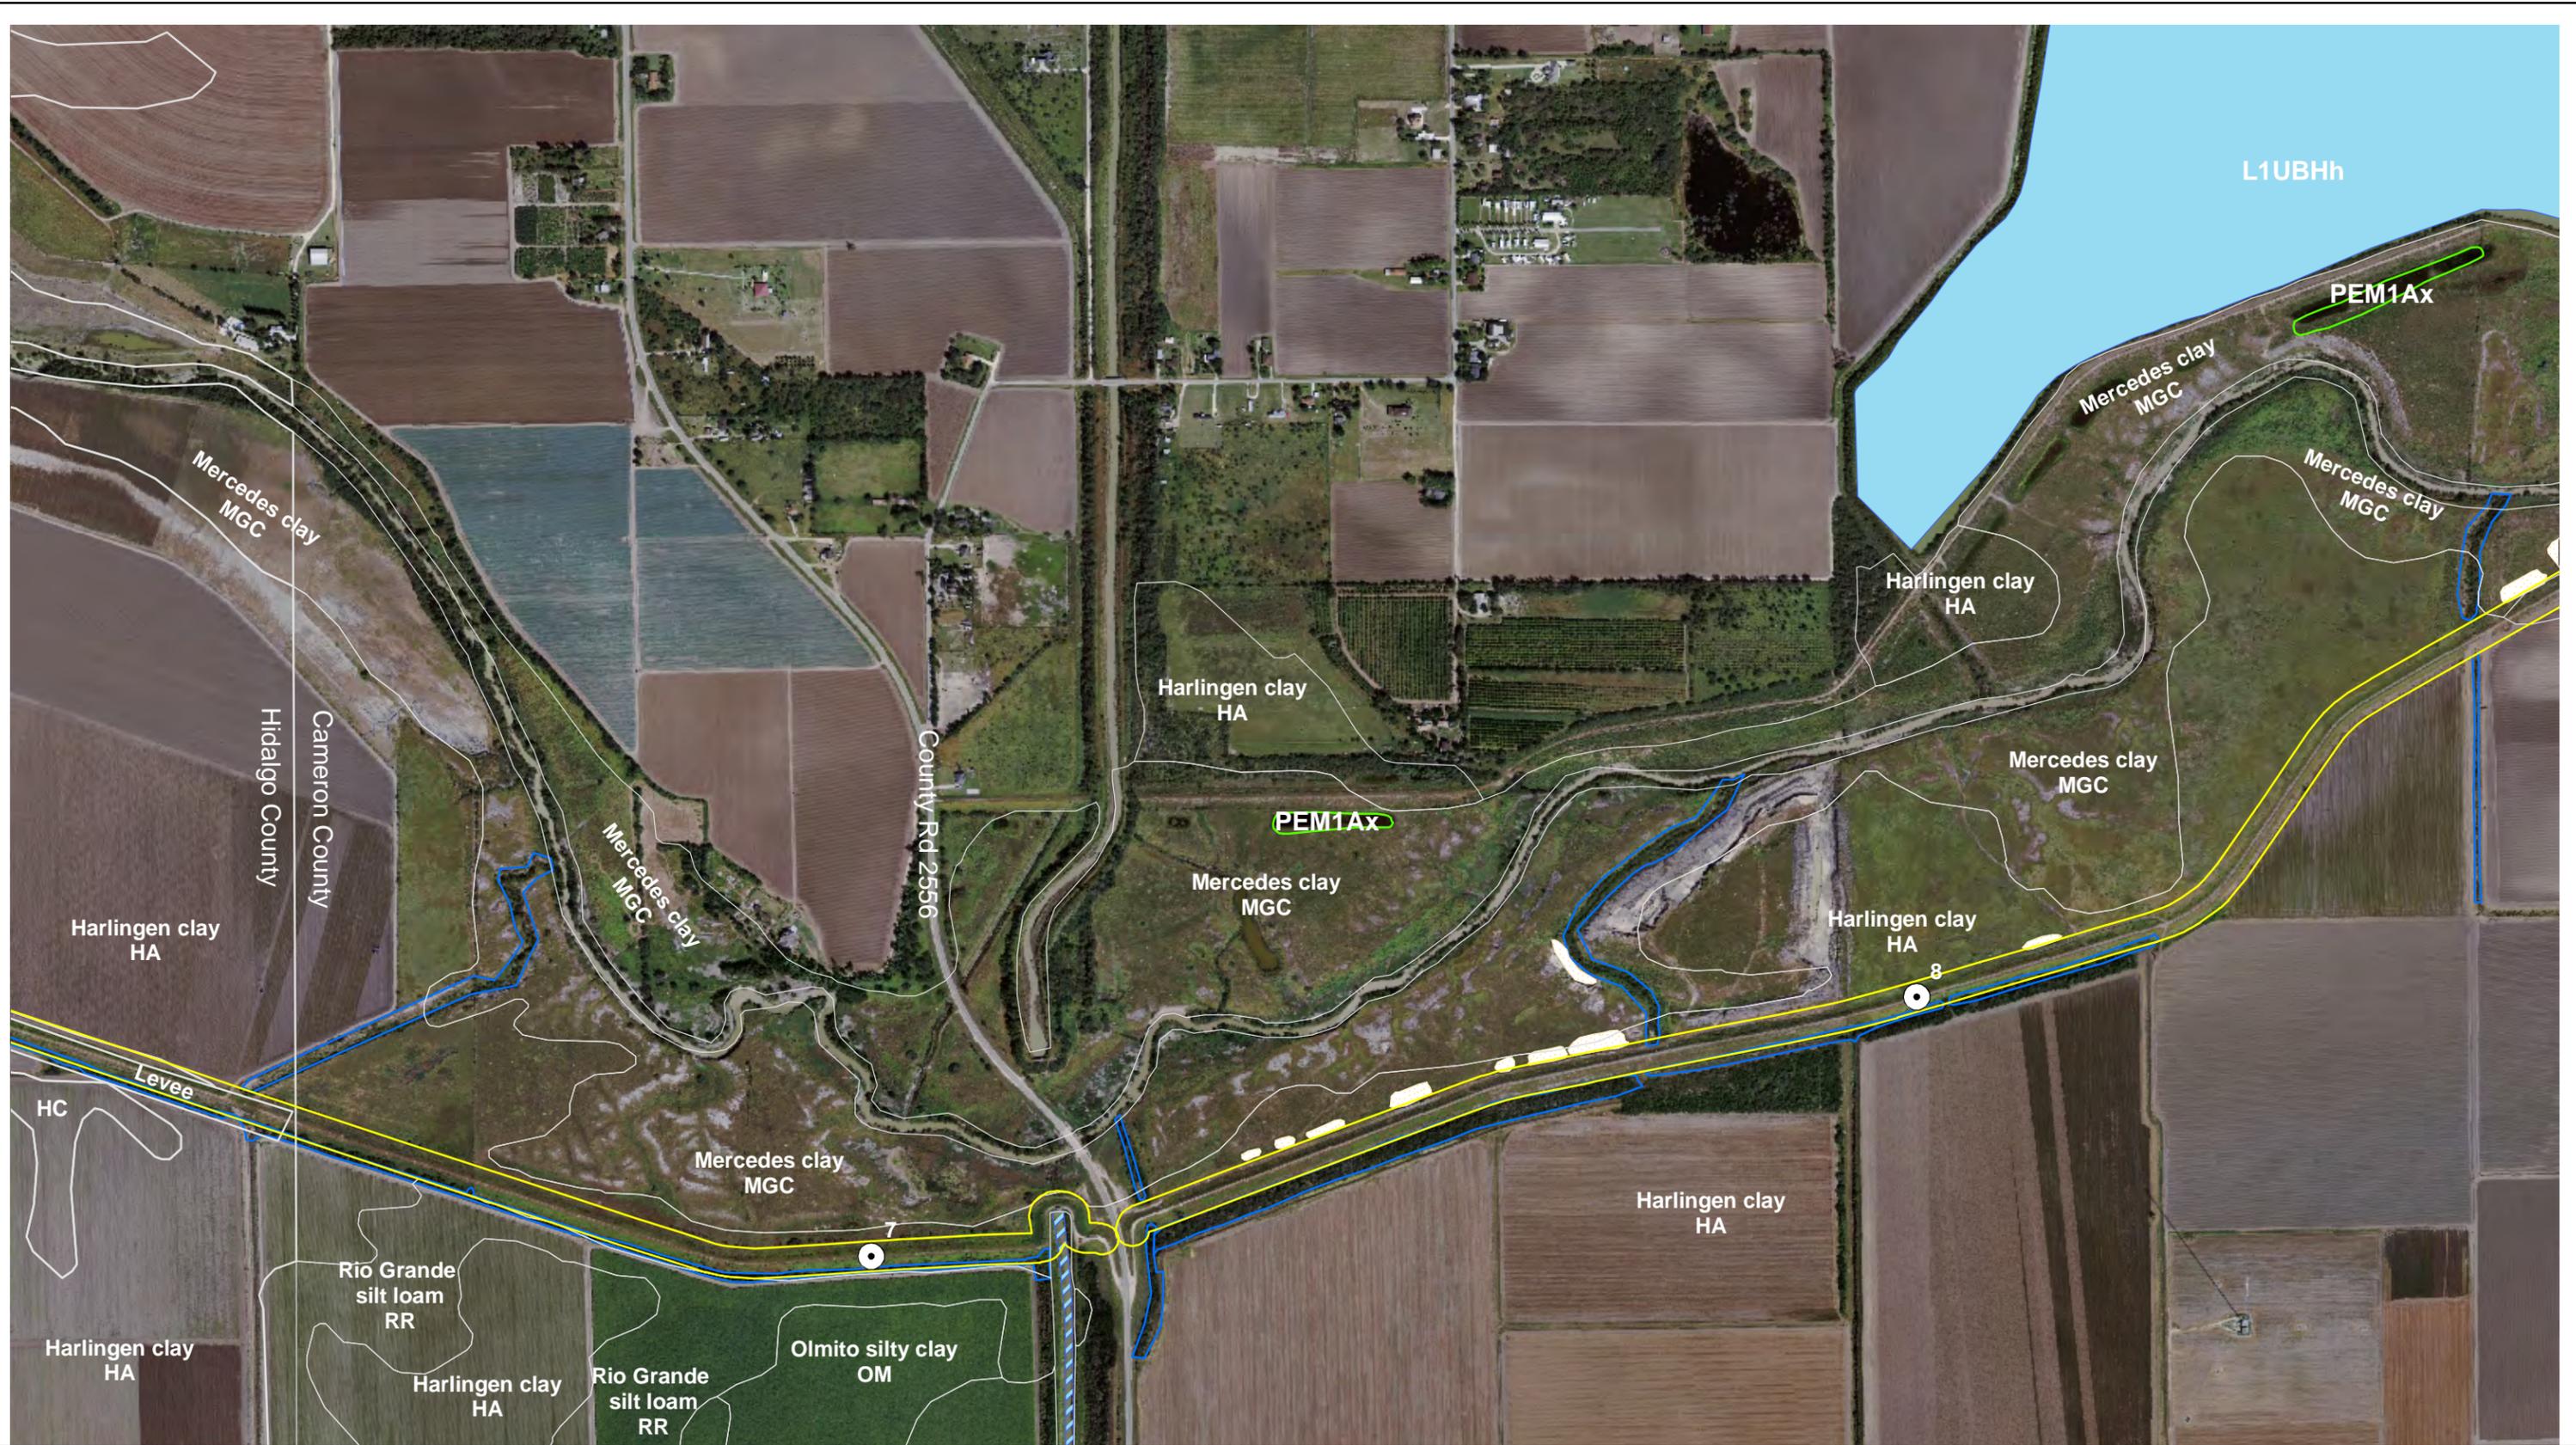
FIGURE 4
Soils Map
Sheet 3 of 7

Arroyo Colorado South Levee
 International Boundary and Water Commission
 United States Section

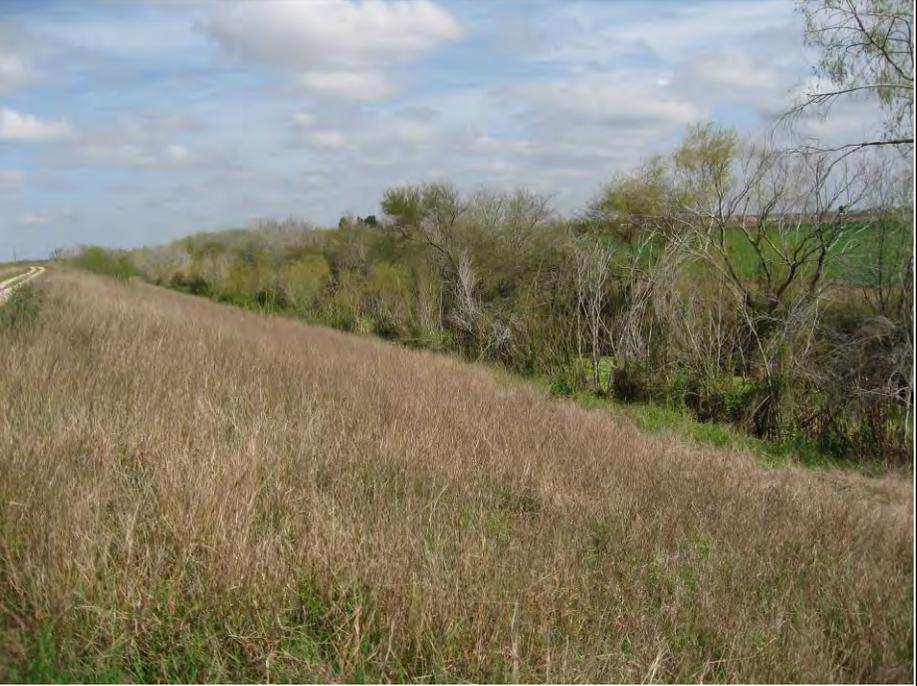
Feature: Agricultural/ Levee Borrow Ditch		
Date: 2/22/2010		
Comments: Agricultural/ Levee borrow ditch adjacent to and paralleling south levee with woody vegetation. Agricultural field in background. Facing southeast.		
Photograph ID: 2

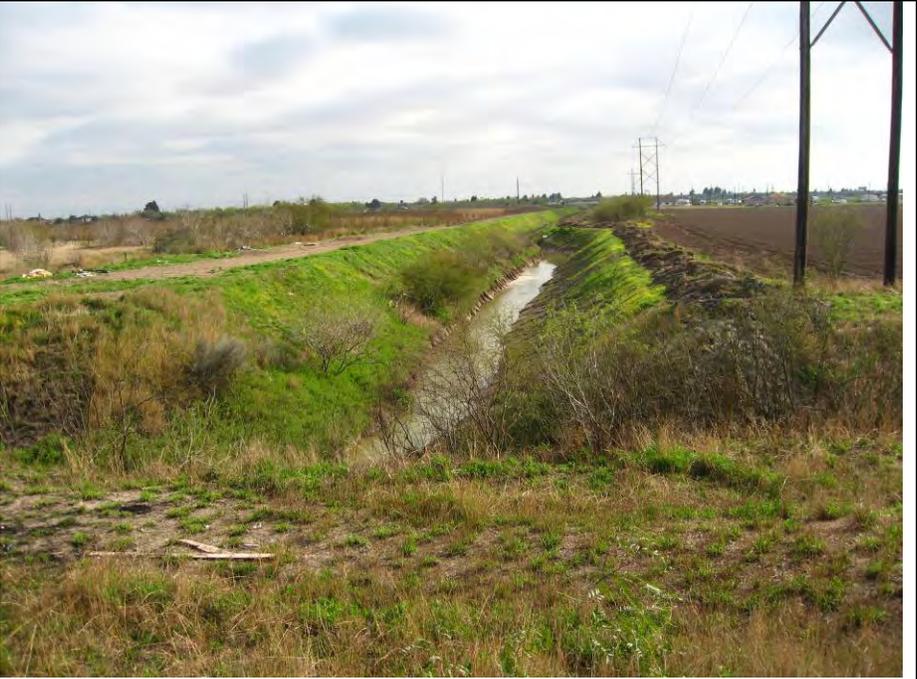
Feature: Agricultural drainage canal		
Date: 2/22/2010		
Comments: Agricultural drainage canal near levee mile 1. Facing south, upstream of south levee crossing.

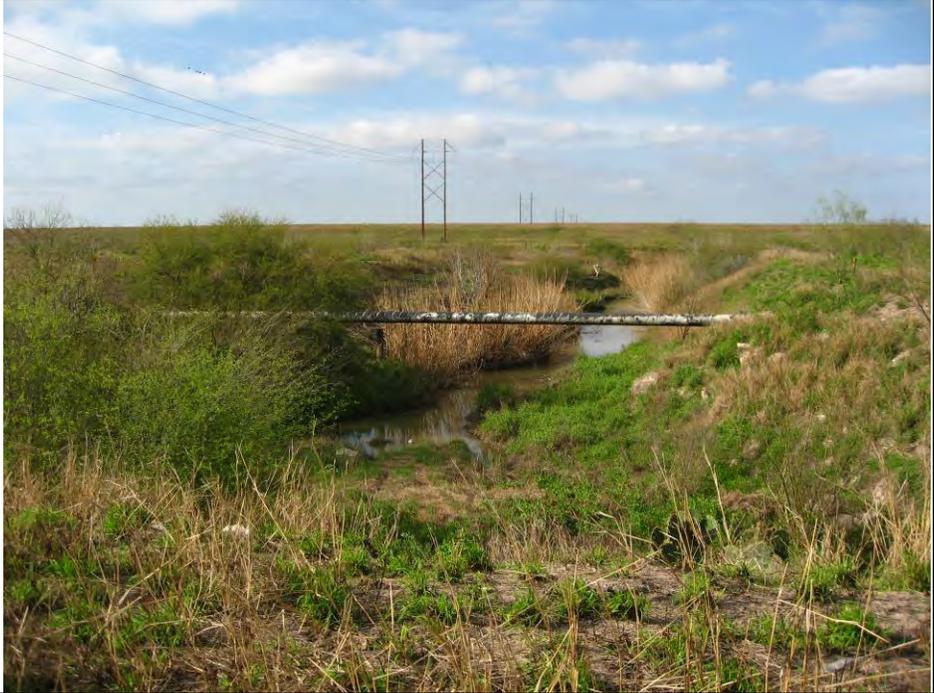
Feature: Agricultural drainage canal	
Date: 2/22/2010	
Comments: Agricultural drainage canal near levee mile 1. Facing north, downstream of south levee crossing.	
Photograph ID: 4

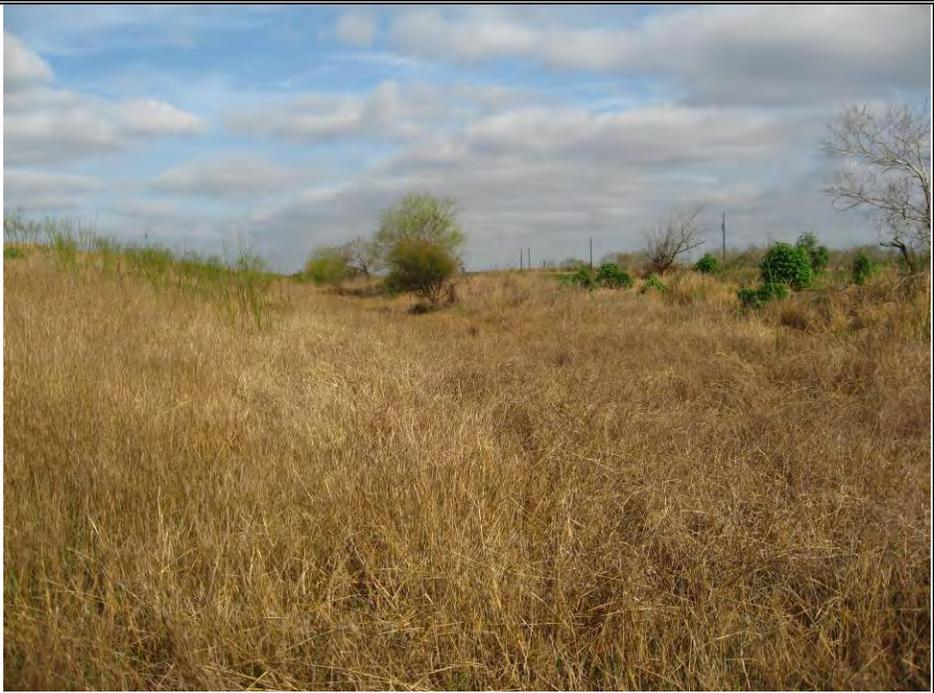
Feature: Agricultural/levee borrow ditch	
Date: 2/22/2010	
Comments: Agricultural/levee borrow ditch adjacent to and paralleling the south levee. Upland vegetation. Facing east.

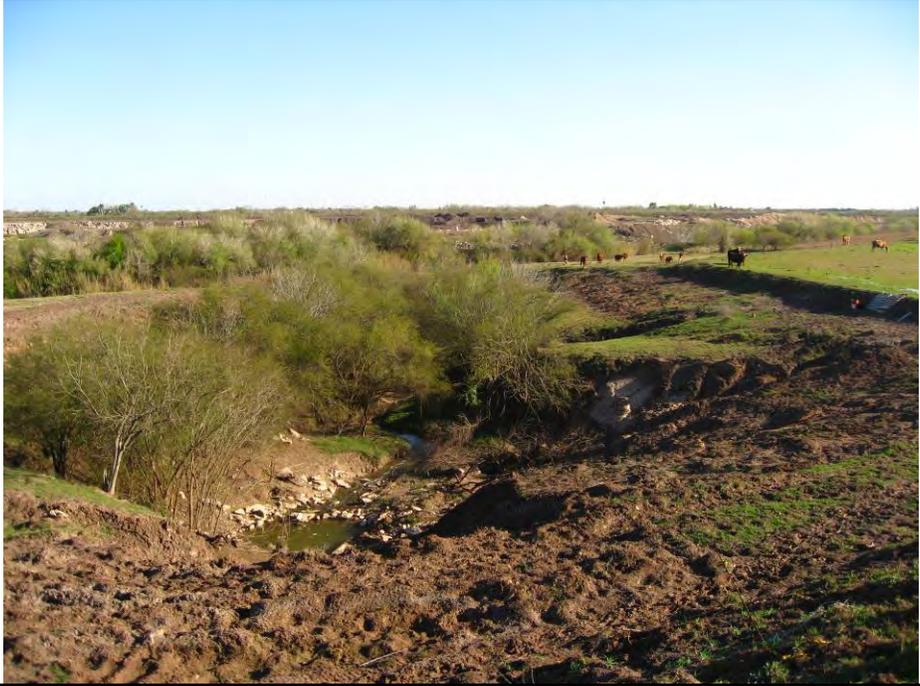
Feature: Agricultural drainage canal	
Date: 2/22/2010	
Comments: Eroded agricultural drainage canal at levee mile 10. Facing north, downstream of south levee crossing. Active cattle rangeland.	
Photograph ID: 6

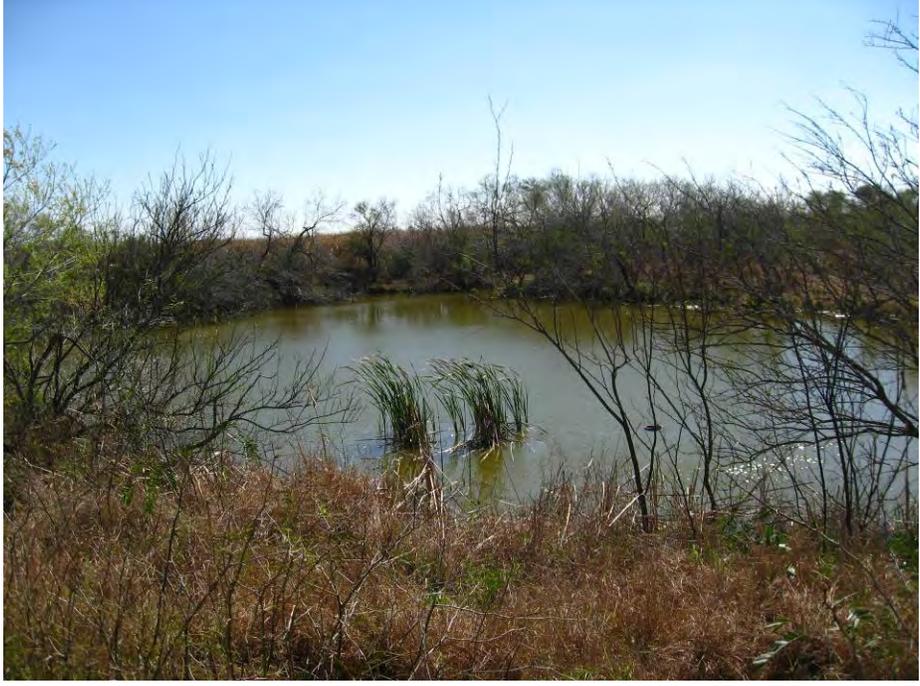
Feature: Impounded drainage canal	
Date: 2/22/2010	
Comments: Impounded drainage canal at levee mile 14. Facing south.

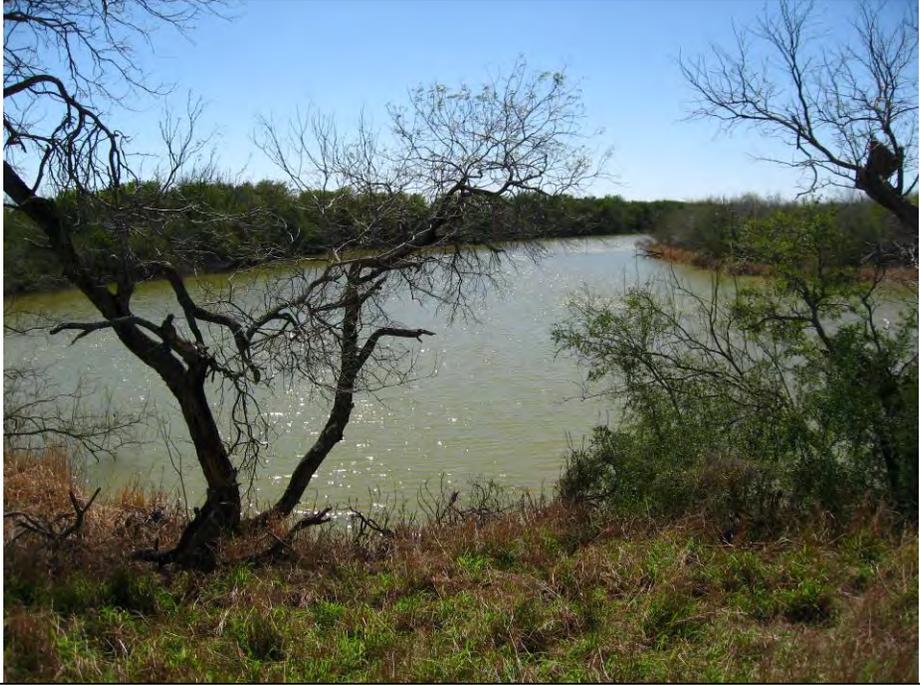
Feature: Impounded drainage canal	
Date: 2/22/2010	
Comments: Impounded drainage canal at levee mile 15. Facing south.	
Photograph ID: 8

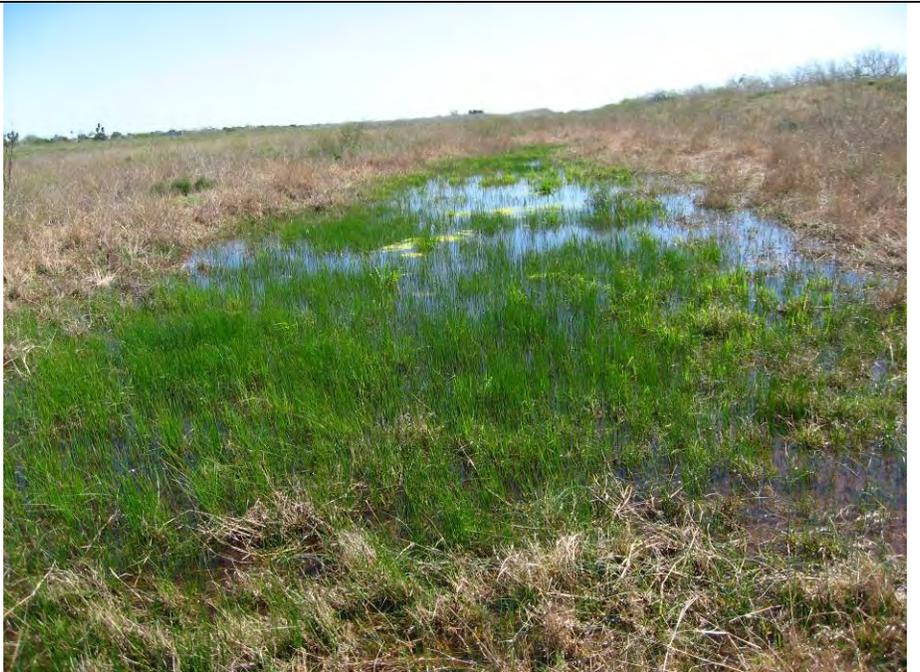
Feature: Wetland A – Levee borrow pit	
Date: 2/25/2010	
Comments: Wetland A, Levee construction borrow pit. Facing east.

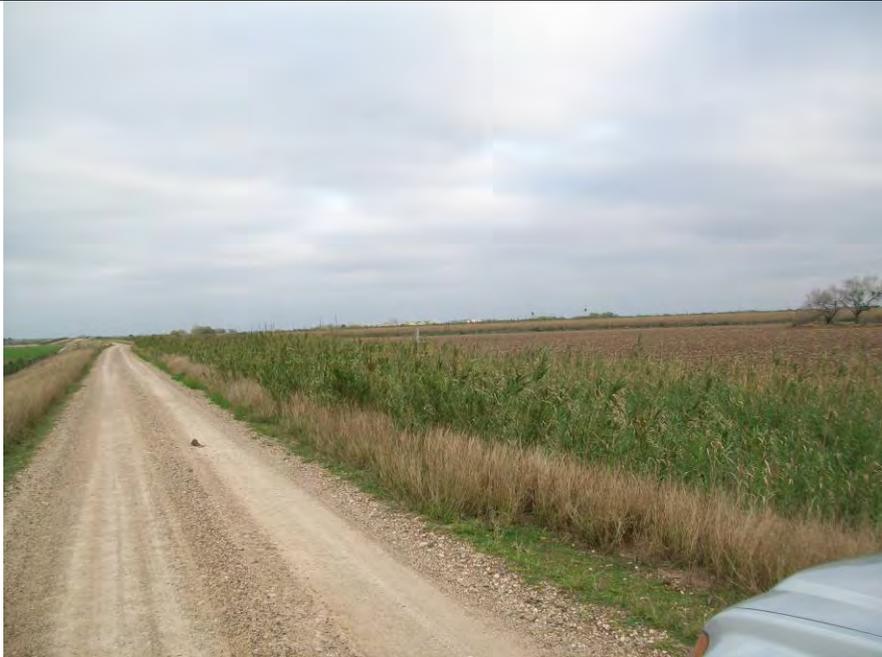
Feature: Agricultural/ levee borrow ditch	
Date: 2/24/2010	
Comments: Agricultural/ Levee borrow ditch adjacent to and paralleling south levee with emergent vegetation. Agricultural field in background. Facing southeast.	
Photograph ID: 10

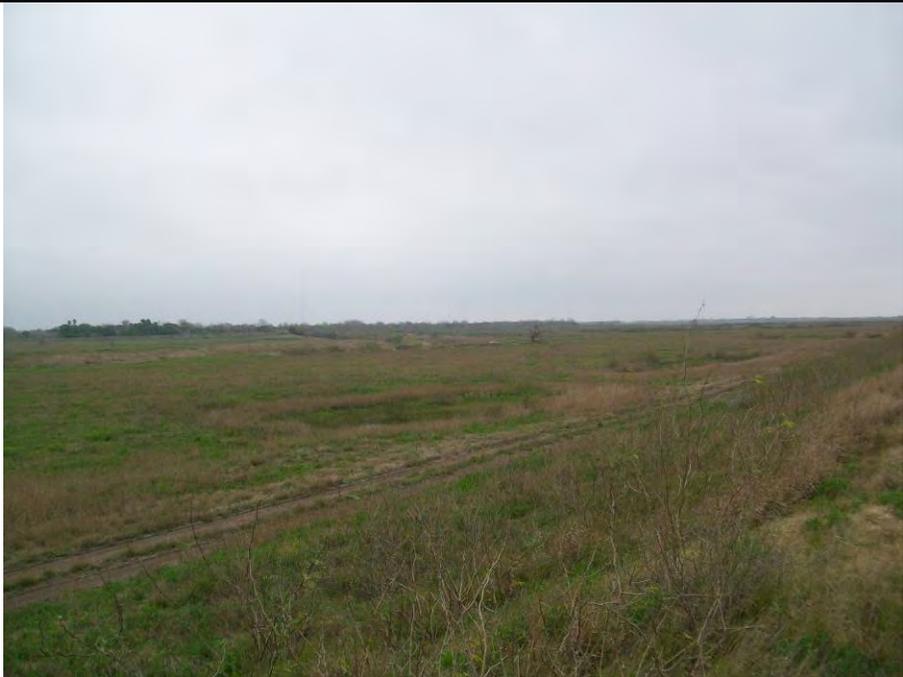
Feature: Levee borrow pits.	
Date: 2/24/2010	
Comments: Non-wetland levee borrow pits within old- field/rangeland. Facing northeast.

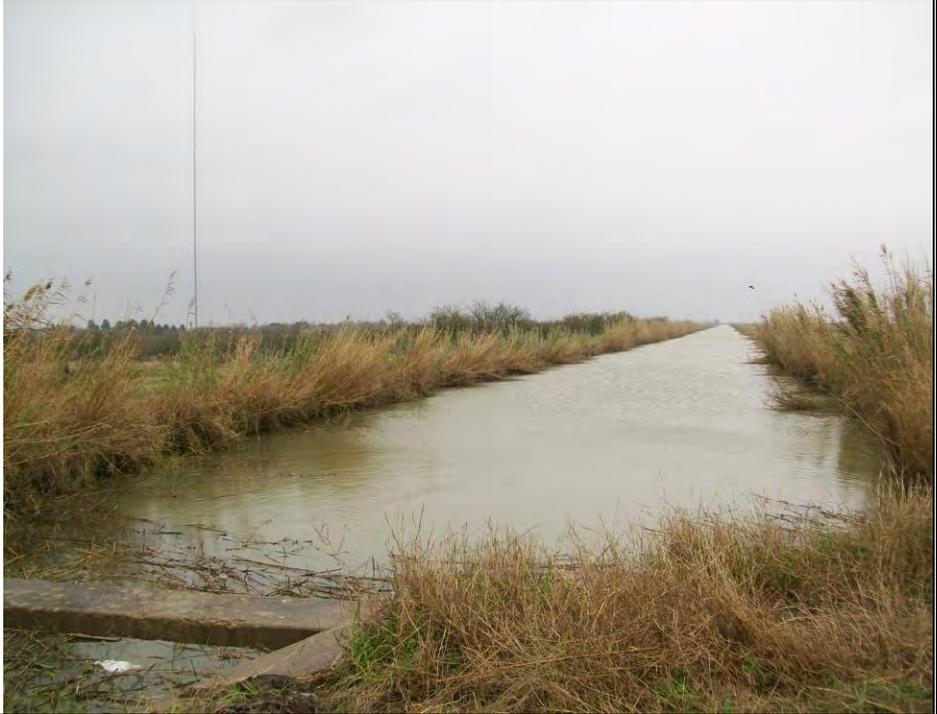
Feature: Irrigation canal	
Date: 2/24/2010	
Comments: Irrigation canal at levee mile 9. Facing south.

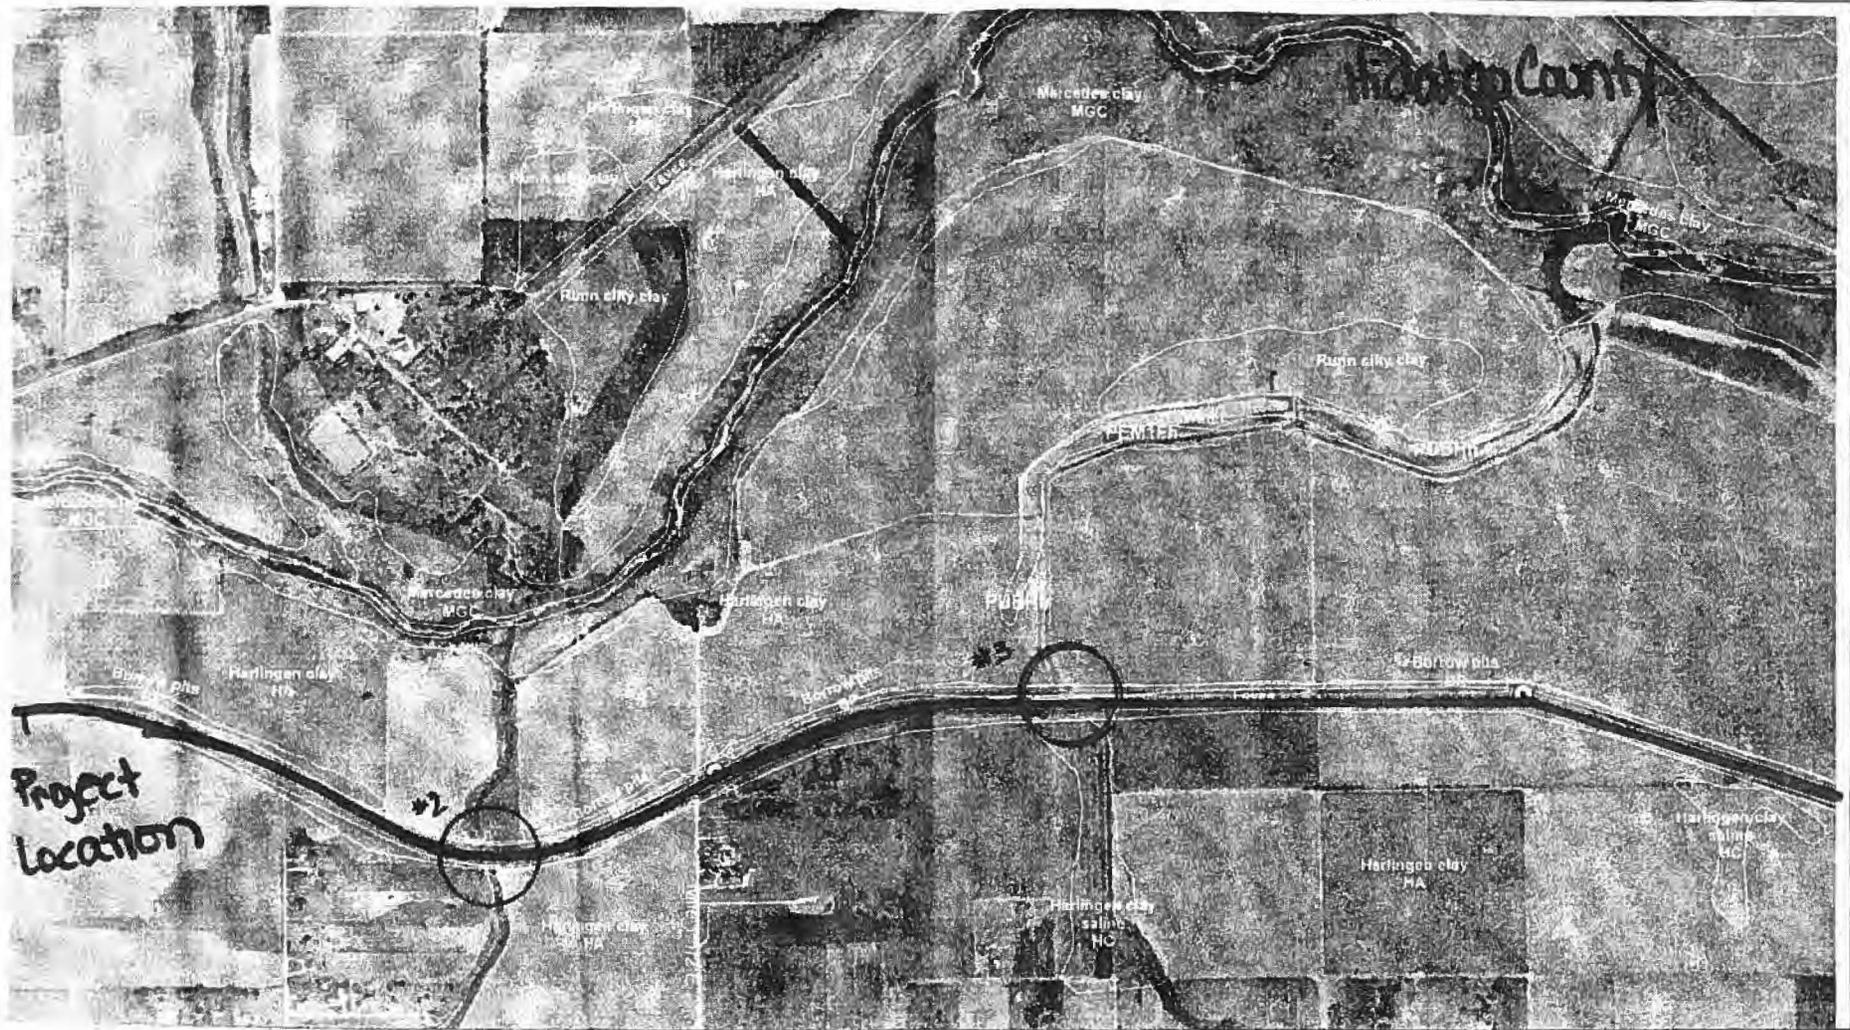
FIGURE 4
Soils Map
Sheet 3 of 7
Arroyo Colorado South Levee
 International Boundary and Water Commission
 United States Section

Mile Marker	Freshwater Emergent Wetland
Soil Boundary	Freshwater Pond
Survey Area	Lake
Drainage Ditch	Riverine
Elevation Contour

Source: 1. Aerial, National Geospatial Intelligence Agency (2009).
 2. Soils, USDA-NRCS SSURGO Database, Hidalgo County, Texas
 3. Wetlands, USDOI-USFWS National Wetland Inventory (2010)
