FINAL REPORT

THE CONSTRUCTION OF THE CANALIZATION FEATURE

RIO GRANDE CANALIZATION PROJECT

W. W. Baker  
Project Engineer

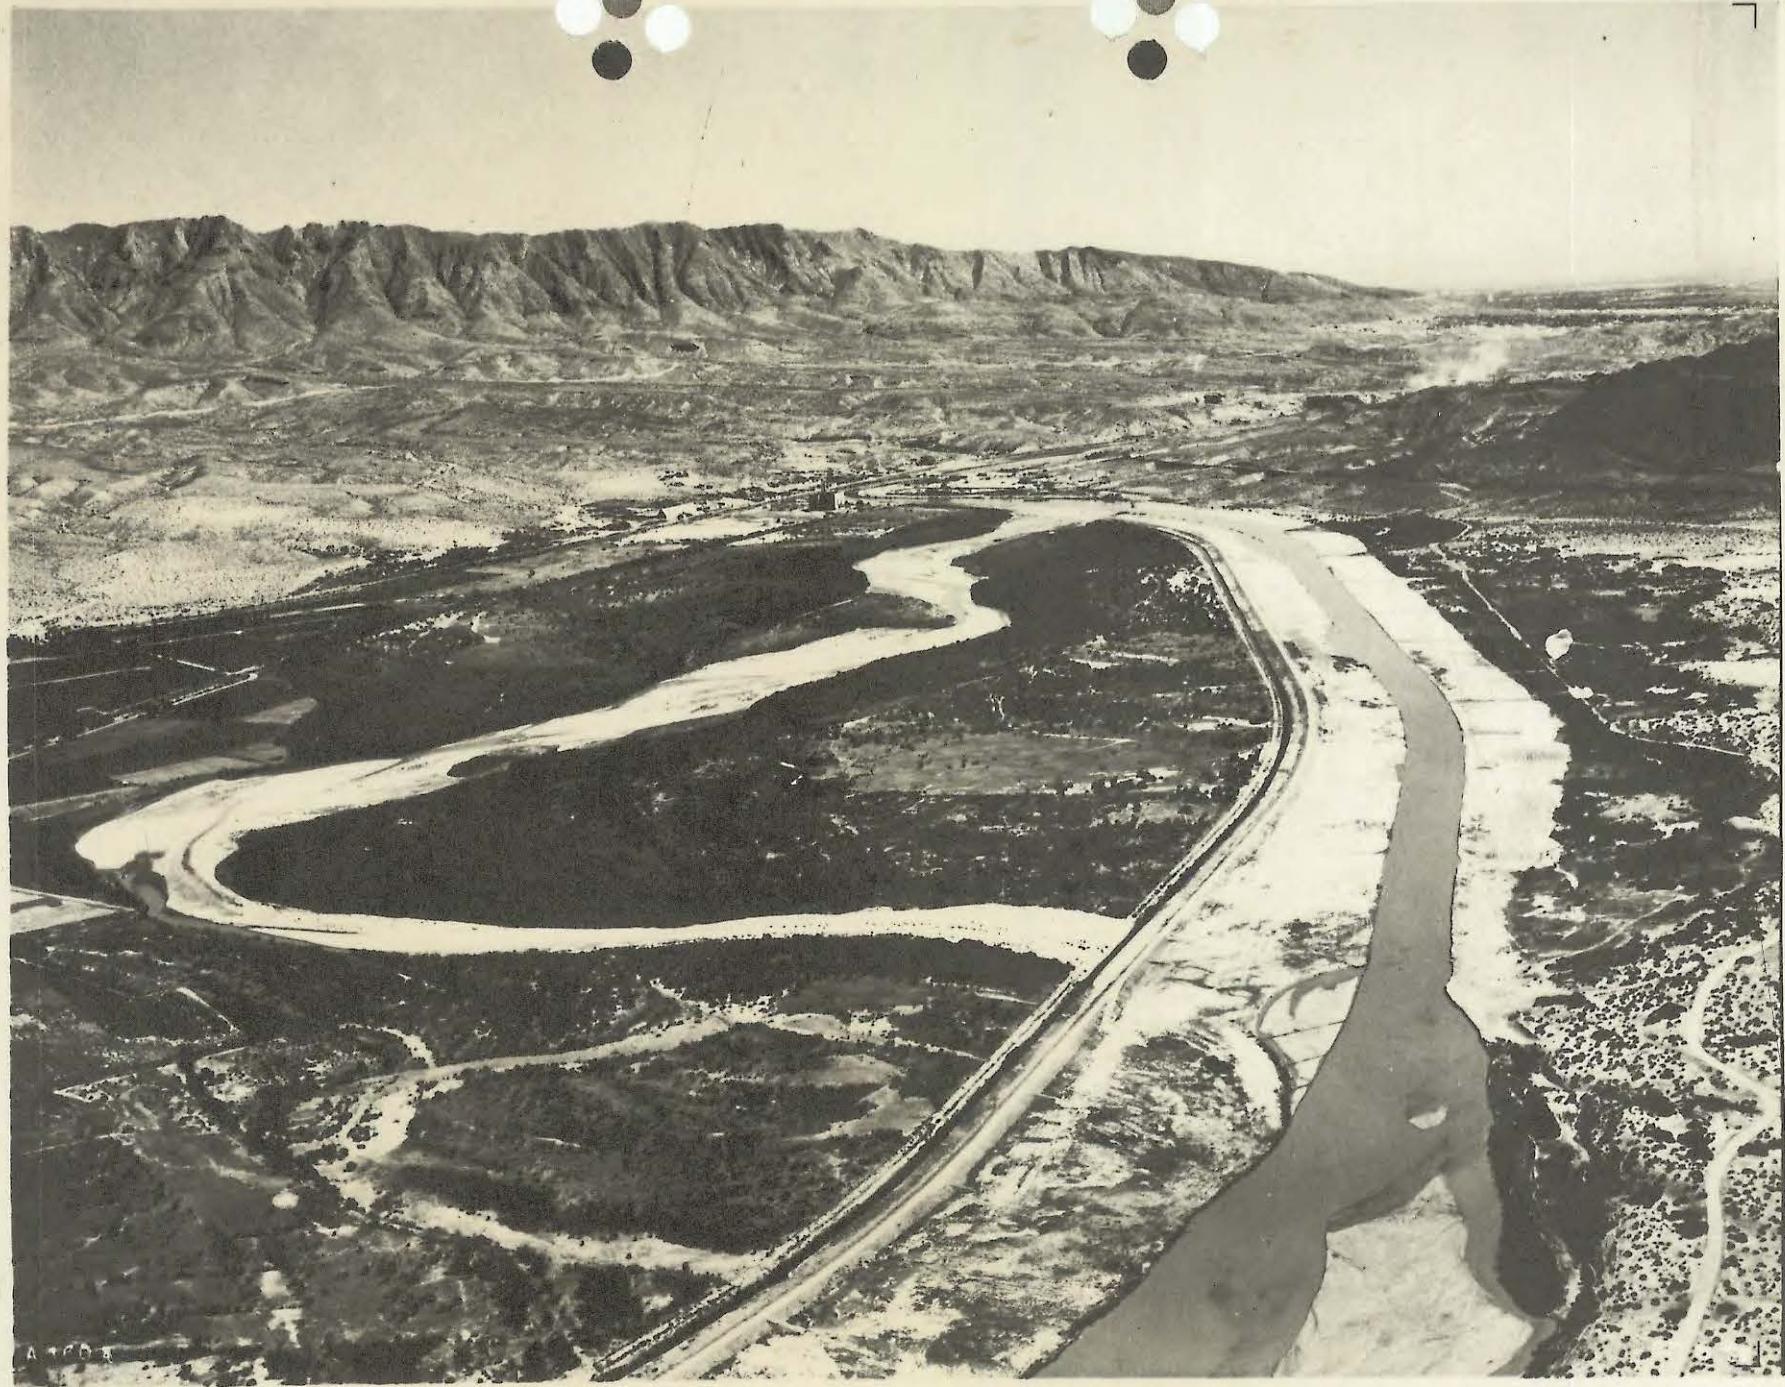
Downstream View of Jundt Cut-off

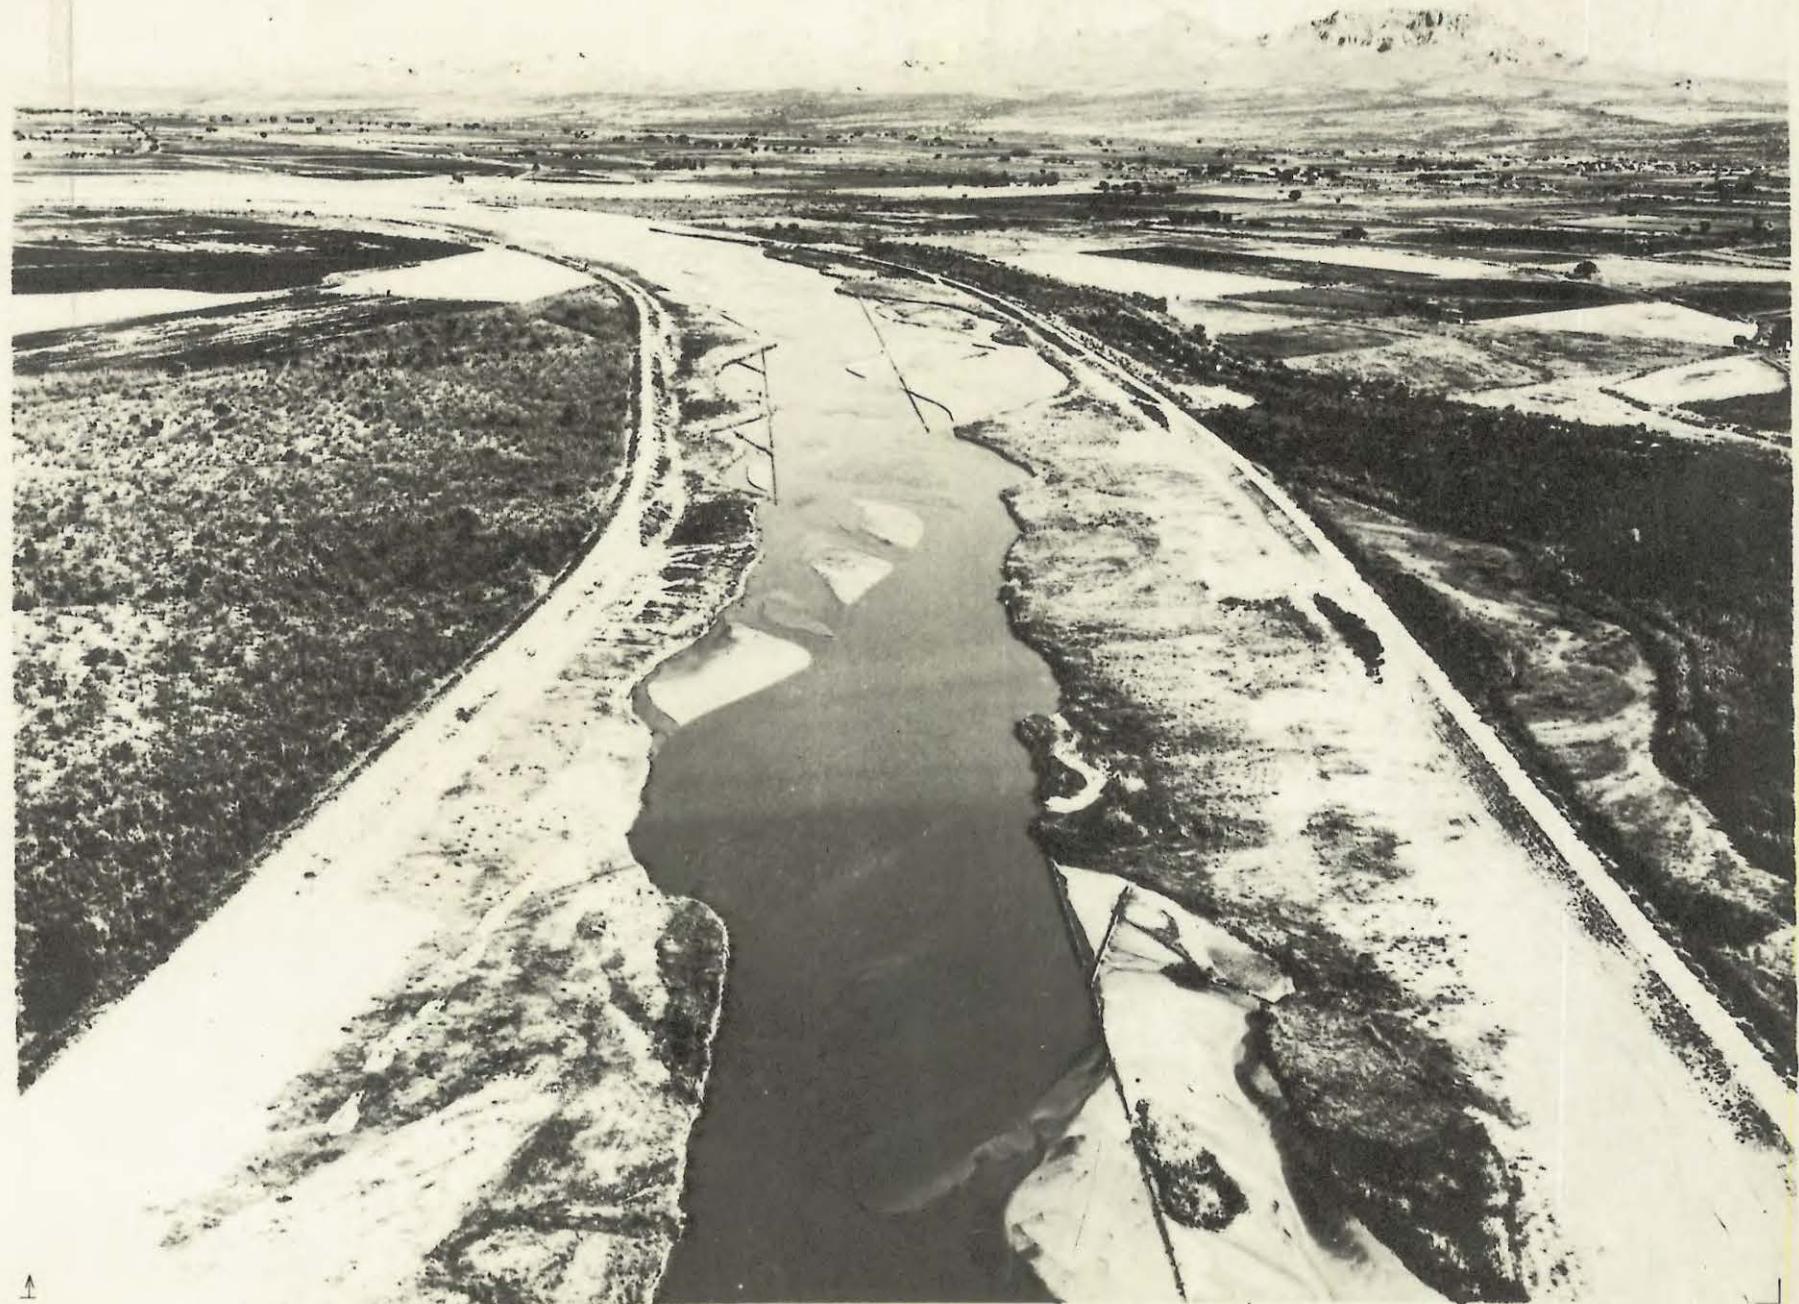
Shalem Bend ~ Looking Upstream

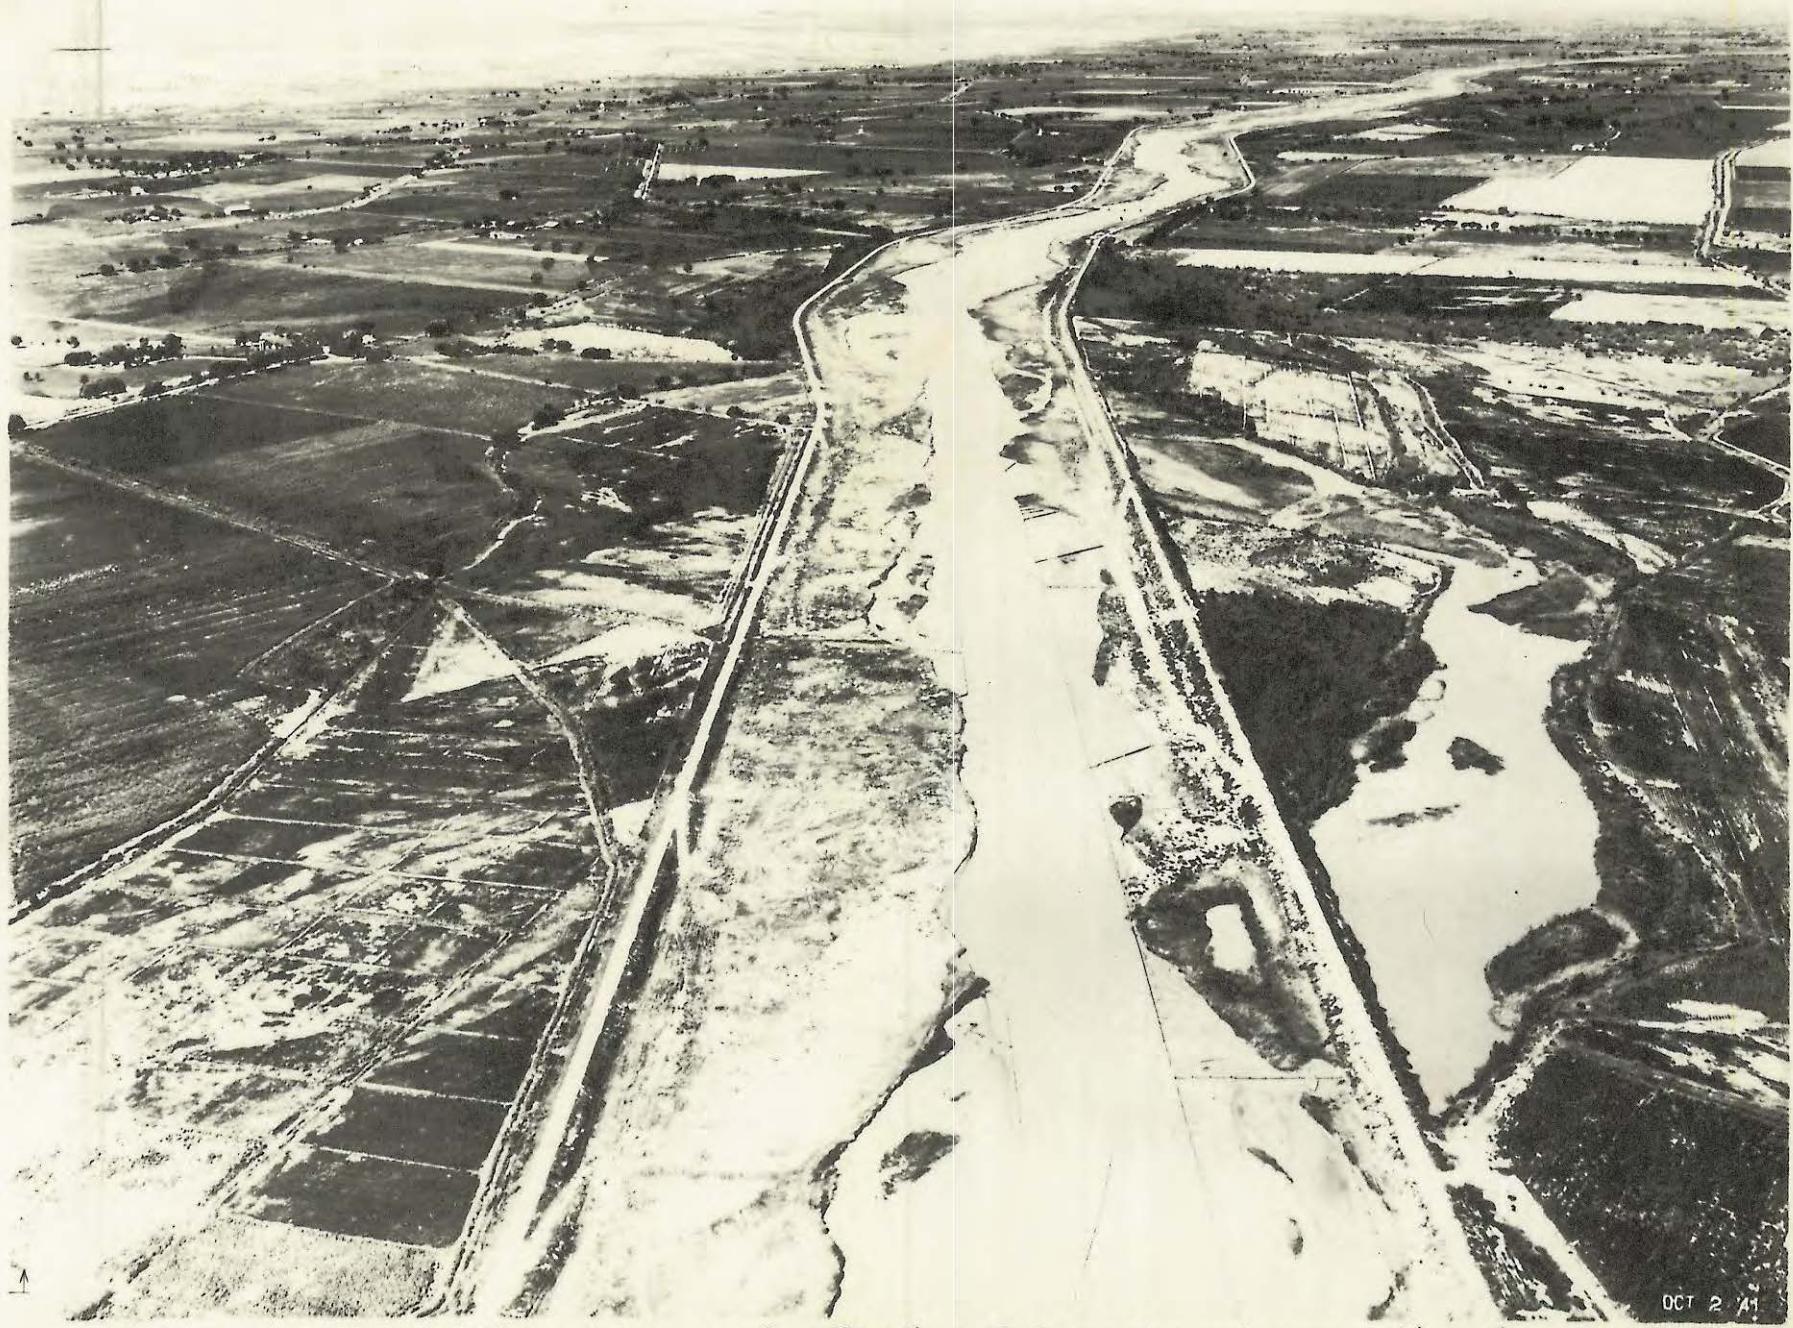
Greewood Cut-off ~ Looking Upstream

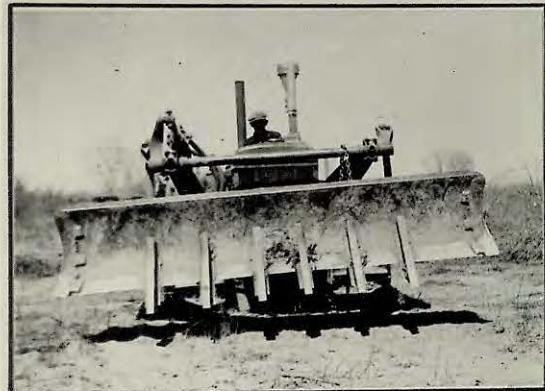
Original tractor grubber idea

Mesilla Valley on February 23, 1938. This clearing was done by hand with axes and grub hoes. The crew was large, the foreman green at the job and the area cleared during the first few months small. A second crew employing about the same number of men and tools started work on the Zack White farm near the Country Club Bridge in March of 1938. As the cost of the work was high under this method and tractor equipment became available, each crew was supplemented with an International Harvester T.D. 40 Tractor. The tractor was used to pull or knock down the larger trees and the hand labor employed in cutting the smaller brush. A shop-made grubber was built and hooked on the T.D. 40 in place of the bulldozer blade. These worked well; however, the tractors were not powerful enough to root out the larger trees. To overcome this objection two large R.D. 8 Caterpillar tractors were purchased equipped with winches. The bulldozer was replaced with a revised shop-made grubber and the tractors put to work. The D-8 Caterpillar with the grubber attached was a highly successful piece of equipment for clearing and grubbing. They did all the heavy clearing.

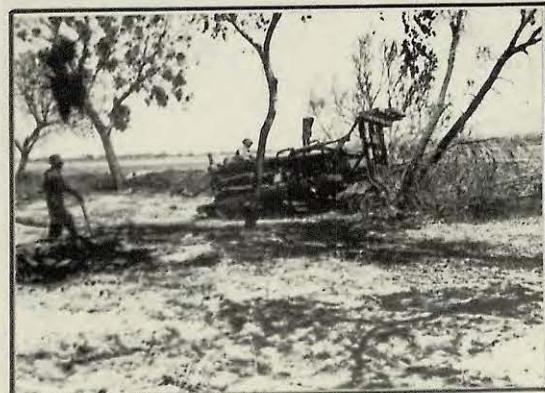
Second model at work

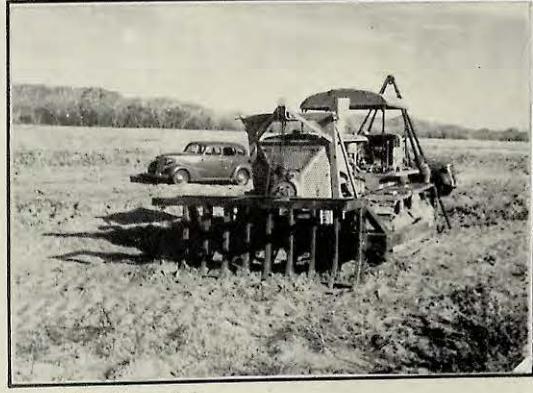
Final model

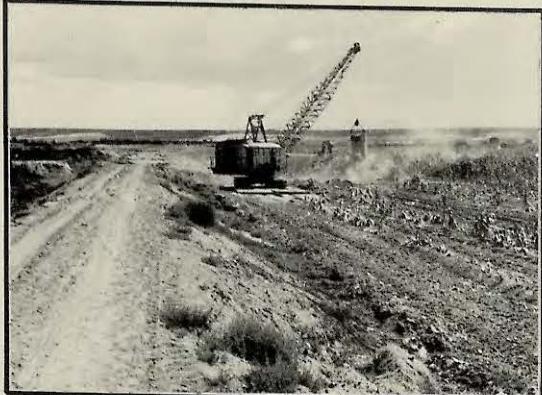
DRAGLINE No. 3 - Building levee

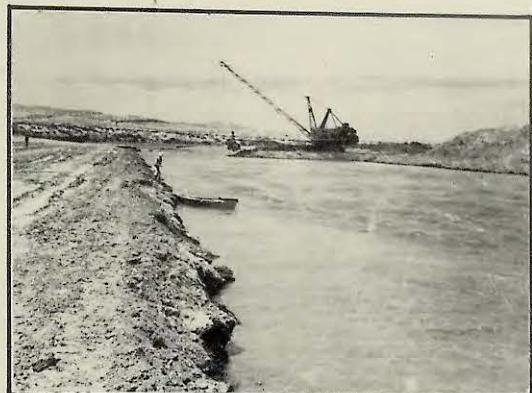
DRAGLINE No. 6 - Opening Jundt Cut-off

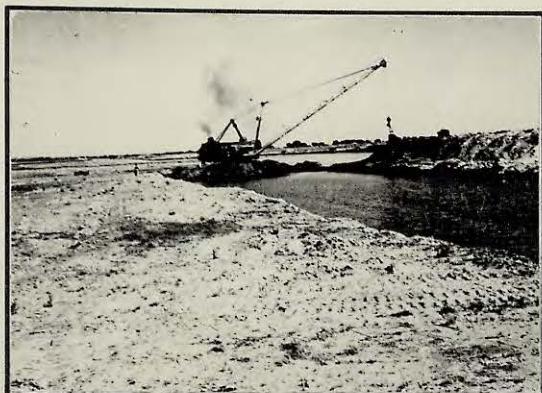
DRAGLINE No. 6 - Excavating Channel Cut-off

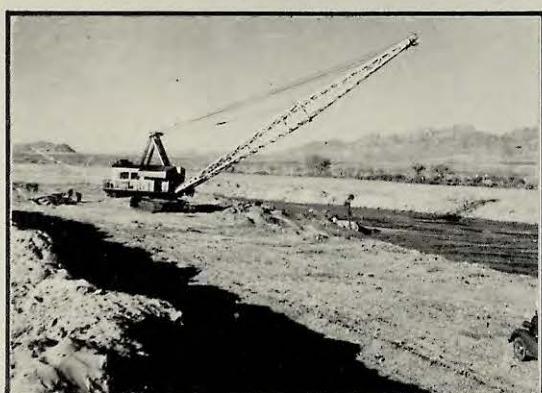
DRAGLINE No. 5 - Excavating Mesquite Cut-off

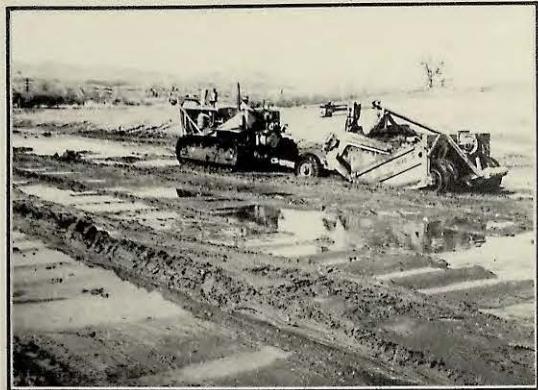
Carryall excavating low flow channel - Rincon Valley

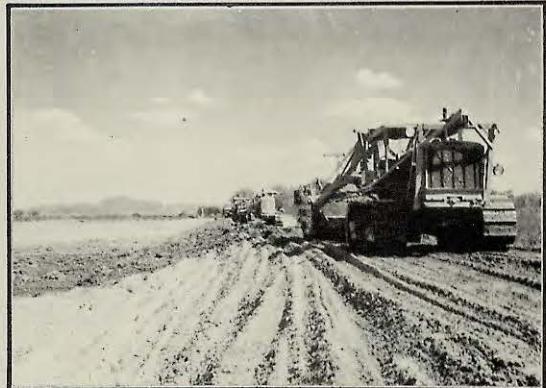
Carryalls plating levee - Mesilla Valley

In many instances only sandy material was available for levee construction. In these cases clay had to be hauled for some distances to plat the slopes and crowns of the levees to prevent blowing and to make a serviceable embankment.

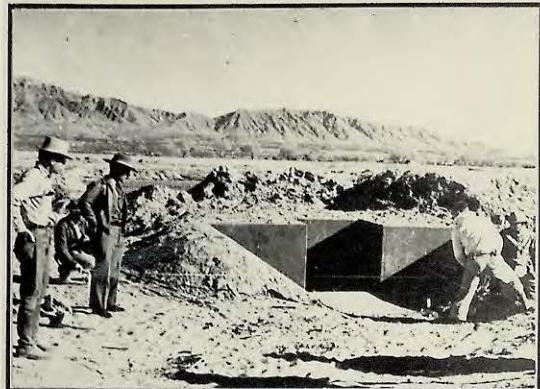
Culvert Wasteway

The main structures were located in the levees at their intersection with the Reclamation wasteways and drain outlets. Generally bridges were built over the drains and main wasteways where larger water openings were required and the banks of the drain or wasteway built up to prevent flooding of adjacent farm lands by backwater during high floods in the river. The concrete pipe culverts were used on the smaller wasteways and provided with an automatic drainage gate to prevent flooding of lands by backwater.

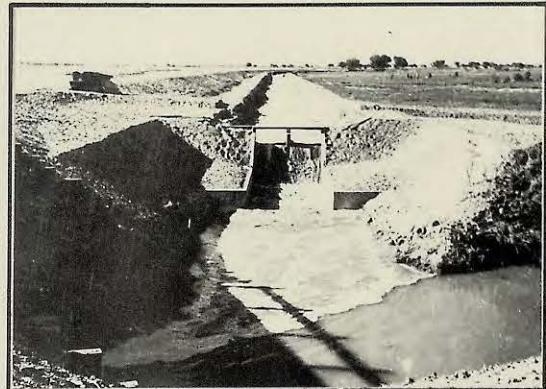
Texas Lateral Drop Wasteway

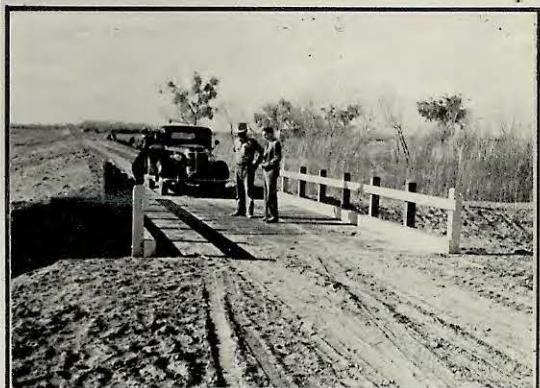
20 Ton Treated Timber Bridge

Structures: The structures on the canalization project were all small. They consisted of 20-ton capacity treated-timber bridges, a few 4' x 4' concrete box culverts with gates to control the backwater, 48", 36", 30" and 24" diameter concrete pipe culverts with automatic drainage gates on the outlet ends, a few corrugated pipe culverts and a number of small timber irrigation structures built in relocated laterals.

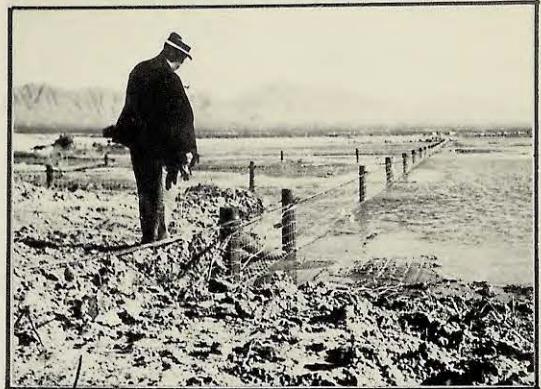
Revetment on East Levee near  
Vinton Bridge

The fence was constructed of creosoted piling 5" to 8" in diameter from 16 feet to 22 feet long and spaced from 15 feet to 30 feet apart depending on the river condition at the site of installation. A heavy cable and woven wire fence was stretched along the line of piles. The piles were set usually about three to three and one half feet above the low water surface of the river. The piling were all jettied into place with powerful jetting pumps and work was usually done during the low water season. A typical installation and layout is pictured on the next page.

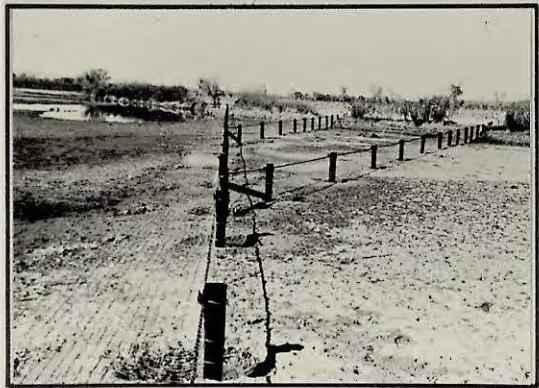
Revetment on East Levee Station  
850 - Feature 401

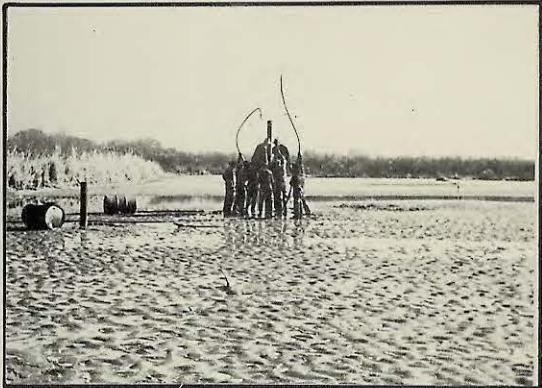
Crew jetting piling

The construction crews employed to install the revetment usually consisted of a foreman, one revetment placer, two or three revetment helpers, a pump operator and about twenty laborers. This crew under normal conditions could jet from forty to fifty piles in place and stretch the woven wire on about 1000 feet of piling in a day. They used a powerful pressure pump with two nozzles or jets to wash the holes out for the piles. As a rule the revetment program was carried on during the winter time; however, during other periods it was often necessary to work to prevent bank erosion.

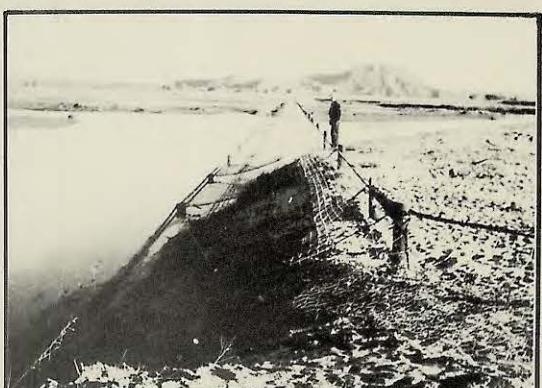
Special type of revetment -  
Rincon Valley

The revetment construction was stronger, the piles spaced closer together and heavier cable used on all work in the Rincon Valley. The first installations in the upper valley, built according to Mesilla Valley standards, were not able to withstand the flood conditions occurring in that reach of the project. The heavier fence was built due to this situation.

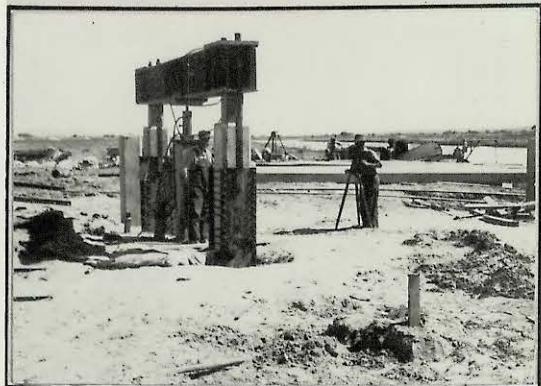
Testing concrete piles

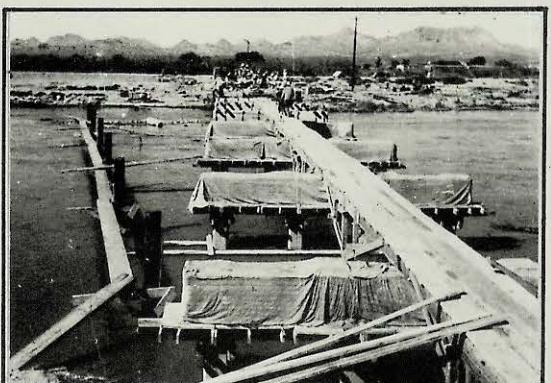
SHALEM BRIDGE - Construction  
of new concrete bridge

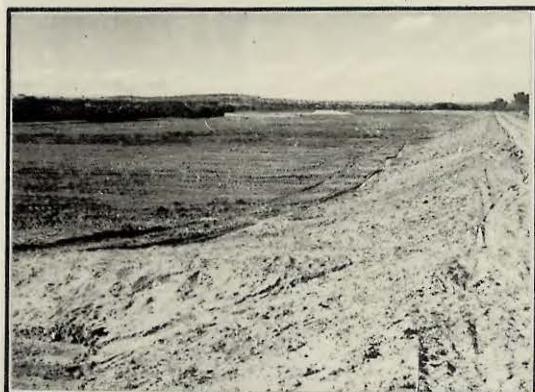
Completed levee and channel  
near El Paso
