Rio Grande Basin Summary Report

U.S. International Boundary
and Water Commission

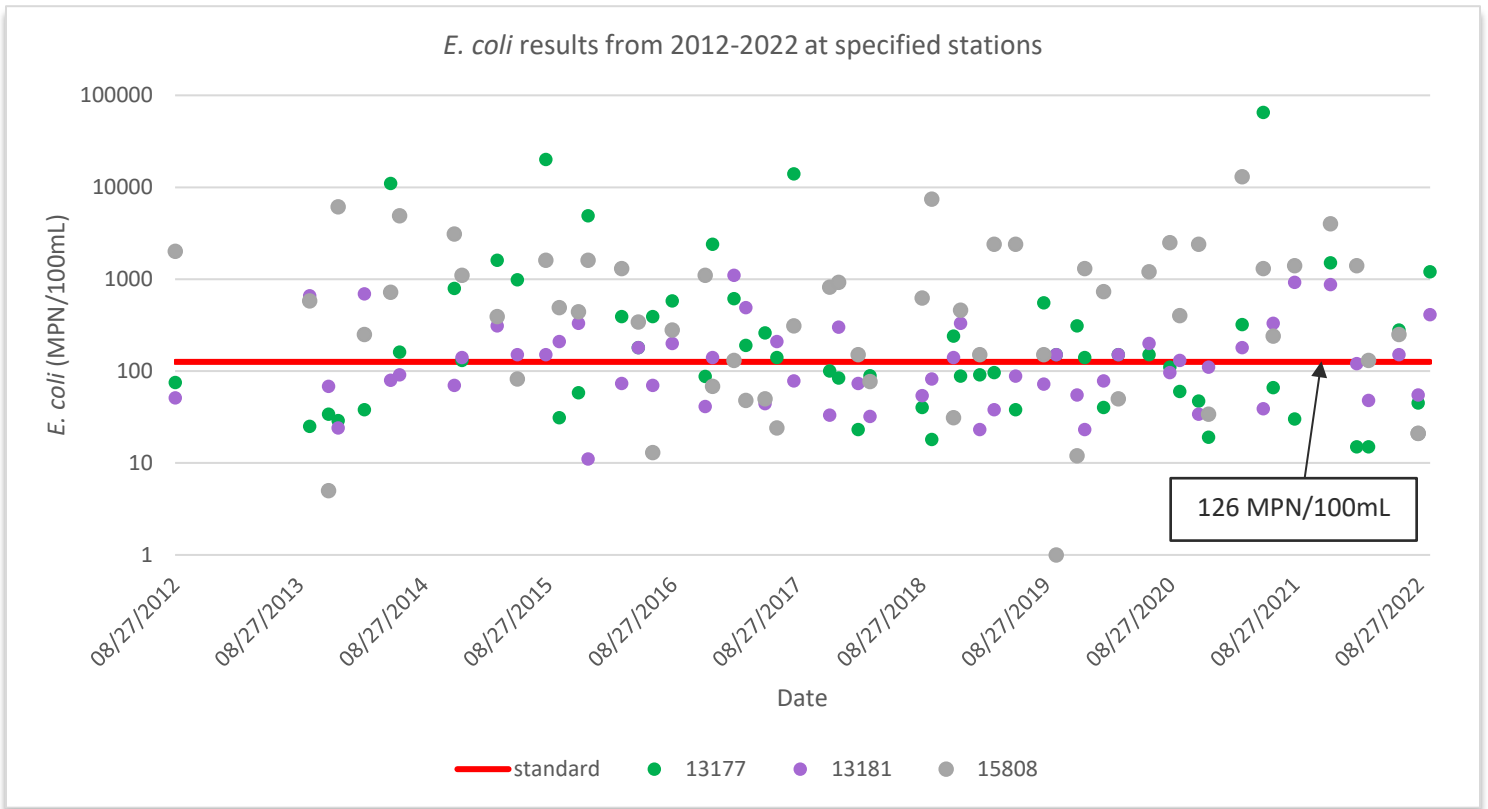
Figure 8. *E. coli* results for stations 13177, 13181 and 15808 from the years 2012-2022.

Station	Geometric mean (MPN/100mL)	Count (n)	Slope	p-value
Highest geomean	15808	348	58	0.15	0.60
	13177	187.2	61	0.34	0.76
	13181	123.2	69	0.06	0.12
Lowest geomean	10249	21.5	31	-0.019	0.45
	20449	24	104	-0.018	0.40
	21012	25.8	26	-0.013	0.73

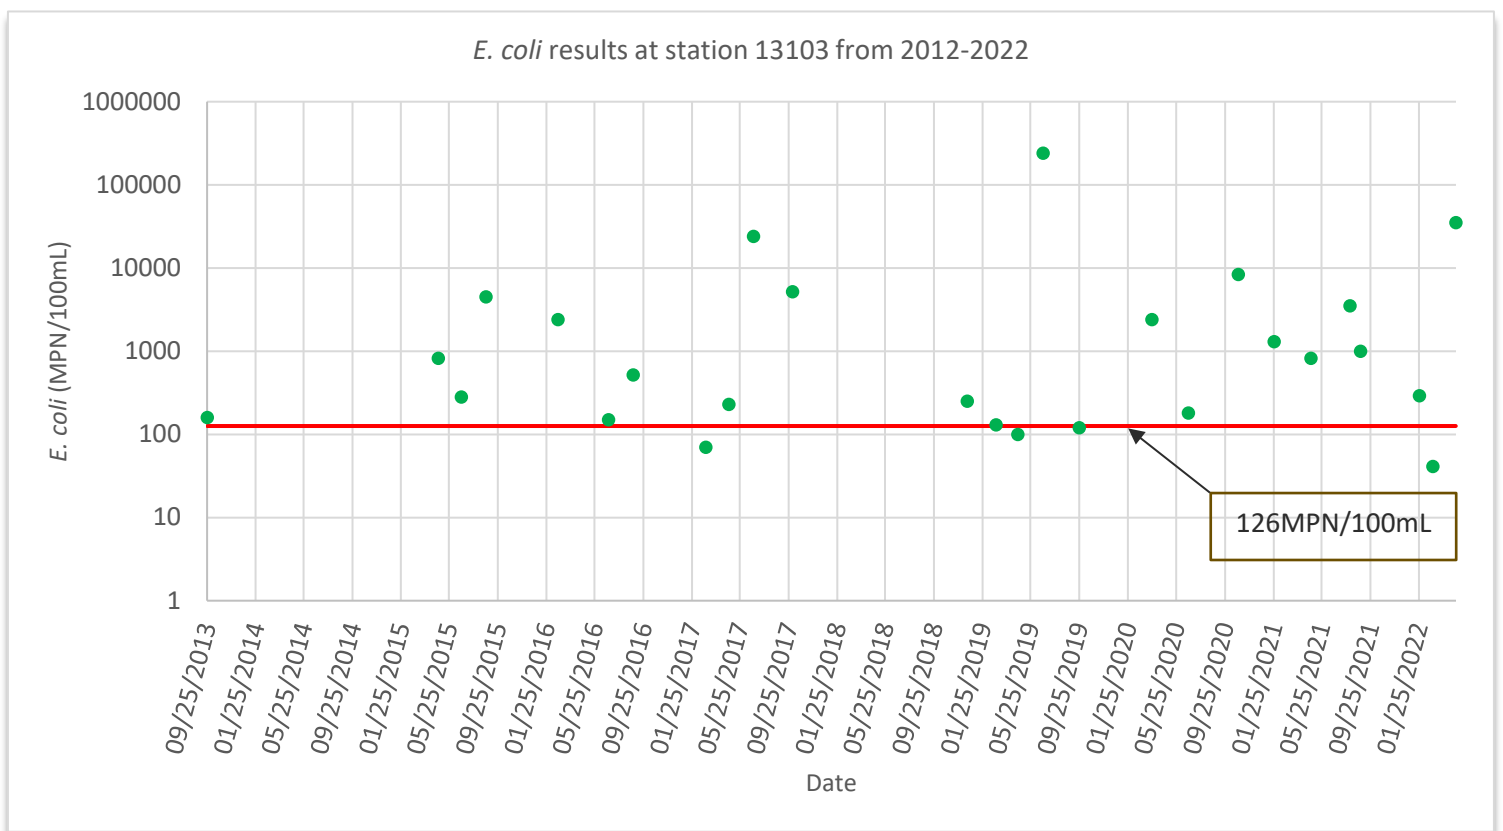
Figure 11. *E. coli* results at station 13103 from the years 2012-2022.

Segment 2302A stretches from Rio Grande confluence at Rio Grande City to El Sauz in Starr County. This segment includes only assessment unit 2302A_01 and is monitored by stations 13103, 13104, and 21591. Arroyo Los Olmos is impaired for bacteria and dissolved oxygen and has a concern for chlorophyll-*a*. Out of the three stations, only station 13103 had sufficient data to conduct a statistical analysis. Station 13103 is located at Los Olmos Creek at US 83 East of 2nd Street South of Rio Grande City. Levels of bacteria are above the standard at this station. For the ten-year period, the geometric mean for *E. coli* was 877 MPN/100 mL. This value is well above the standard of 126 MPN/100 mL. Figure 11 shows the results for bacteria at station 13103. Station 13103 has low flow, which can contribute to accumulation of contaminants. This coupled with urban run-off create unsuitable conditions. As plants photosynthesize (using chlorophyll) they produce oxygen, which in turn can create a saturation of DO. In the case of this segment low flow, accompanied by the decay of plants can be a contributing factor to the low DO.

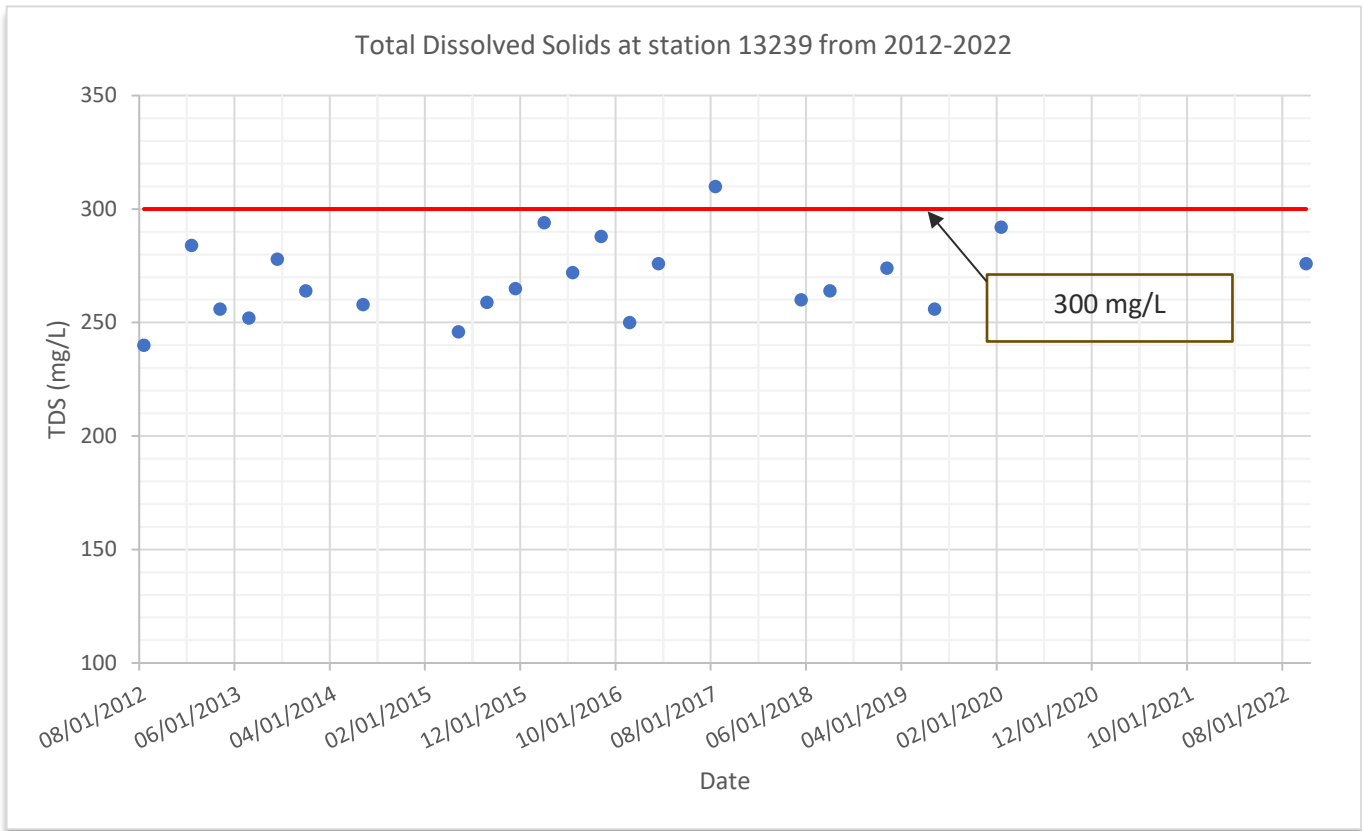
Figure 47. Total dissolved solids results for station 13239 from the years 2012-2022.

All other parameters remained under the standard or screening level. Table 16 shows the ten-year average for the specified parameters at station 13239. Figure 47 shows the results for TDS from 2012-2022 (only missing year 2021). Elevated levels of TDS can impact aquatic life by altering the water chemistry, increasing salinity levels, disrupting nutrient balance, and introducing toxic contaminants. This can have cascading negative impacts on water quality.
