Riparian Habitat Restoration at Three Sites in New Mexico and Texas: Country Club East, Sunland Park, and Anapra Bridge Restoration Sites

Final Restoration Report

Version: October 2017 to January 2020

Prepared by: ***IDEALS-AGEISS, LLC***

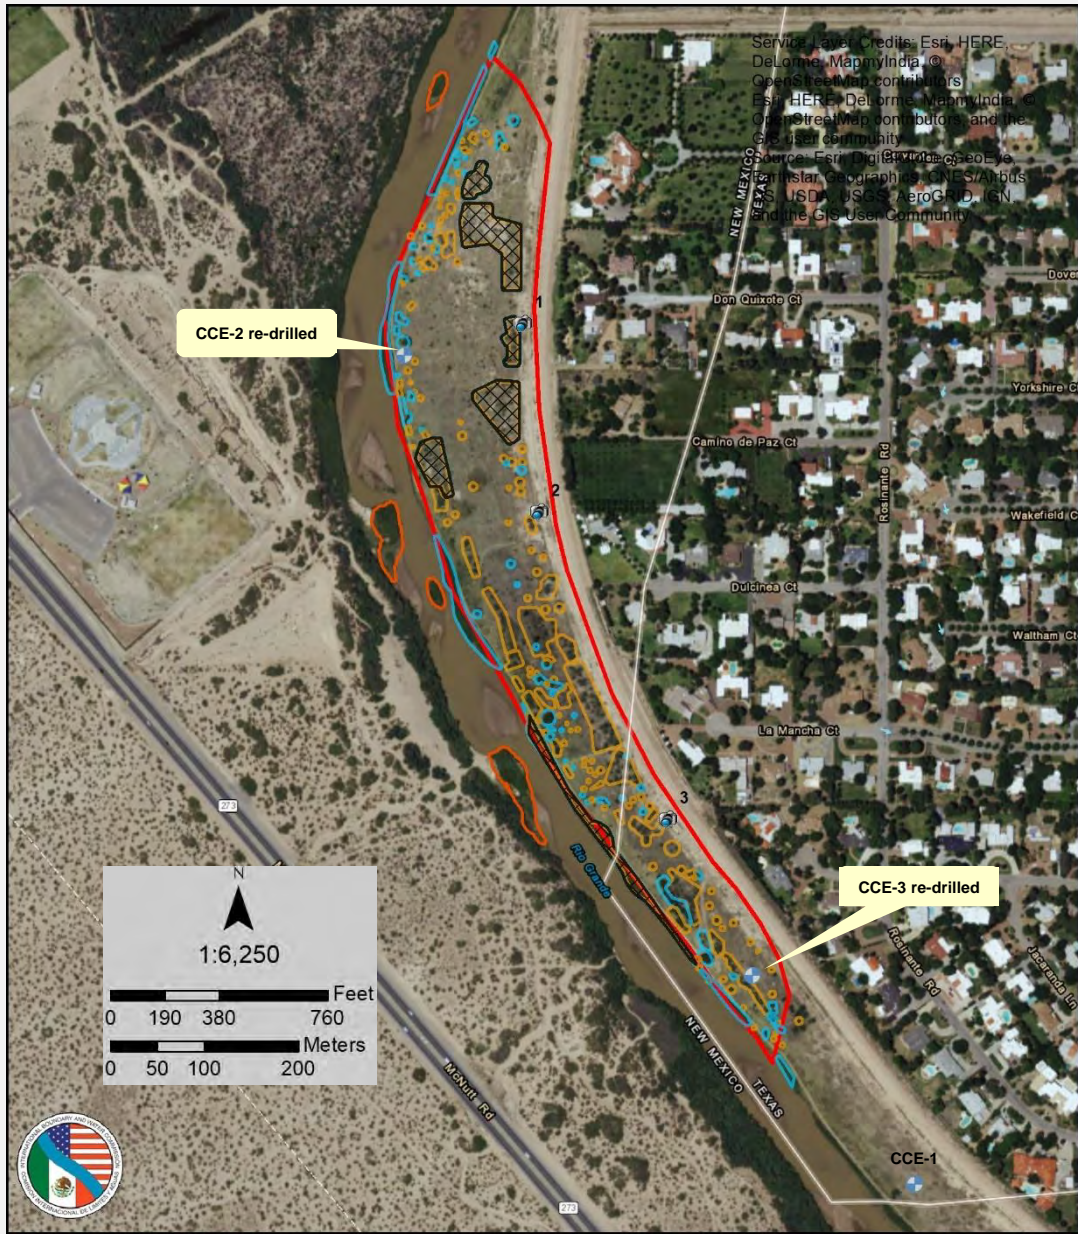
Figure 3-1. Pre-restoration Conditions at the Country Club East Restoration Site

The southern end of this site has moderate patches of screwbean mesquite (*Prosopis pubescens*) with a thin coyote willow (*Salix exigua*) component along the river bank and a few cottonwoods (*Populus deltoides*). Away from the river there are some mixed native and non-native vegetation patches with scattered Siberian elm (*Ulmus pumila*) and cottonwood amongst severely stressed saltcedar (*Tamarix ramosissima*). Within the channel, there are some narrow islands in this stretch dominated by coyote willow and common reed (*Phragmites spp.*). Ground cover vegetation was dominated by alkali sacaton (*Sporobolus airoides*) and pigweed (*Amaranthus spp.*). Habitat at this site has the potential to provide suitable flycatcher habitat within the next few years with restoration efforts. Mowing has been discontinued at Country Club East since 2011. Pre-restoration site conditions and saltcedar distribution are noted in Figure 3-1. Country Club East had minor infestation of mistletoe (4 to 6 clumps) in two trees.

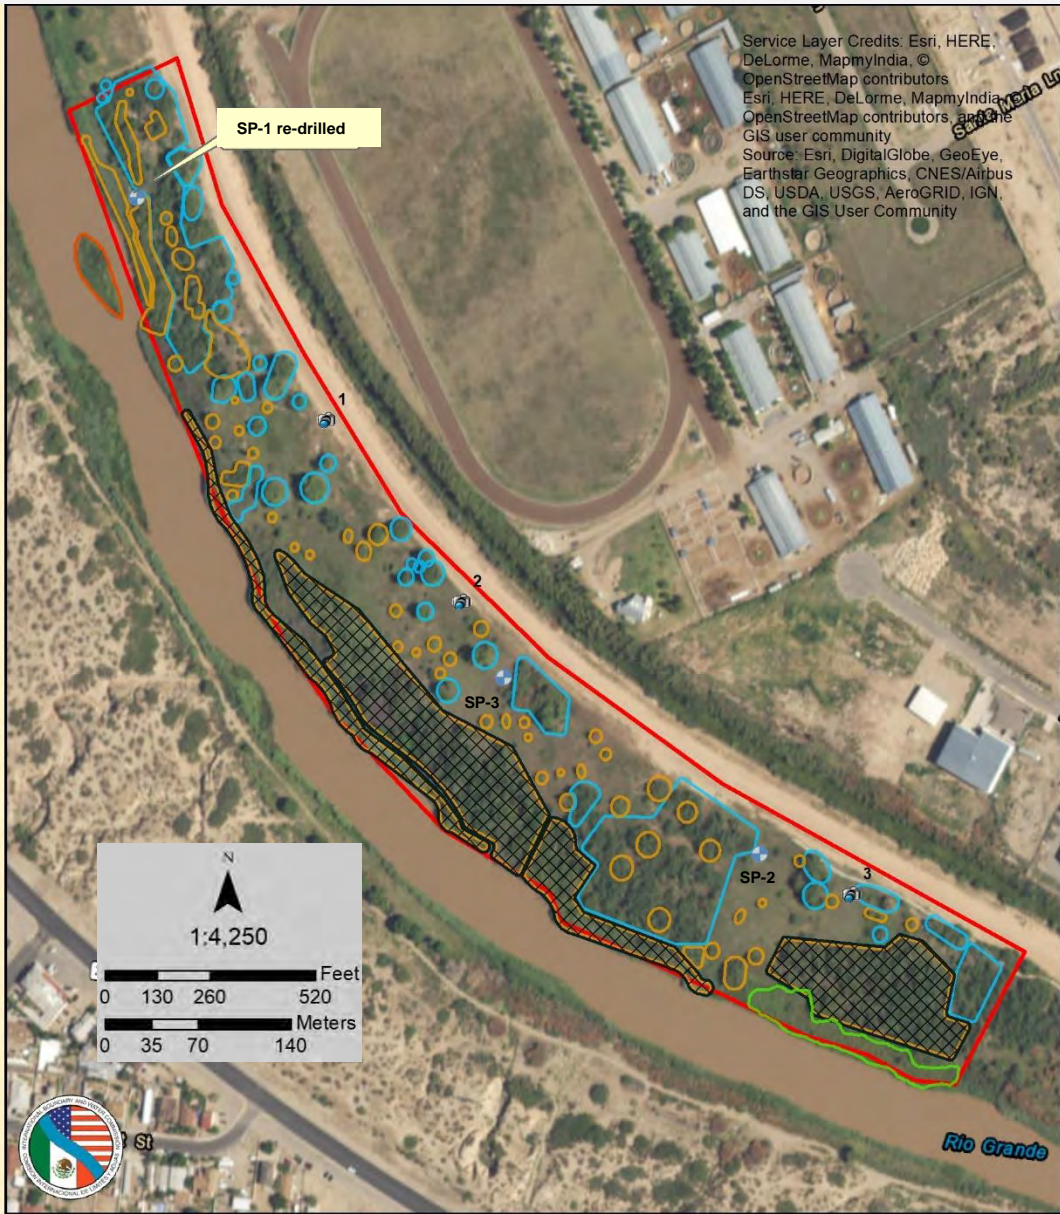
Figure 3-2. Pre-restoration Conditions at the Sunland Park Restoration Site

The Sunland Park site, part of a recreation lease to the City of Sunland Park, was left unmaintained for many years, allowing for the growth of large cottonwoods and mature mesquite, willows, and mature saltcedar. This site contained a thin row of coyote willow (in moderate abundance) along the river bank with patchy, diverse mixed vegetation away from the river. The diverse mixed vegetation habitat contains large screwbean mesquite and saltcedar with larger cottonwood growing amongst them towards the southern end of the site. The cottonwoods become more concentrated in an open gallery toward the north end of the site; many of which are heavily infested with mistletoe. Of the 39 cottonwoods surveyed, mistletoe infestation ranged from 0-120 clumps with a mean per tree of 33. Ground cover was primarily fescue grass and silverleaf nightshade (*Solanum elaeagnifolium*). Russian olives (*Elaeagnus angustifolia*) are sporadic through the site along the river bank along with Siberian elm. Russian thistle (*Salsola tragus*) occurs in moderate abundance in the open areas. Saltcedar in this section was suffering from *Diorhabda*. This site has good potential for flycatcher habitat. Figure 3-2 shows the pre-restoration distribution of native species (mixed and protected areas) and saltcedar on the site.

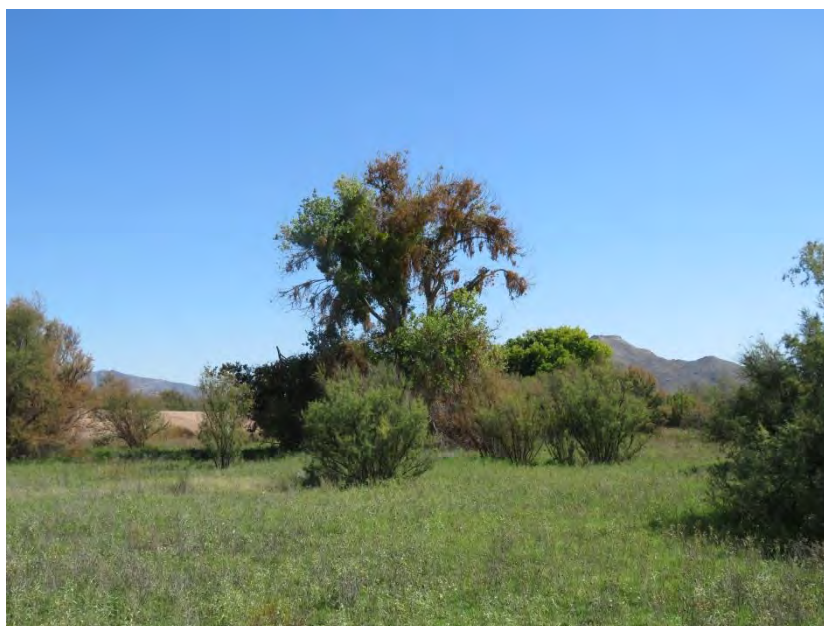
Sunland Park pre-restoration effort with example of mistletoe infected cottonwood, 14 November 2017.

As noted, mature cottonwood trees were present on the Sunland Park site prior to restoration efforts. The cottonwoods become more concentrated in an open gallery toward the north end of the site; many of which were heavily infested with mistletoe. Thirty-nine cottonwoods were surveyed at Sunland Park and 82 percent of these trees were infested. Mistletoe tends to spread faster in multi-storied and monoculture stands (USDA 2010). Seeds may also fall from mistletoe in the upper parts of the trees creating new infestations on lower branches. Birds feed off of the berries, digest the pulp, and excrete the seeds, which can then adhere to the branches of living trees. When the seed germinates, it grows into tree tissues. It may take up to 2 years for the plant to bloom and produce viable seed. Based on discussions with arborists and New Mexico State University Extension, there is a good chance that mistletoe, once established on a host tree that is dominant to the area, tends to remain attracted to that specific tree

The most effective way to control mistletoe and prevent its spread is to prune infected branches, if possible, as soon as the parasite appears. Thinning-type pruning cuts to remove infected branches at their point of origin or back to large lateral branches was used. Infected branches were cut at least 1-foot below the point of mistletoe attachment in order to completely remove embedded haustoria. Mistletoe mitigation occurred in February 2019 for those trees with less than 25 clumps per individual ($n = 24$ trees).

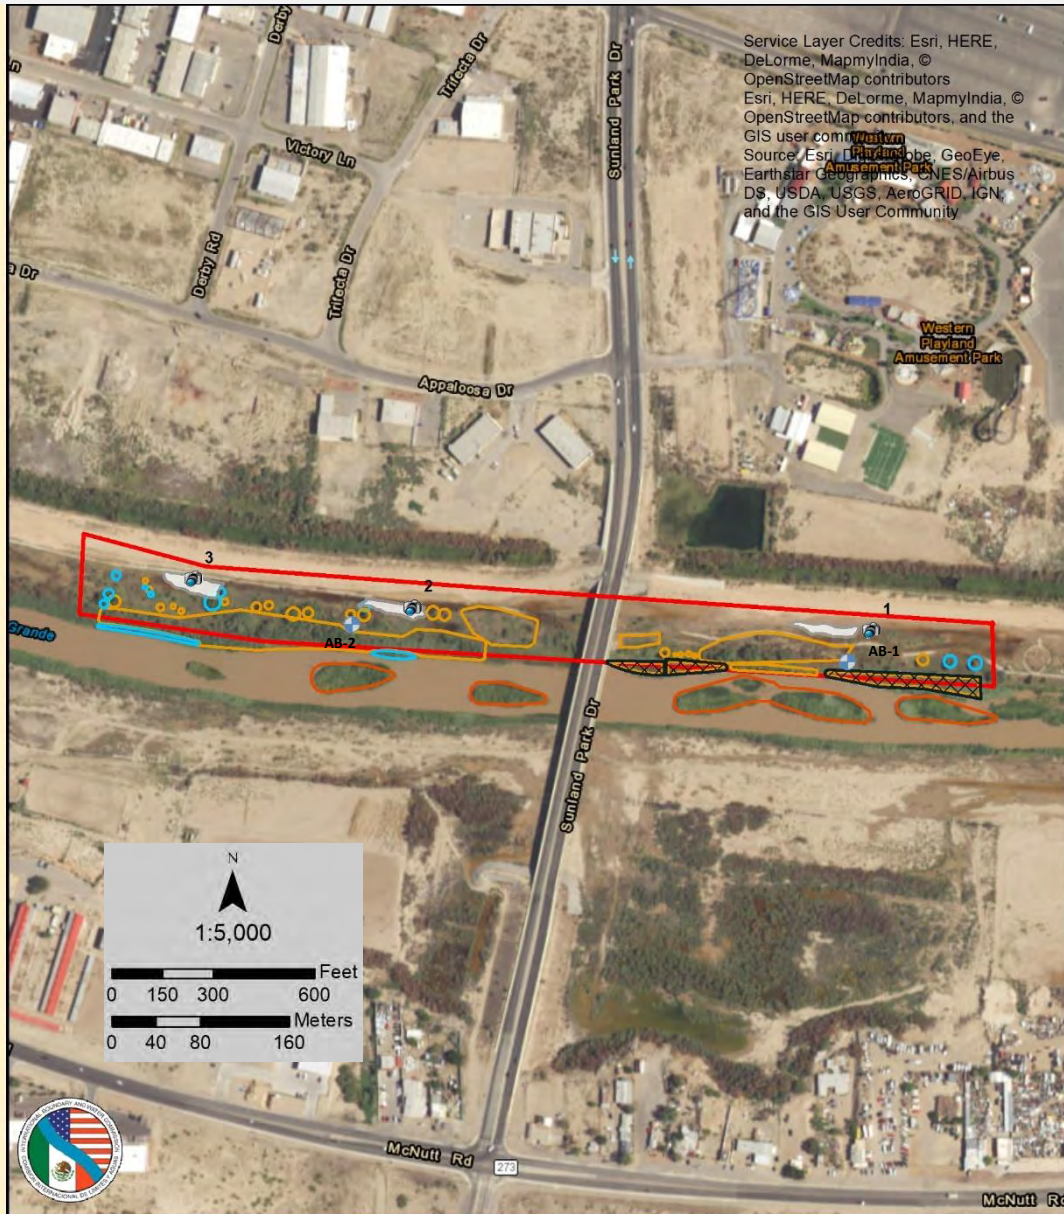
Figure 3-3. Pre-restoration Conditions at the Anapra Bridge Restoration Site

The Anapra Bridge site is part of the hike and bike trail and should have been mowed, per the lease agreement with Sunland Park; however, the City of Sunland Park prior to the pre-restoration survey, had not mowed in several years. The site has good potential structure. A thin strip of mixed vegetation comprised of coyote willow, seep willow, screwbean mesquite, and saltcedar runs along the bank of the river with a few Siberian elm and Russian olive. Further away from the river a young stand of saltcedar and screwbean mesquite was growing in what appears to be a depression. Saltcedar in this area showed slight stress from *Diorhabda* and is easily accessible for removal. A moderate abundance of Russian thistle occurred away from the site and native grass (*Distichlis spp.*) was found in the open areas (Figure 3-3).

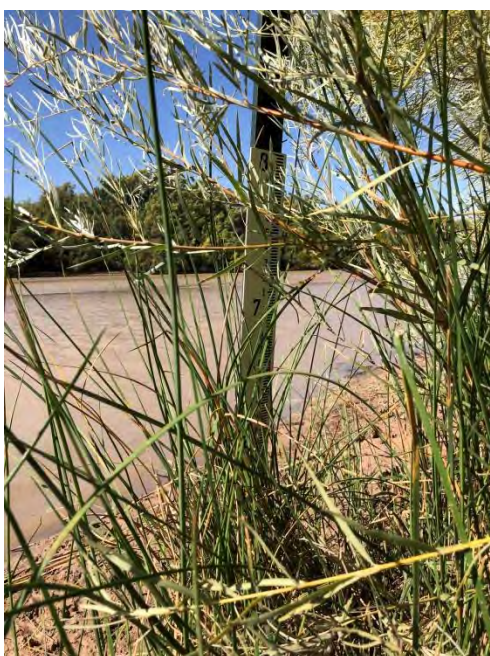
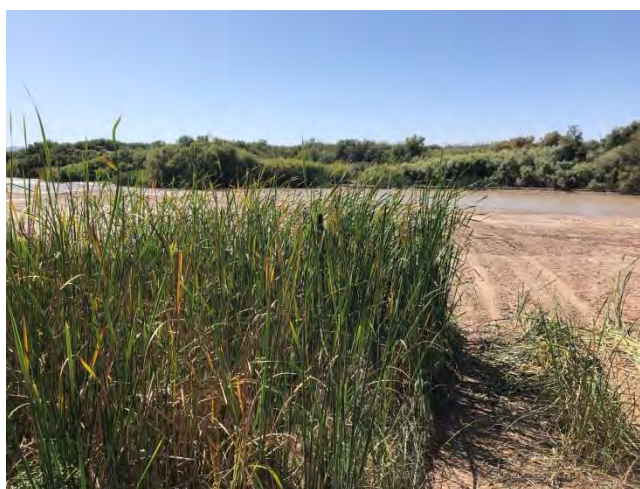
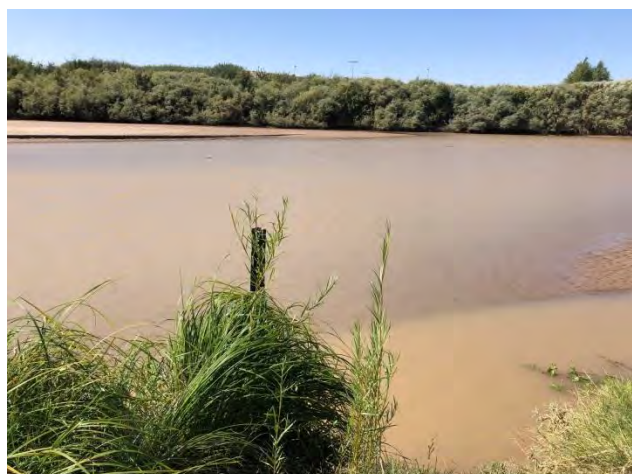
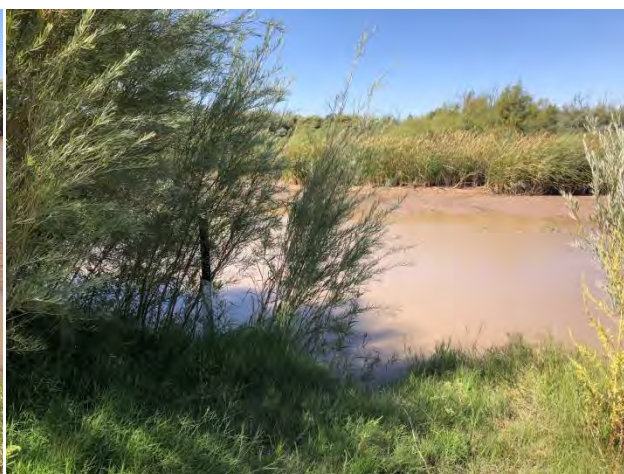
Gauges were installed at the cuts for the Country Club East restoration site to monitor water levels. Water levels at each gauge were similar during the irrigation release period at each bank cut (Table 3-4).

Gauge No.	Height of Water (feet)					
	May 2018 ^a	Aug 2018	Oct 2018	April 2019	Aug 2019	Oct 2019
1	-	4.67	0	0	4.7	4.9
2	-	4.9	0	0	missing	missing
3	-	4.46	0	0	5.4	3.8
4	-	4.67	0	0	5.4	4.3

Gauge meters at all four bank cuts at Country Club East during October 2019 from south (Gauge #1) to north (Gauge #4).

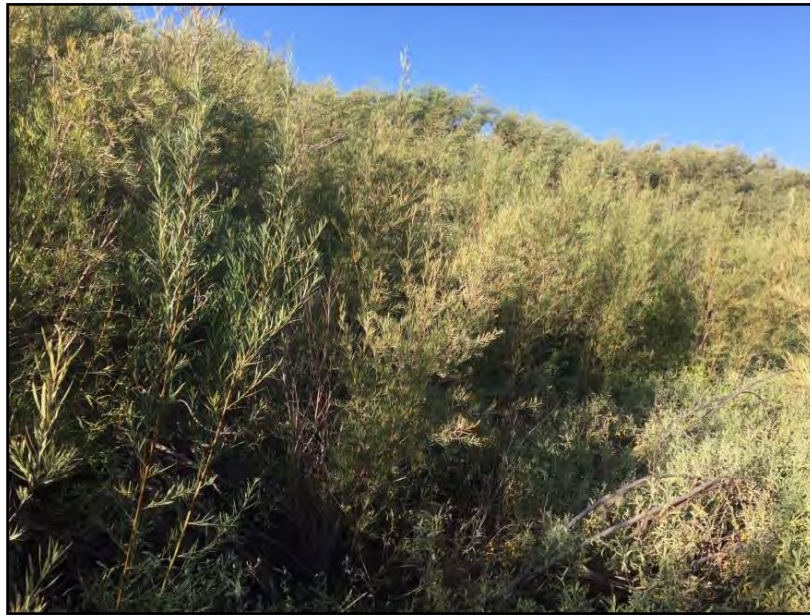
**Transplanted coyote willows along the river bank in the flycatcher habitat
at Sunland Park, 16 October 2019.**

During the October 2018 monitoring, IDEALS-AGEISS biologists noted that funastrum (*Funastrum cynanchoides*), a twining milkweed species, established within the transplanted coyote willows and Goodding's willows area; the area recently exposed for the saltcedar removal. At times, only individual trees were entwined by the vine, but in some areas the vine developed into a large mat which overgrew the naturally occurring coyote willows on the bank and engulfed the planted willows. However, by October 2019 the vine was not as prevalent although some of the trees in the area had been damaged/killed by the vine.

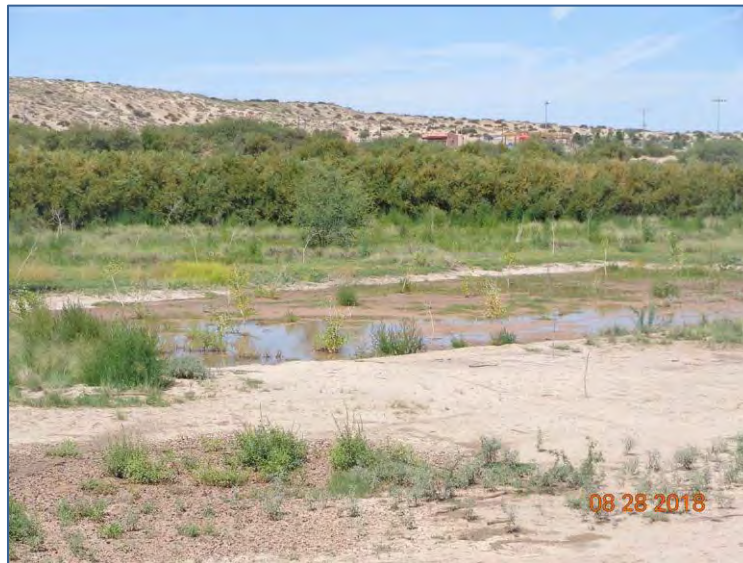
Drainage swales created at Country Club East, 28 August 2018.

During the first growing season, cottonwood survival at the site was roughly 78 percent. However, 56 percent of the cottonwoods showed some form of stress. Cottonwood survival throughout the site dropped dramatically the second year to only 22 percent. The majority of the surviving cottonwoods occurred in the swale areas. This site has incurred damage from several sources as evident by the trees that are recovered and the tire tracks through the site and may have been the cause of the missing trees.

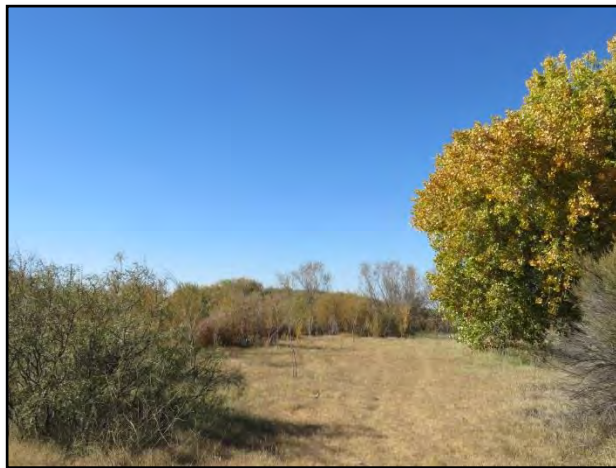
**Overview of riparian habitat at Sunland Park,
15 November 2018.**

Overall long stem shrub survivorship was good at the site (82 percent) and like the Country Club site, varied by species (Table 3-8). The unknown shrubs were counted (the stems could not be identified to species) and therefore could not be used in the species-specific mortality calculations.

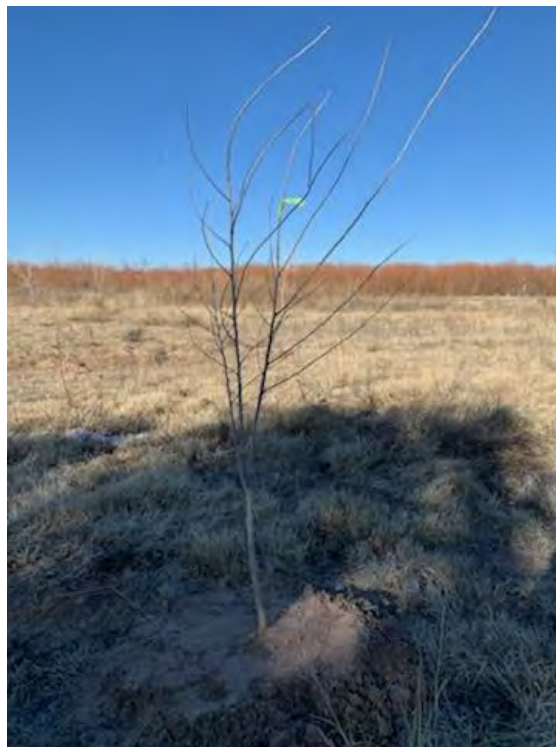
The Country Club site incurs heavy recreational use. IDEALS-AGEISS field crews noticed that once the water in the river stopped flowing, that motor cross and four-wheeler activity significantly increased. The grass was extremely high and dense during the monitoring and some cottonwood re-sprouting may have gone unnoticed. It was noted in November 2018 during long stem shrub planting that some re-sprouting was occurring from the ground with no pole evident in the areas. The re-spouts were approximately 6 inches high and would not have been very visible during the October monitoring due to the height and density of the grass. There is no way to determine if the missing trees were damaged (they were mostly missing along the edges of the site) or if they were actual mortalities. IDEALS-AGEISS recorded 78 dead and 57 destroyed cottonwoods at this site during the 2018 monitoring. We were unable to locate 260 trees but assume based on our findings and the known activity in the area that a portion of these trees is likely destroyed and gone. IDEALS-AGEISS recommended replacing the known 78 dead cottonwoods and an additional 151 cottonwoods based on the known ratio of dead versus damaged (58 percent of the

Country Club East pole replanting, 13 January 2020.

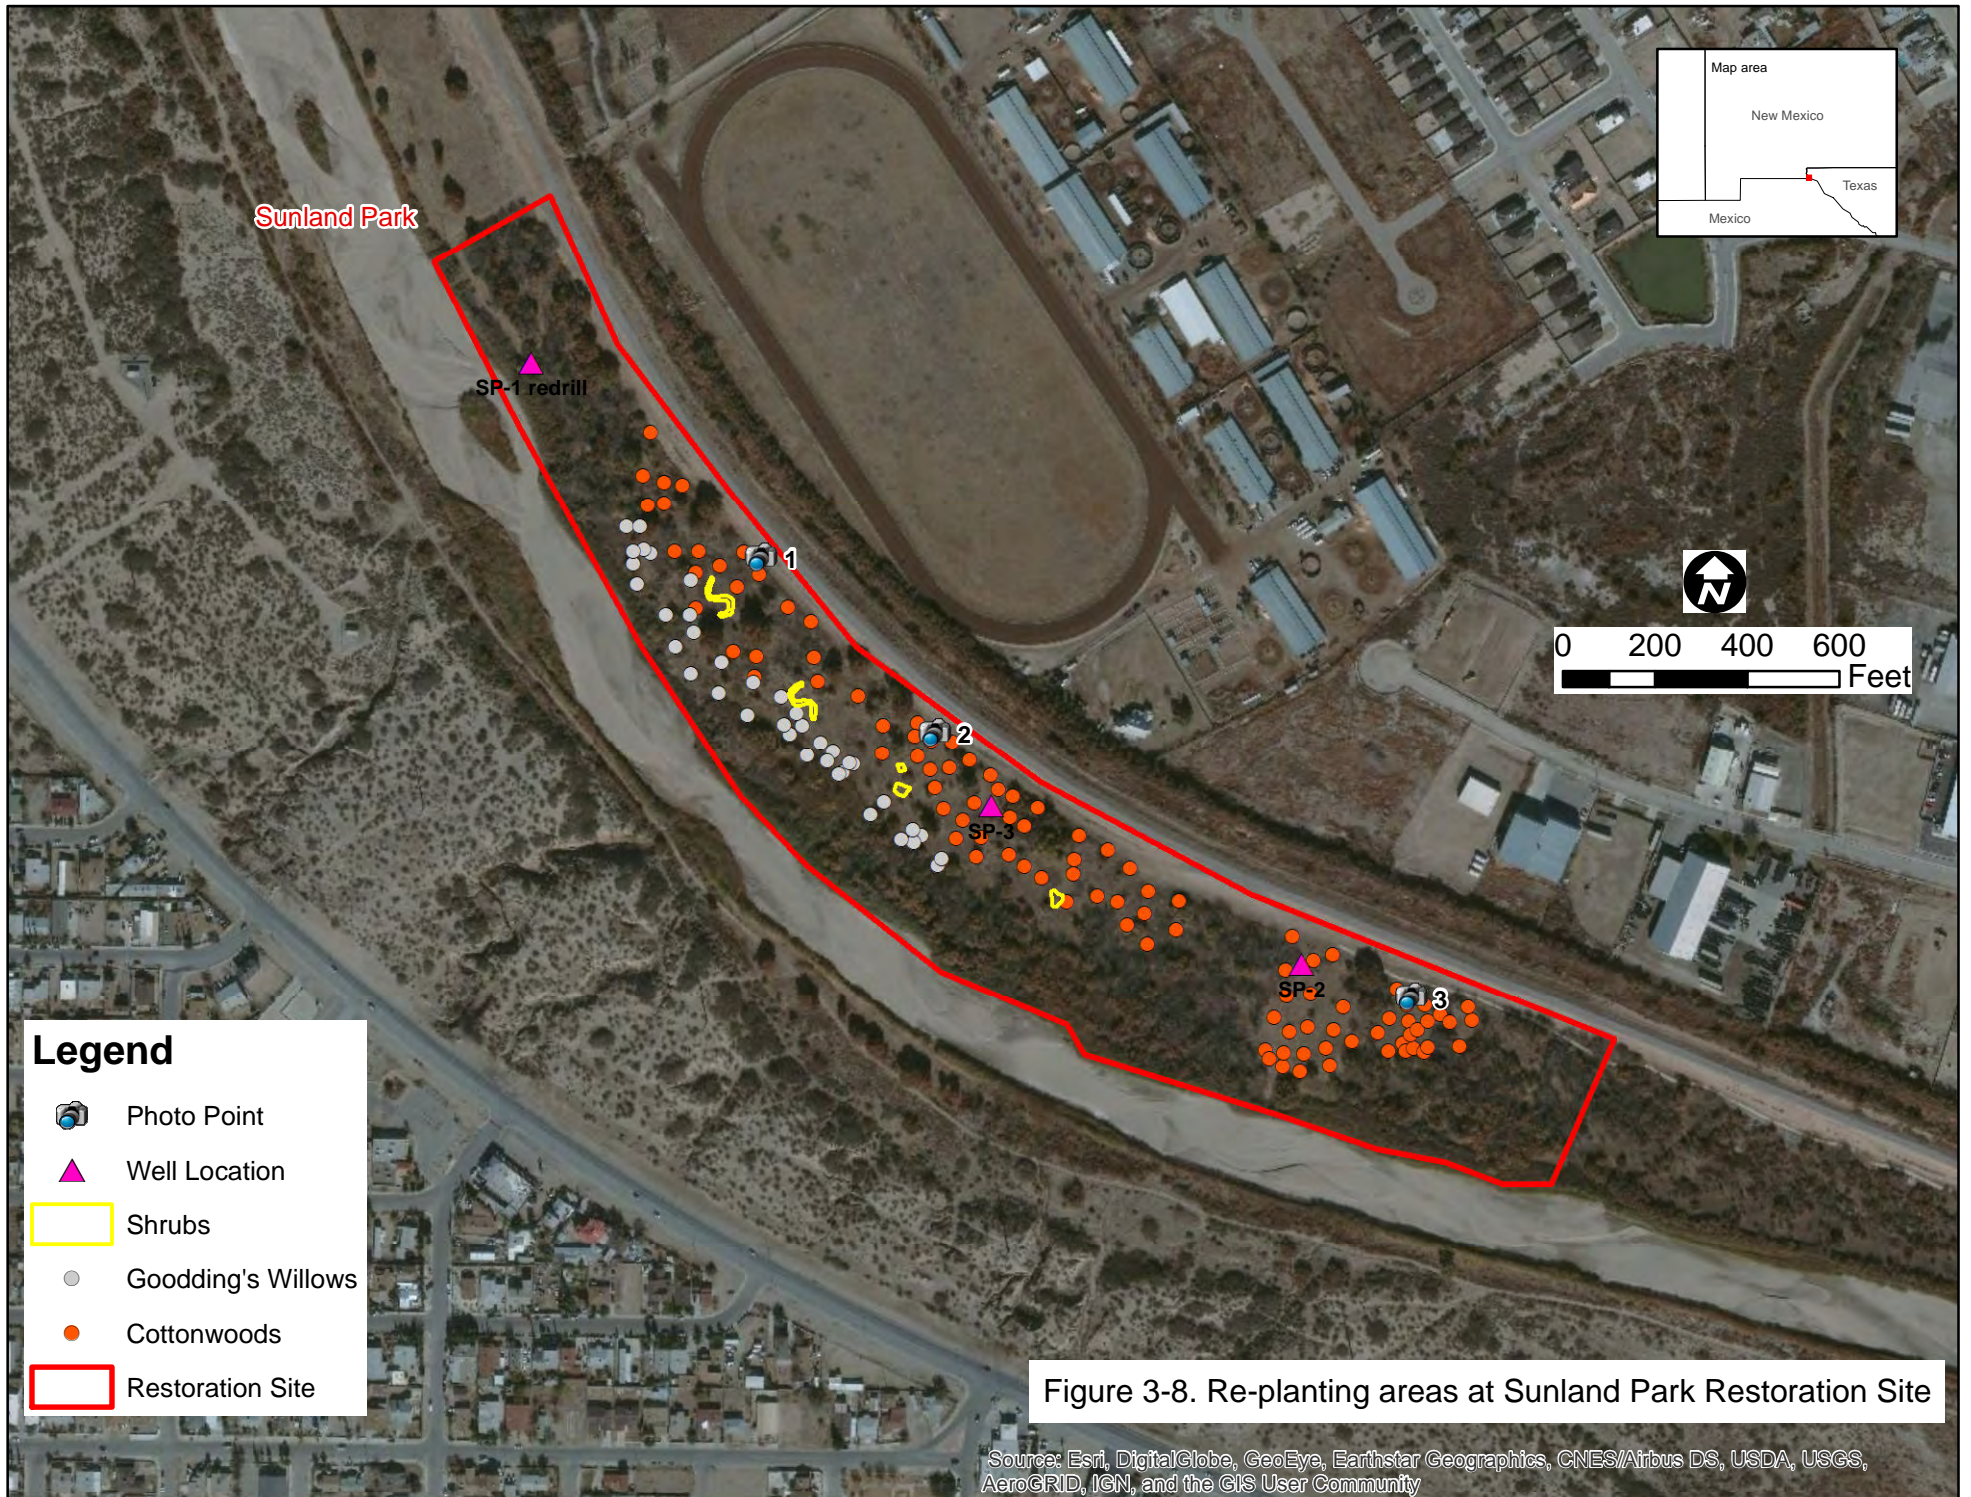
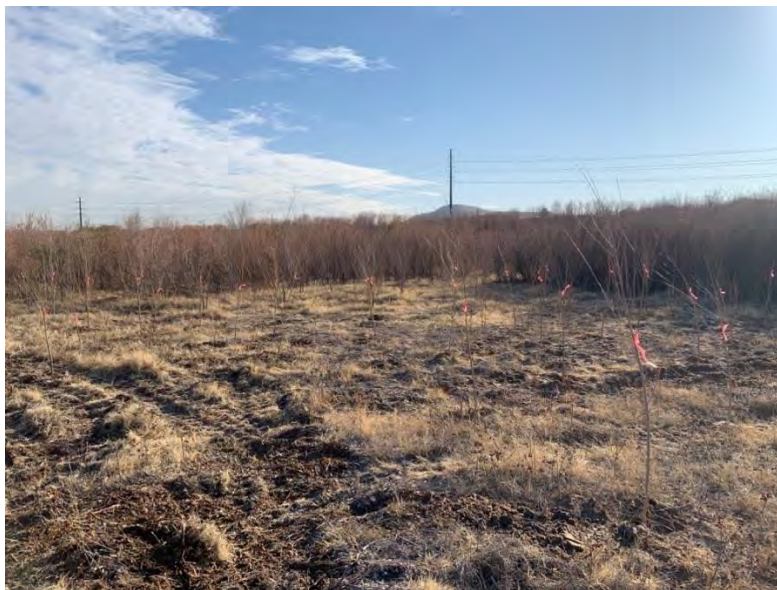
In addition to the 273 dead Goodding's willows at the Sunland Park site, 473 trees were unaccounted for. Some areas north of the SP-3 well along the levee toe road were devoid of Goodding's willow plantings. It is unknown if this is from trees dying or potential incursions into the site that may have damaged the trees. In addition, a large area containing Goodding's willows was inundated with funastrum and the densely populated flycatcher areas made locating trees difficult. An estimated 68 to 100 trees were potentially affected by this twining vine. At the Sunland Park site, IDEALS-AGEISS overplanted the coyote willows by 145 plants. IDEALS-AGEISS recommended that the 273 documented dead Goodding's willows be replaced in the flycatcher habitat. Of the missing 473 Goodding's willows, IDEALS-AGEISS recommended replacing 80 additional Goodding's willows based on documented October mortality rate of 17 percent (17 percent of 473). It is likely that some of the willows under the funastrum are still viable; and that trees were missed in the flycatcher area because they were tucked away in existing vegetation and blended in with the transplants. The 145 additional coyote willows are a supplement to the flycatcher habitat and the potential loss of the Goodding's willows. IDEALS-AGEISS recommended the Sunland Park replacement of the 188 cottonwoods be composed of half cottonwoods (94) and half Goodding's willows (94) to further augment the flycatcher habitat (Table 3-10). Cottonwoods were replanted from 7-9 January 2020. Goodding's willows were re-planted on the site during 23-24 December 2019 and were concentrated in the middle to northern end of the site closer to the river than the levee road at Sunland Park (Figure 3-8).

Replanting efforts for Goodding’s willow at the Sunland Park Restoration site, 7 January 2020.

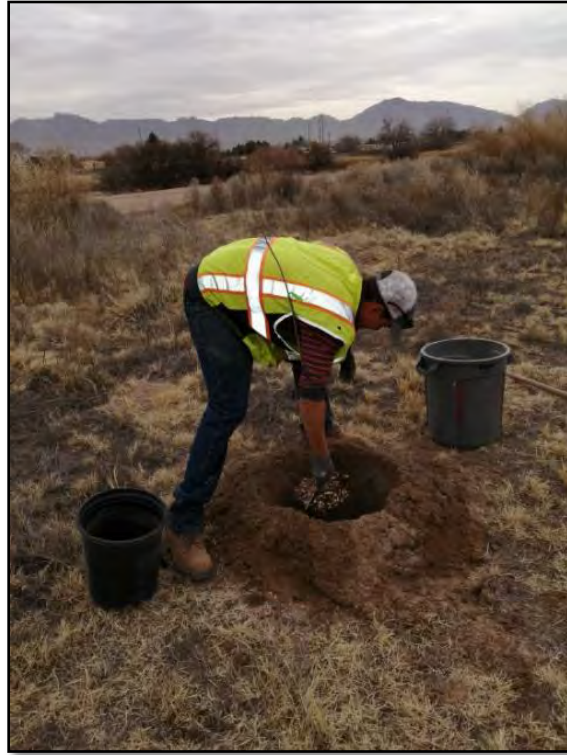
Ash tree replanting at Country Club East, 17 January 2020.

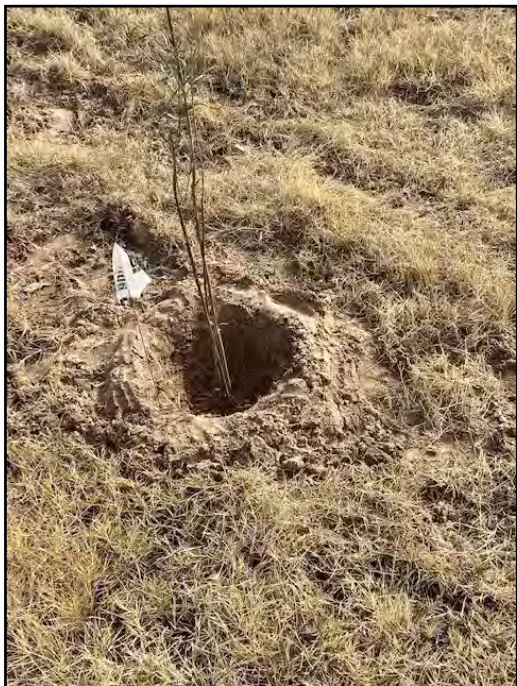
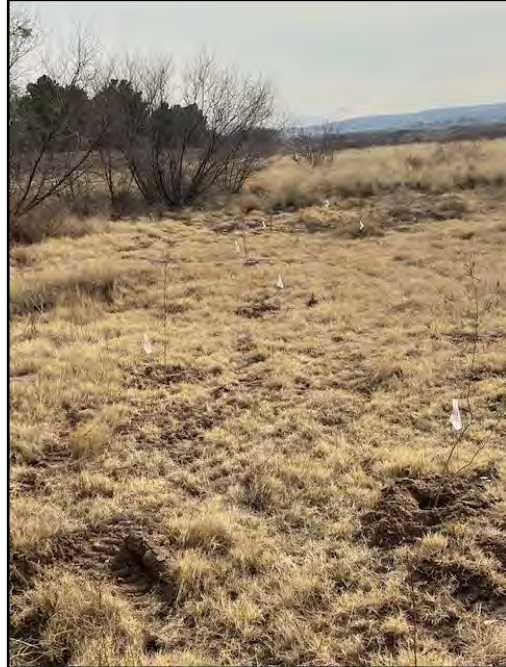
Shrub replanting at the Country Club East Restoration site, 12 December 2019.

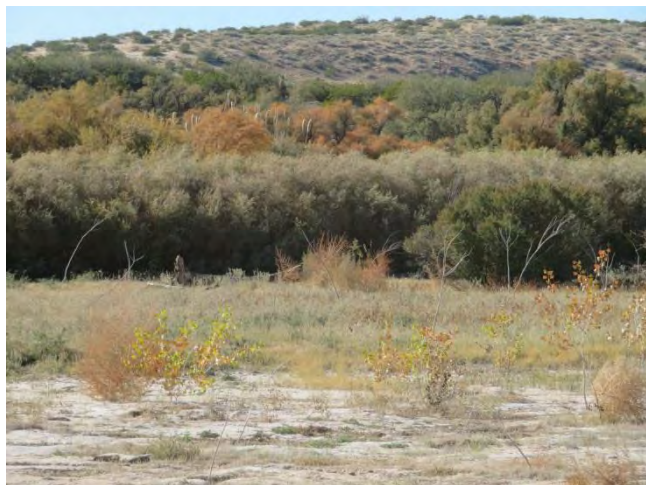
Cottonwoods planted in the Country Club East excavated swales (15 October 2018).

cottonwoods closer to the levee toe road that were often impacted by recreationists. Shafroth, Auble, and Scott (1995) noted that cottonwood establishment success drops off if groundwater levels drop below 1 meter (3.3 feet) in the first year. The swales constructed through the site, with the fine sandy loam that poorly drains, provided sources of water retention for the cottonwoods to promote increase survival.

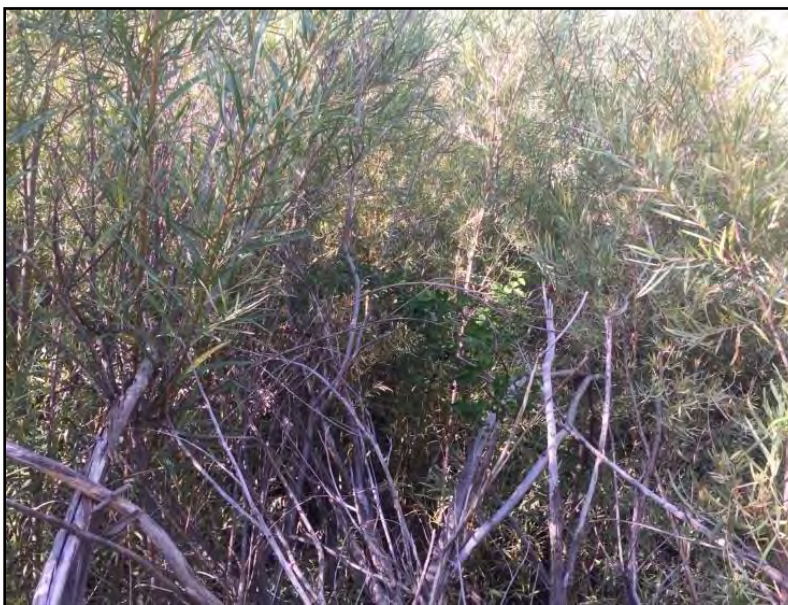
Although the coyote willow transplants are thriving at this site, the Goodding's willows and cottonwood trees did not survive as well. As with the Country Club East site, the poles planted closer to the river had better survival and vigor than those in the open areas closed to the levee toe. Water tables are high at this site during the non-irrigation season and the high clay content in the soil tends to have low water-holding capabilities (TRC 2010) which could potentially impact plant establishment. Although originally recommended after the first year of monitoring (October 2018) that the Goodding's willows be replanted in the flycatcher area, after the October 2019 monitoring effort, it was determined that this area was developing well. Goodding's willows were re-planted along the northern edge of the flycatcher habitat and then further north towards the mesquite grove (Figure 3-8) to provide a more continuous riparian area from the river bank. Shrub survival at this site was good and was pretty high for all species except three-leaf sumac. As this site matures the riparian woodland will develop with additional structure. No further plantings are recommended; however, the flycatcher habitat area should be monitored for any invasive species encroachment.

Flycatcher habitat area at Sunland Park in October 2019.

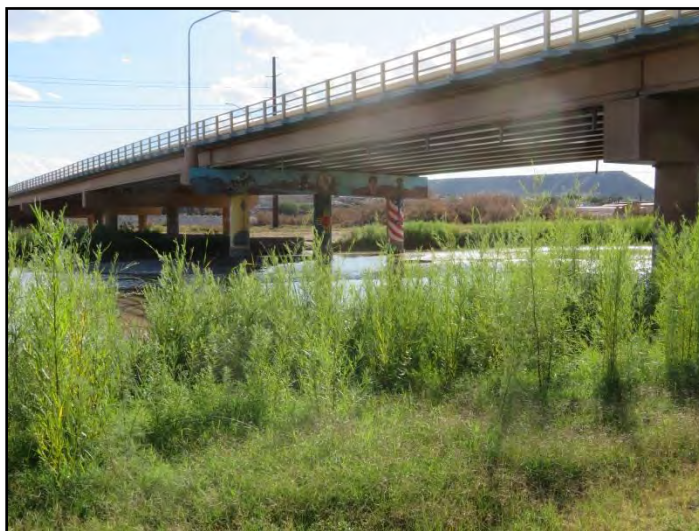
The Anapra Bridge site is characterized by areas with high salinity, shallow groundwater levels, and disturbance. Cottonwood survival was low at this site even with the shallow water table. Stem rot was noted on cottonwoods which may be attributed to the constant exposure to water. Although the Agua wet soil variant is composed of fine sandy loam, high clay concentrations in the soil (TRC 2010) which do not provide high aeration potential, in conjunction

Coyote willow re-sprouts at Anapra Bridge, 15 October 2019.

Given the high salt content at Anapra Bridge and the root-rot that occurred in the cottonwoods, IDEALS-AGEISS recommends that in the future the USIBWC consider focusing on species such as four-wing saltbush, bachharis, or mesquite to provide the species diversity at the site if additional plantings are implemented.

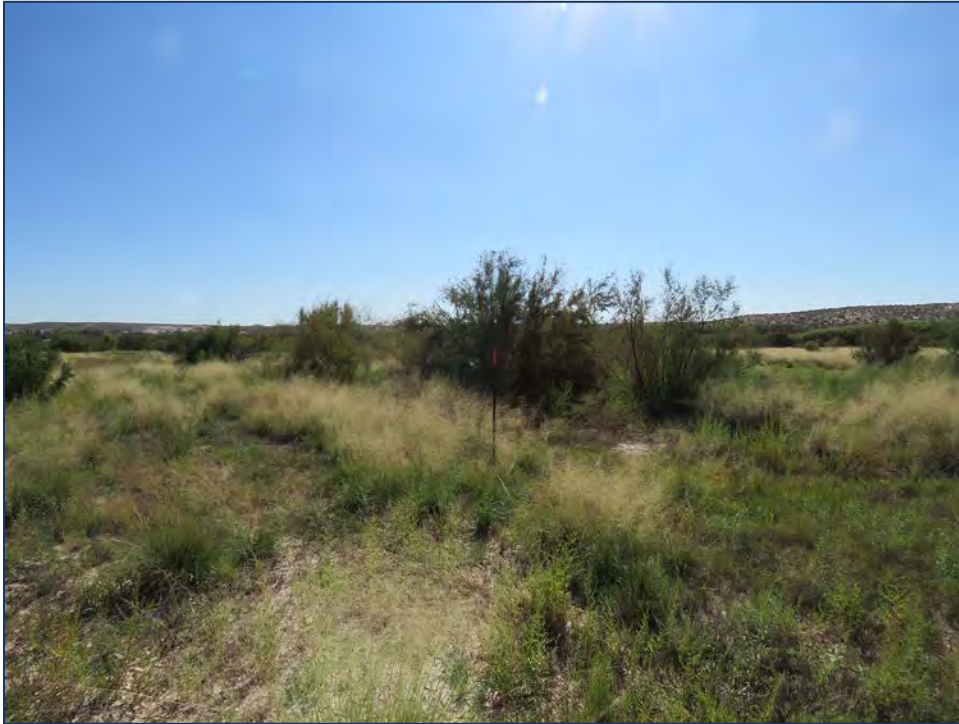
Figure 3-1. Pre-implementation Photo of Country Club East from Photo Point 1

The southern end of this site has moderate patches of screwbean mesquite (*Prosopis pubescens*) with a thin coyote willow (*Salix exigua*) component along the river bank and a few cottonwoods (*Populus deltoides*; Figures 3-1 and 3-2). Away from the river there are some mixed native and non-native vegetation patches with scattered Siberian elm (*Ulmus pumila*) and cottonwood amongst severely stressed saltcedar (*Tamarix ramosissima*; Table 3-1). Within the channel, there are some narrow islands in this stretch dominated by coyote willow and common reed (*Phragmites*). Faunal species observed during the 2017 site visit are listed in Table 3-2. Ground cover vegetation is dominated by alkali sacaton (*Sporobolus airoides*) and pigweed (*Amaranthus spp.*). Habitat at this site has the potential to provide suitable flycatcher habitat within the next few years with restoration efforts. Mowing has been discontinued at Country Club East since 2011. Current site conditions and saltcedar distribution are noted in Figure 3-3. Country Club East has minor infestation of mistletoe (4 to 6 clumps) in two trees.

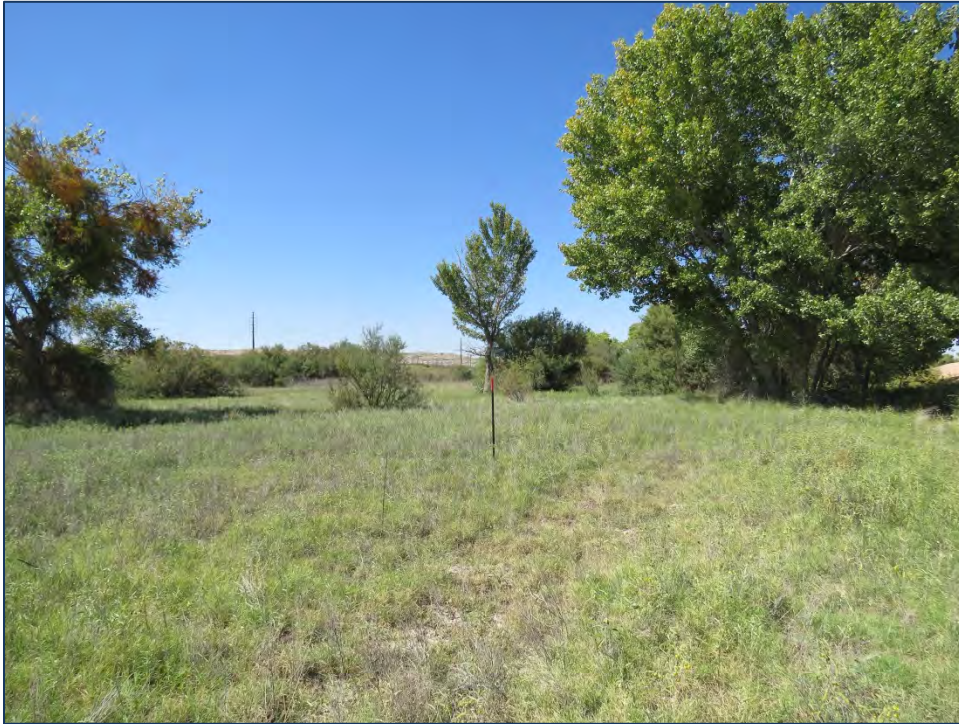
Figure 3-4. Pre-implementation Photo of Sunland Park at Photo Point 2

The Sunland Park site, part of a recreation lease to the City of Sunland Park, was left unmaintained for many years, allowing for the growth of large cottonwoods and mature mesquite, willows, and mature saltcedar. This site has a thin row of coyote willow (in moderate abundance) along the river bank with patchy, diverse mixed vegetation away from the river. The diverse mixed vegetation habitat contains large screwbean mesquite and saltcedar with larger cottonwood growing amongst them towards the southern end of the site (Figure 3-4). The cottonwood becomes more concentrated in an open gallery toward the north end of the site; many of which are heavily infested with mistletoe. Of the 39 cottonwoods surveyed, mistletoe infestation ranged from 0-120 clumps with a mean per tree of 33. Ground cover is primarily fescue grass and silverleaf nightshade (*Solanum elaeagnifolium*). Russian olives (*Eleagnus angustifolia*) are sporadic through the site along the river bank along with Siberian elm (Figure 3-5). Russian thistle (*Salsola tragus*) occurs in moderate abundance in the open areas. Saltcedar in this section is currently suffering from *Diorhabda*. This site currently has good potential for flycatcher habitat. Figure 3-6 shows the distribution of native species (mixed and protected areas) and saltcedar on the site. Vegetation and fauna detected during the habitat assessment are provided in Tables 3-3 and 3-4.

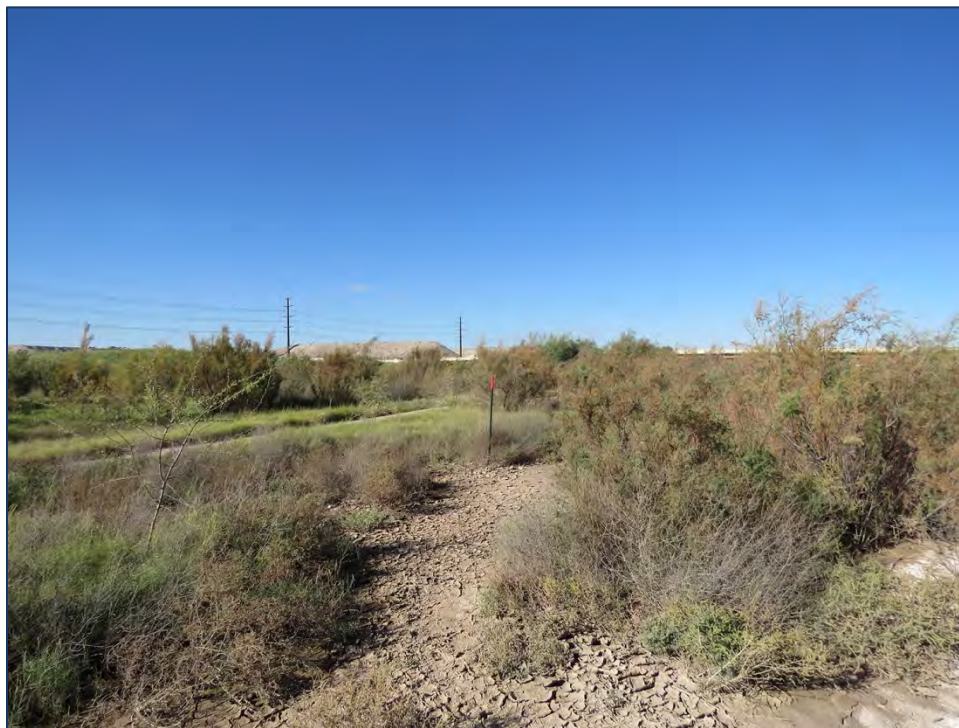
Figure 3-7. Pre-implementation Photo of Anapra Bridge Site at Photo Point 1

The Anapra Bridge site is part of the hike and bike trail and should have been mowed, per the lease agreement with Sunland Park; however, the City of Sunland Park has not mowed in several years. The site has good potential structure. A thin strip of mixed vegetation comprised of coyote willow, seep willow, screwbean mesquite, and saltcedar, runs along the bank of the river with a few Siberian elm and Russian olive (Figure 3-7). Further away from the river a young stand of saltcedar and screwbean mesquite is growing in what appears to be a depression. Saltcedar in this area is showing slight stress from *Diorhabda* and is easily accessible for removal.

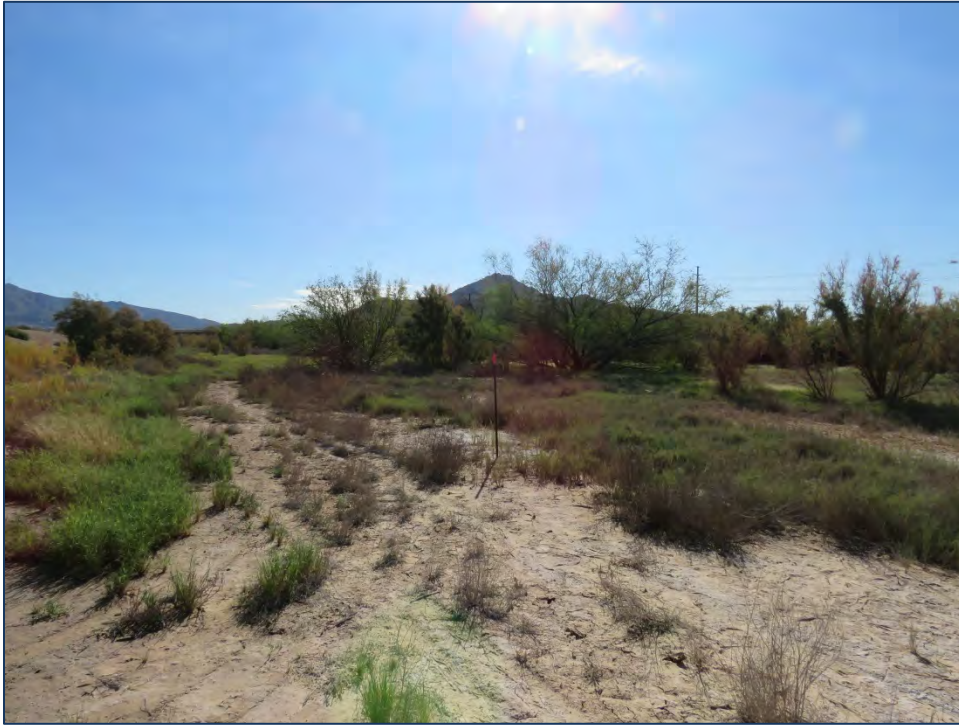
Figure 3-8. Pre-implementation Photo of Anapra Bridge Site at Photo Point 3

A moderate abundance of Russian thistle occurs away from the site and native grass (*Distichlis spp.*) is found in the open areas (Figure 3-8). This site has the potential to be a good candidate for the transplant of willows from island removal (see Section 5.0) once the saltcedars are removed (Figure 3-9). Vegetation and fauna detected at this site are listed in Tables 3-5 and 3-6.

The soils at the Anapra site are also Agua wet variant. Clay concentration in the soil is higher at this site than the other restoration sites varying between 3 to 35 percent (TRC 2010). Salinity on this site varies with one area containing surface salt which may potentially affect plant survivorship. The water table is high at this site with groundwater levels ranging from 1.1 to 5.1 feet below the surface.

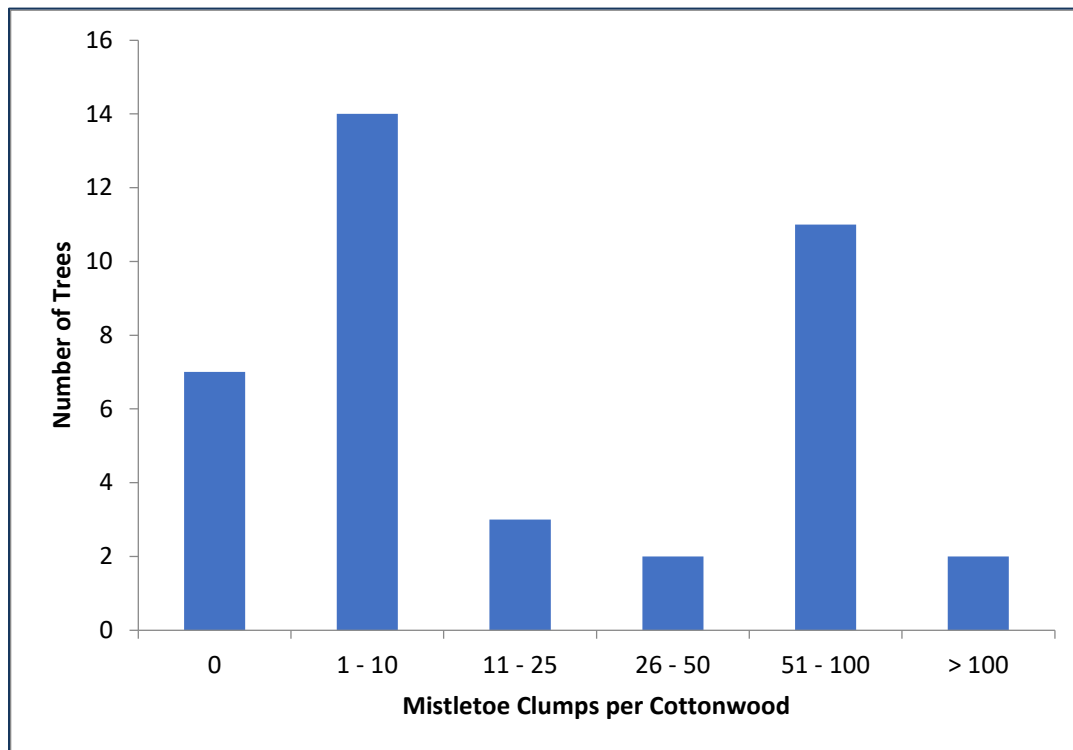
Figure 4-5. Histogram of Mistletoe Clumps per Cottonwood at the Sunland Park Restoration Site

Cottonwoods at all sites were assessed for mistletoe infestation during the pre-implementation monitoring period and the number of clumps for each individual tree noted. Figure 4-5 shows the number of mistletoe clumps per cottonwood at the Sunland Park restoration site where the heaviest infestation was noted. Thirty-nine cottonwoods were surveyed at Sunland Park and 82 percent of these trees were infested. Mistletoe tends to spread faster in multi-storied and monoculture stands (USDA 2010). Seeds may also fall from mistletoe in the upper parts of the trees creating new infestations on lower branches. Birds feed off of the berries, digest the pulp, and excrete the seeds, which can then adhere to the branches of living trees. When the seed germinates, it grows into tree tissues. It may take up to 2 years for the plant to bloom and produce viable seed. Based on discussions with arborists and New Mexico State University Extension, there is a good chance that mistletoe, once established on a host tree that is dominant to the area, tends to remain attracted to that specific tree species. With Sunland Park receiving a large number of new Goodding's willow (as opposed to cottonwood) there may be some control by utilizing a larger number of Goodding's willows and providing a buffer as field conditions dictate. New cottonwoods should be planted a minimum of 100 feet away from infested cottonwoods.

Mistletoe provides important components for wildlife habitat and some recommend that removing the infestation should be avoided unless other defects in the tree are significant (Halooin 2003). The most effective way to control mistletoe and prevent its spread is to prune infected branches, if possible, as soon as the parasite appears. Thinning-type pruning cuts to remove infected branches at their point of origin or back to large lateral branches will be used. Infected branches will be cut at least 1 foot below the point of mistletoe attachment in order to completely remove embedded haustoria. Cuttings will occur in the winter when seeds are not being produced. Done properly, limb removal for mistletoe control can maintain or even improve tree structure. The field crew will avoid severe heading (topping) if possible; such pruning weakens a tree's structure, and destroys its natural form. Pruning to control the mistletoe is recommended for the trees with less than 25 clumps per individual. Removing infestations greater than that at this point may not be beneficial and removal of the severely infested trees would greatly alter the site characteristics. Further monitoring and evaluation of the tree structure should be performed yearly in order to confirm adverse effects and or disease resulting from other parasites, bacteria, or migrating insects. Mistletoes infecting a major branch or the trunk where it cannot be pruned may be controlled by cutting off the mistletoe flush with the limb or trunk. To increase effectiveness of the pruning, the area can be wrapped with a few layers of wide, black polyethylene to exclude light (Perry and Elmore 2006).
