## **Geotechnical Evaluation of the Brownsville Levee Cracking and Partial Slope Failure**

Lucas A. Walshire, Joseph B. Dunbar, Isaac J. Stephens,  
Maureen K. Corcoran, Carla Roig-Silva, and Julie R. Kelley

July 2015

Final report

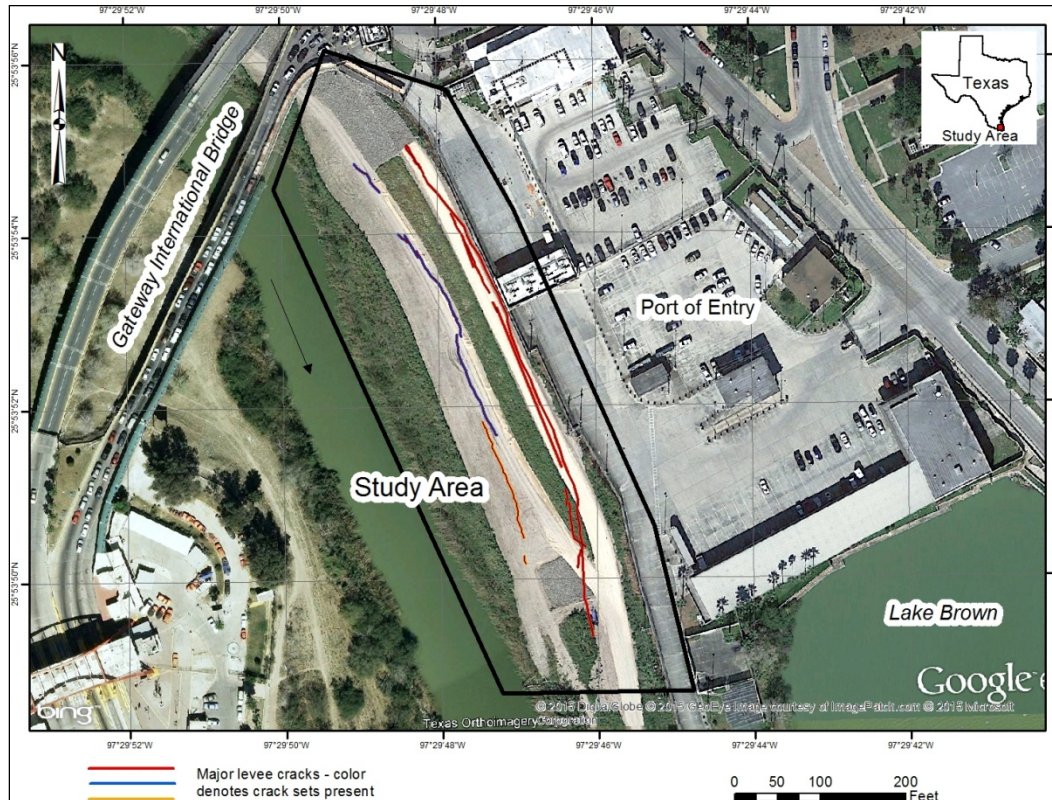
The newly refurbished levee section and adjacent floodplain began cracking and a partial slope failure occurred following a significant drop in the Rio Grande water level in early-April 2014. The USIBWC (2014) discovered the levee cracks between Stations 1899+00 and 1904+85 in early-May 2014 (Figure 1.1). In July 2014, nearly a foot of slippage at the levee crest and two prominent cracks at the levee toe were observed by personnel from the U.S. Army Engineer Research and Development Center (ERDC) (Figures 1.2 to 1.4). USIBWC personnel reported that the river level had been rapidly drawn down several feet to satisfy local irrigation demands between April and June 2014 before the onset of the cracking and slippage of the crest.

Figure 1.1. Location of levee with cracking and partial slope failure.

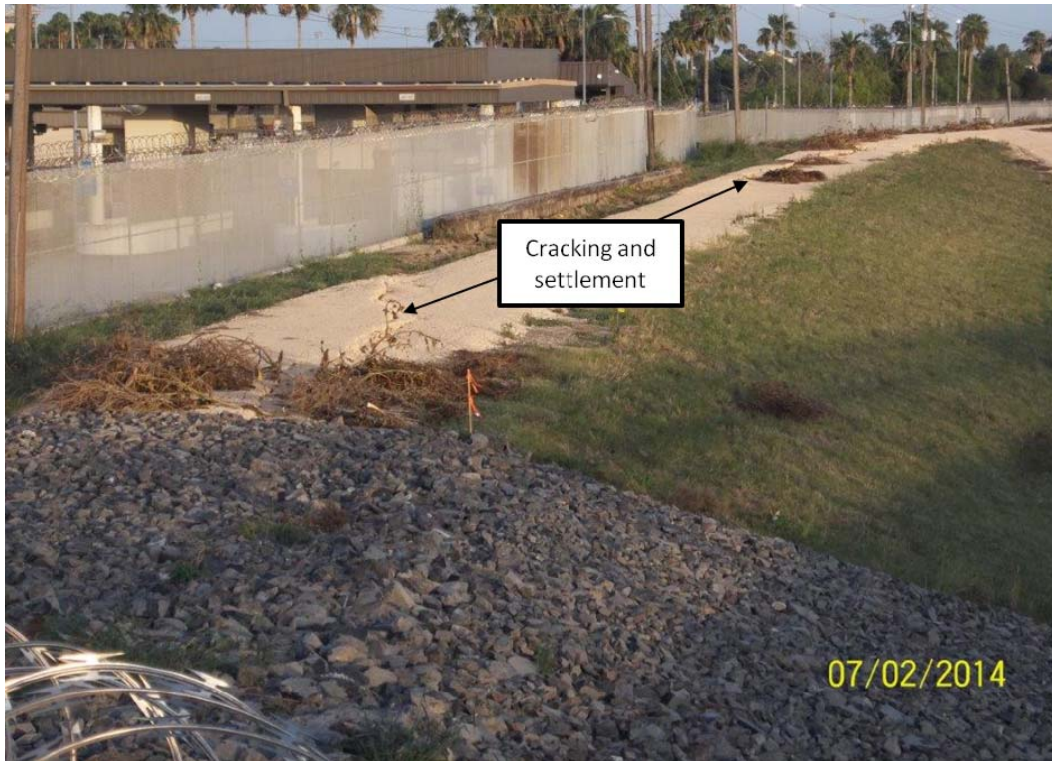
Figure 1.2. Severe cracking at the levee crest.

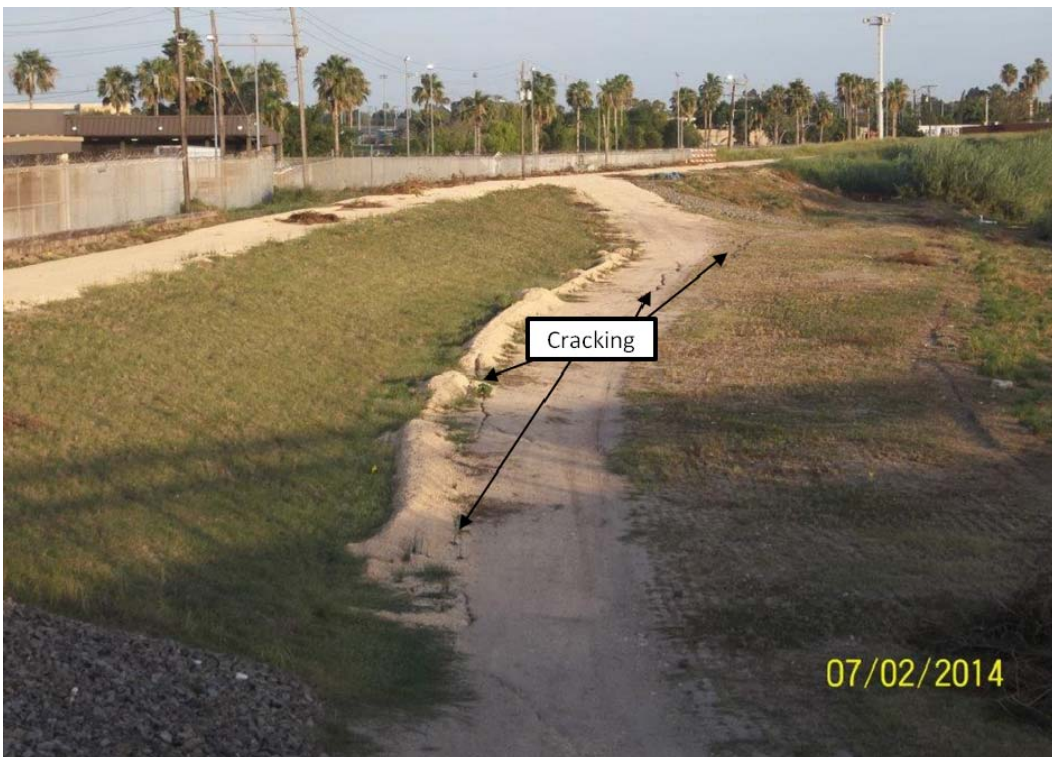
Figure 1.3. Severe cracking and settlement at the levee crest and at the waterside toe.

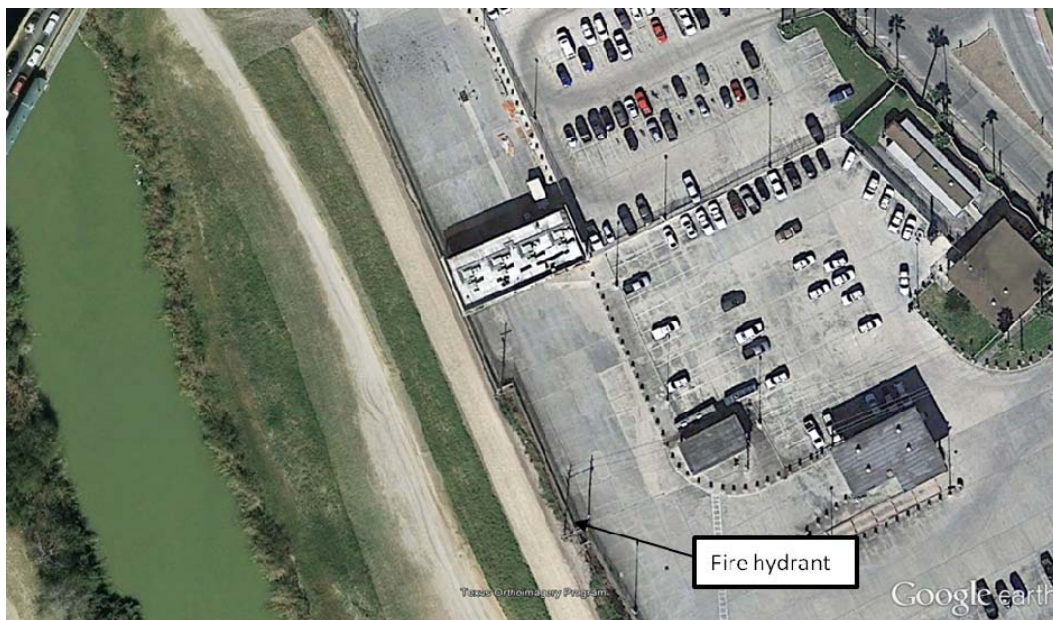
The POE area adjacent to the levee reach experiencing severe cracking contains a fire-hydrant that was visible through the border fence (Figure 2.5). A close inspection of this area was made during the initial site visit by ERDC and USACE District Galveston geotechnical personnel. There were no visible signs of distress (e.g., seepage, sinkholes, wet spots) within the POE area along the levee landside slope to suggest a utility was responsible for any soil being removed and contributing to the severe levee cracking.

Figure 2.5. Location of fire-hydrant that was evaluated for possible leakage.

Department reported the fire hydrant at this location had active water pressure, and there were no reports of leakage.

The level of human foot traffic in this area and border maintenance activities observed at the POE adjacent to the cracking area would have alerted U.S. Customs or U.S. Border Patrol personnel if leakage was occurring with any of the buried water utilities and the fire hydrant nearby. Thus, it was concluded that buried utilities did not contribute to severe cracking within the study area.

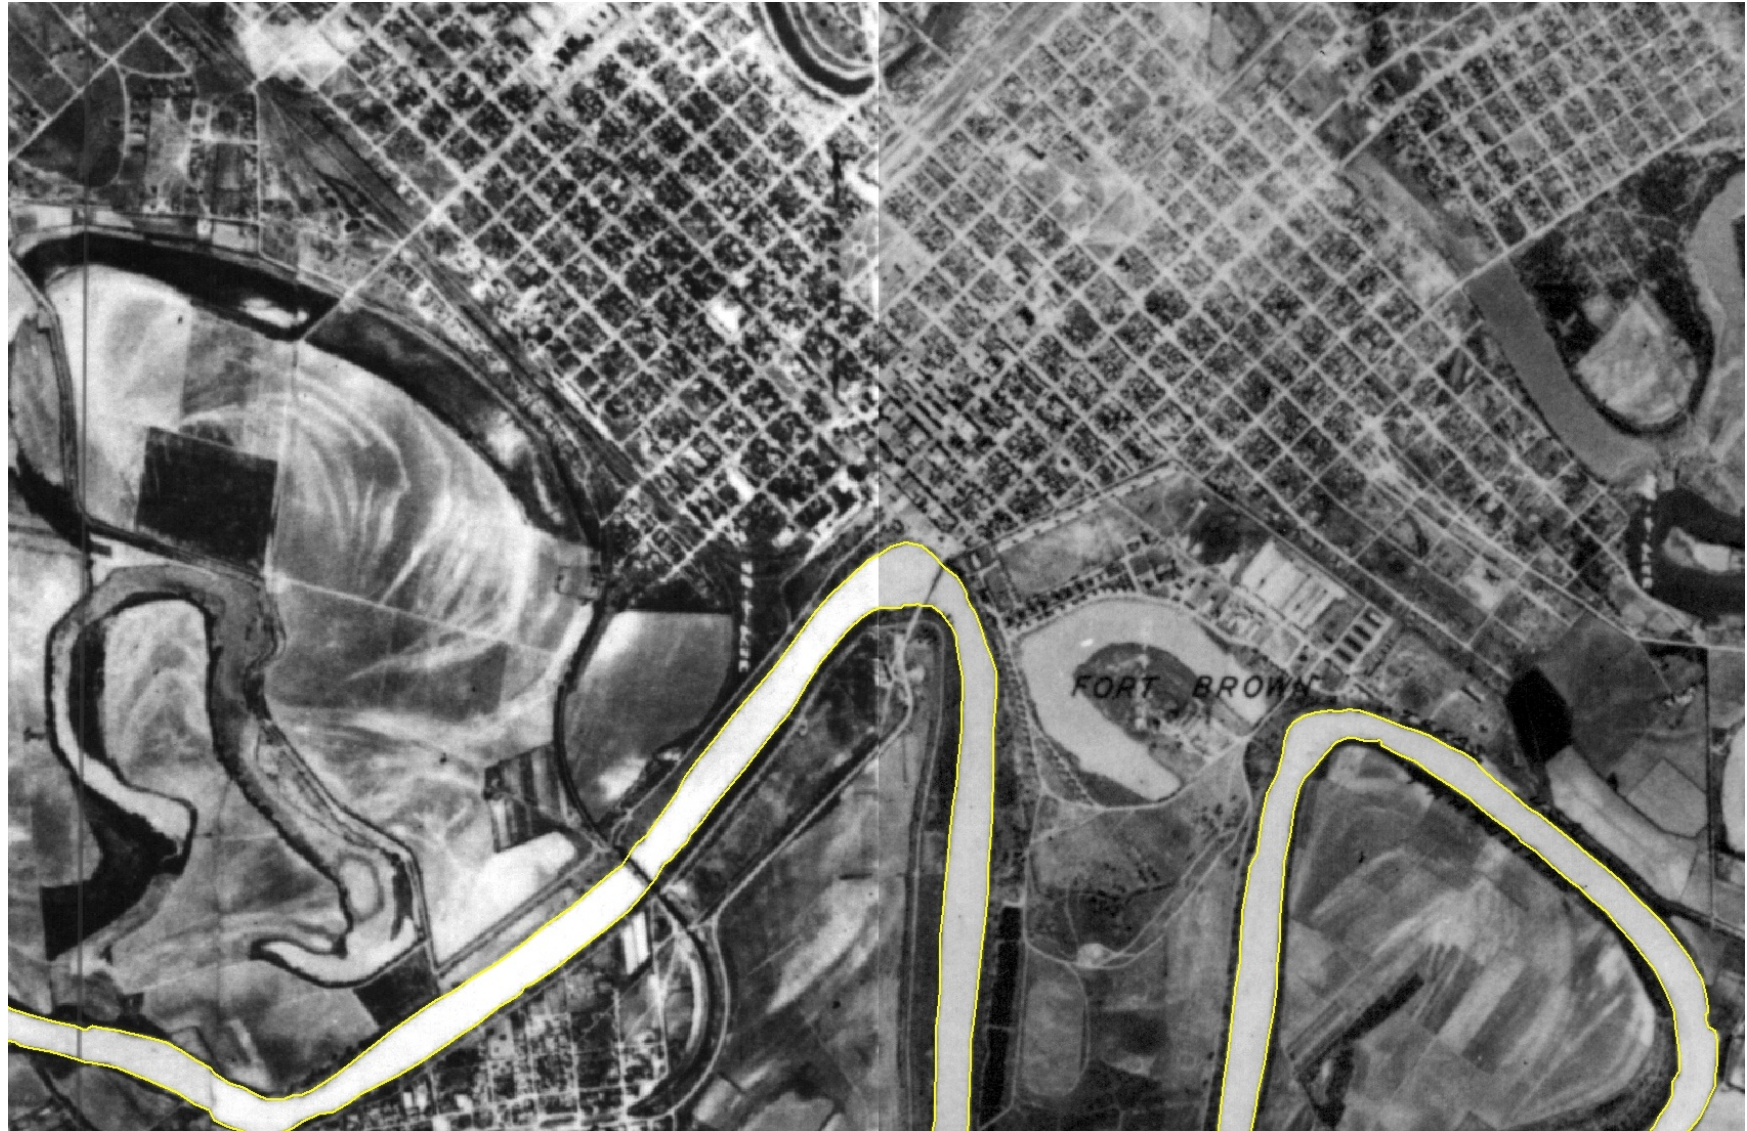
Figure 3.10 shows parts of two Tobin aerial photographs from the Brownsville area (East and West Brownsville 7-1/2 topographic quadrangle maps) in 1930 and confirms the existence of a much wider river channel than

Figure 3.10. East and West Brownsville 1930 Tobin Photographs with channel limits of Rio Grande outlined in yellow.

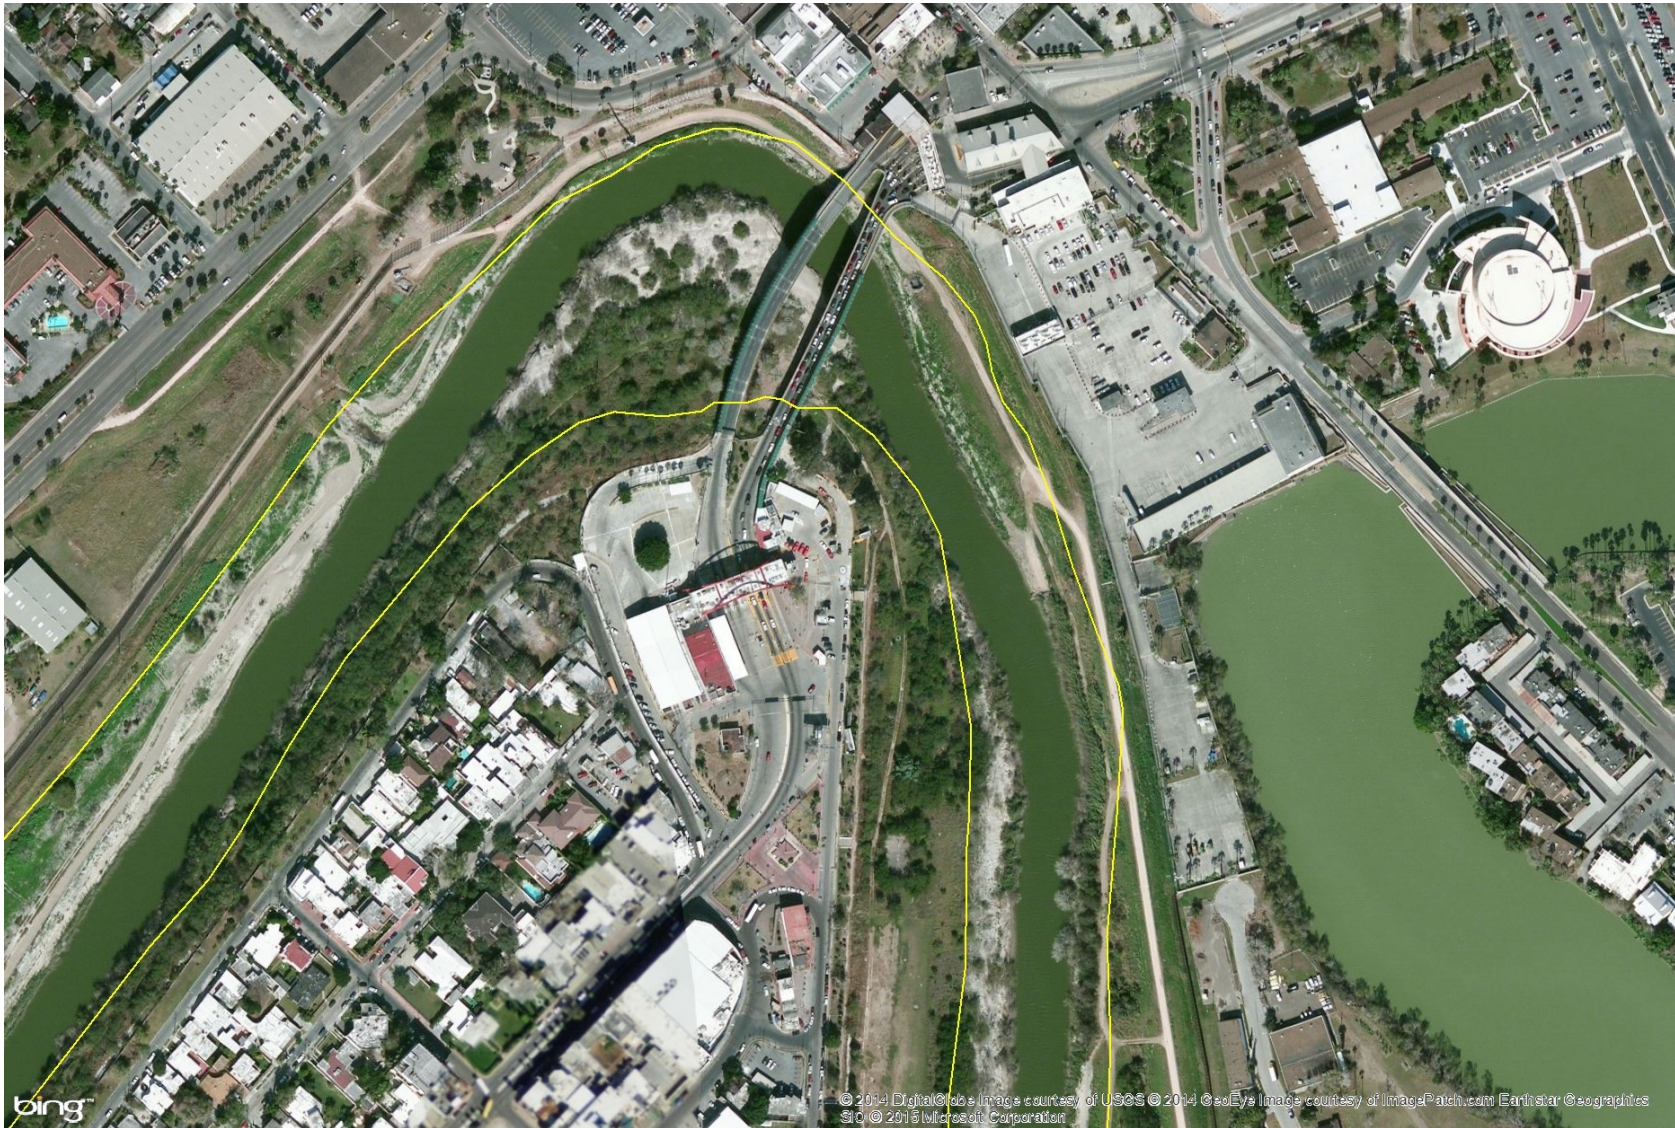
present day limits. The 1930s channel limits have been imposed onto a 2014 Google Earth image of the study reach, which shows the infilling of the Rio Grande by river-borne sediment since 1930 (Figure 3.11). This infilling is the direct consequence of considerably reduced annual river flows caused by the construction of several upstream dams between 1950 and 1970, and the ever increased demands of agricultural irrigation use and water supply within the LRGV from expanding population growth. The maximum limits of the 1930 river channel generally correspond to the current day levee toe (Figure 3.10).

Figure 3.11. 2013 Bing image with 1930 Rio Grande channel limits shown by yellow lines. Edge of the 1930 river channel corresponds to approximate toe of current levee. Gateway International Bridge shown is the second bridge at this location.

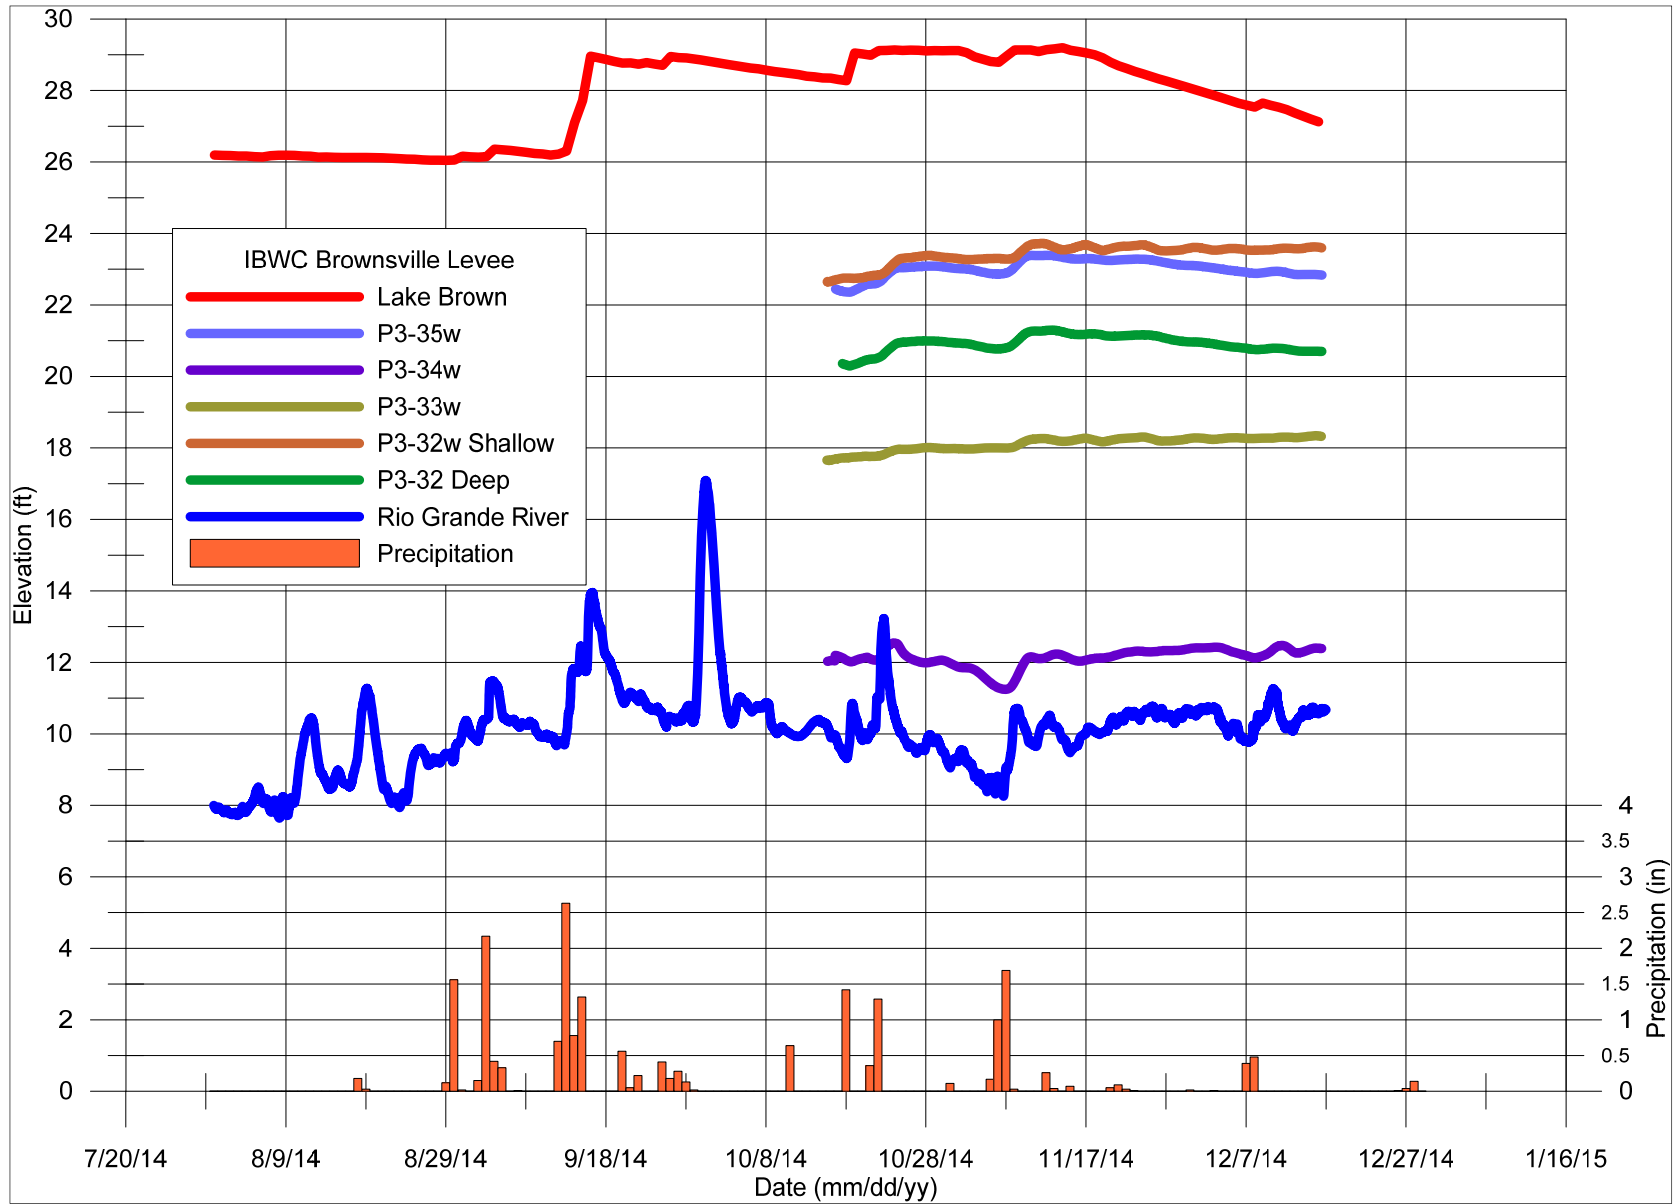
Plots of the groundwater data are presented in Figure 4.8 and show minor fluctuations over the period of record. Water level data in BRN-P3-34W, which is nearest the river, tends to have the greatest variability as would be expected because of the precipitation relationship to the river. However, all the wells reflect a sudden change in groundwater levels at the end of October 2014 due to heavy rainfall at this time. Groundwater elevations indicate a general connection between the different strata as evidenced by the graph in Figure 4.8, and the well screen intervals identified in Table 4.1.

Figure 4.8. Lake Brown stage and monitoring well elevation vs. time.

The water level in Lake Brown during the study period varied between elevations 27 to 29 ft. Locally, the lake level elevation corresponds to the groundwater surface, while near the Rio Grande, the piezometric surface in BRN-P3-34 is at elevation ~12 ft, nearly a 15- to 17-ft head difference between Lake Brown and the river. The lake contains a hydraulic connection to the underlying stratigraphy beneath the levee foundation through pervious point bar deposits that were formed during the oxbow migration and cut-off process. These pervious sediments form the southern limits of the study area near the levee access road to the riverbank and road under the Gateway International Bridge. Geologic data will be presented in detail in the next section of this report, which will help clarify groundwater conditions and provide a better understanding of the hydraulic relationships in the stratigraphy.

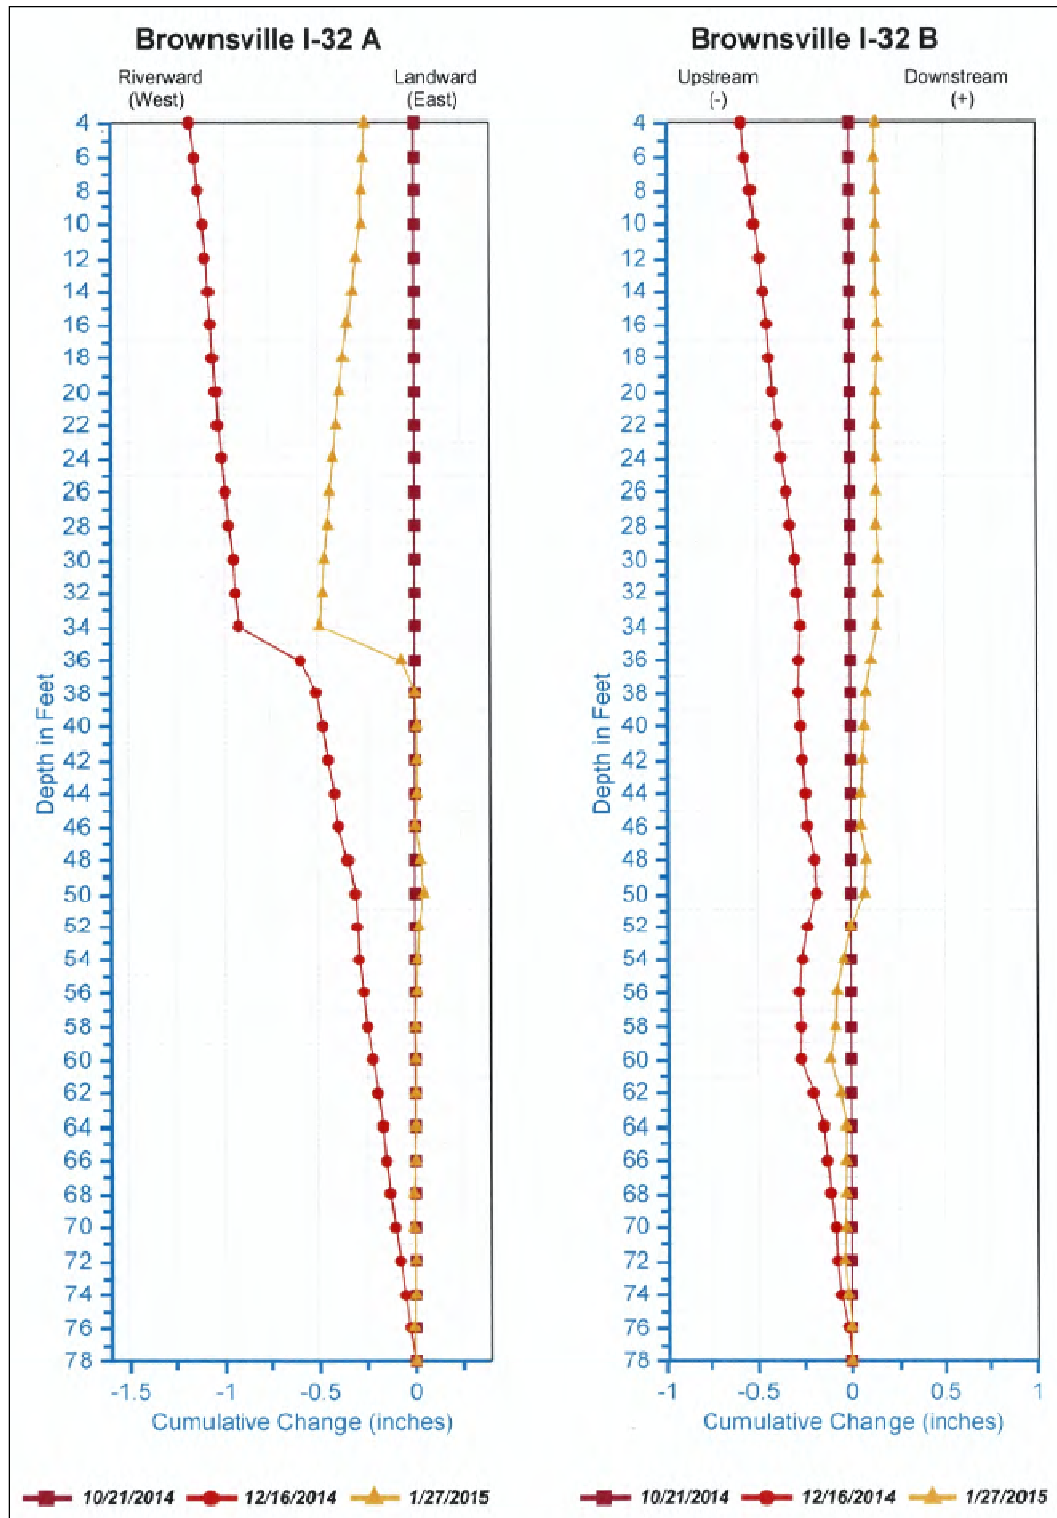
Figure 4.9. Inclinator data as of 27 Jan 2015 for I32.

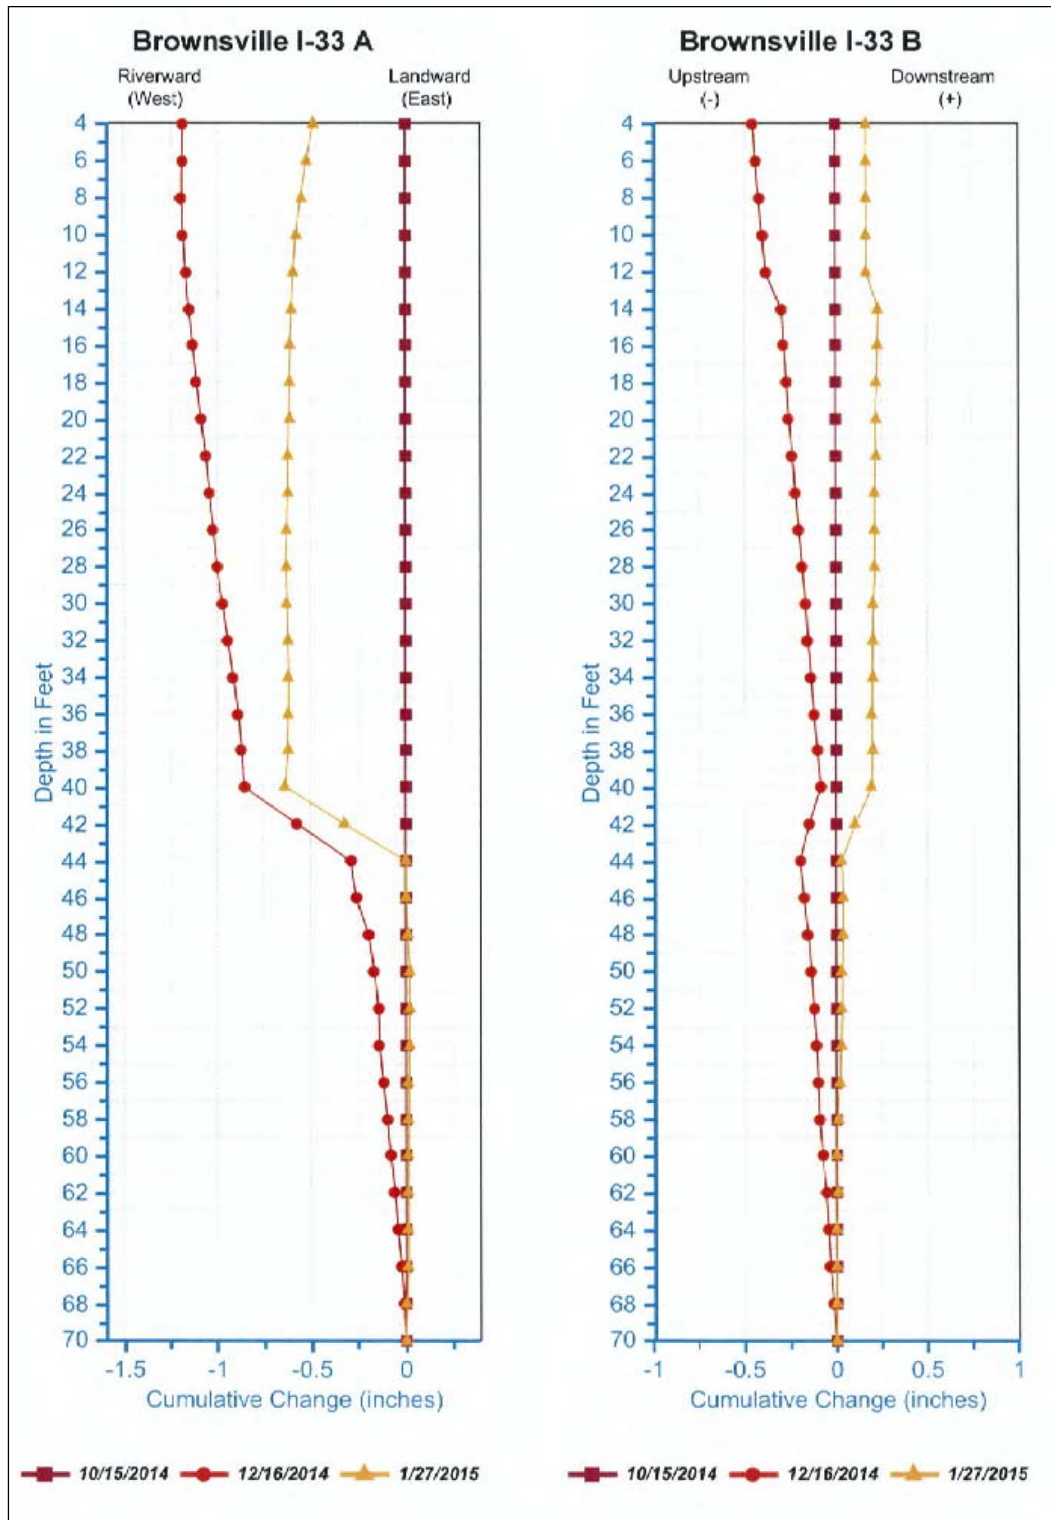
Figure 4.10. Inclinometer data as of 27 Jan 2015 for I33.

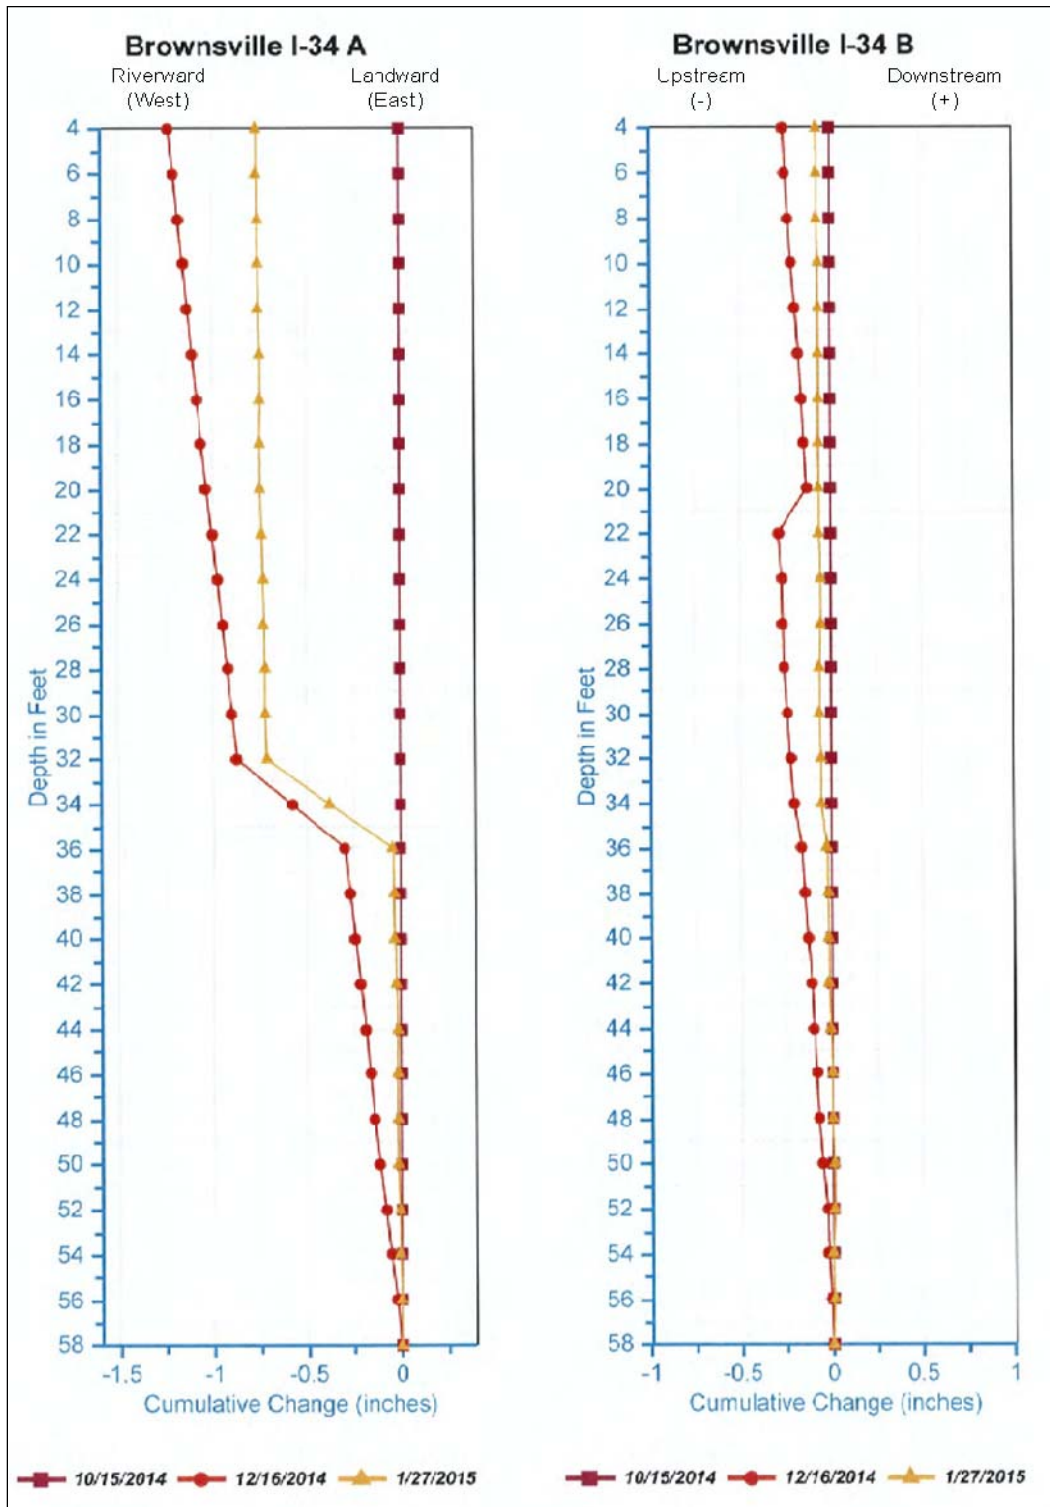
Figure 4.11. Inclinator data as of 27 Jan 2015 for I34.

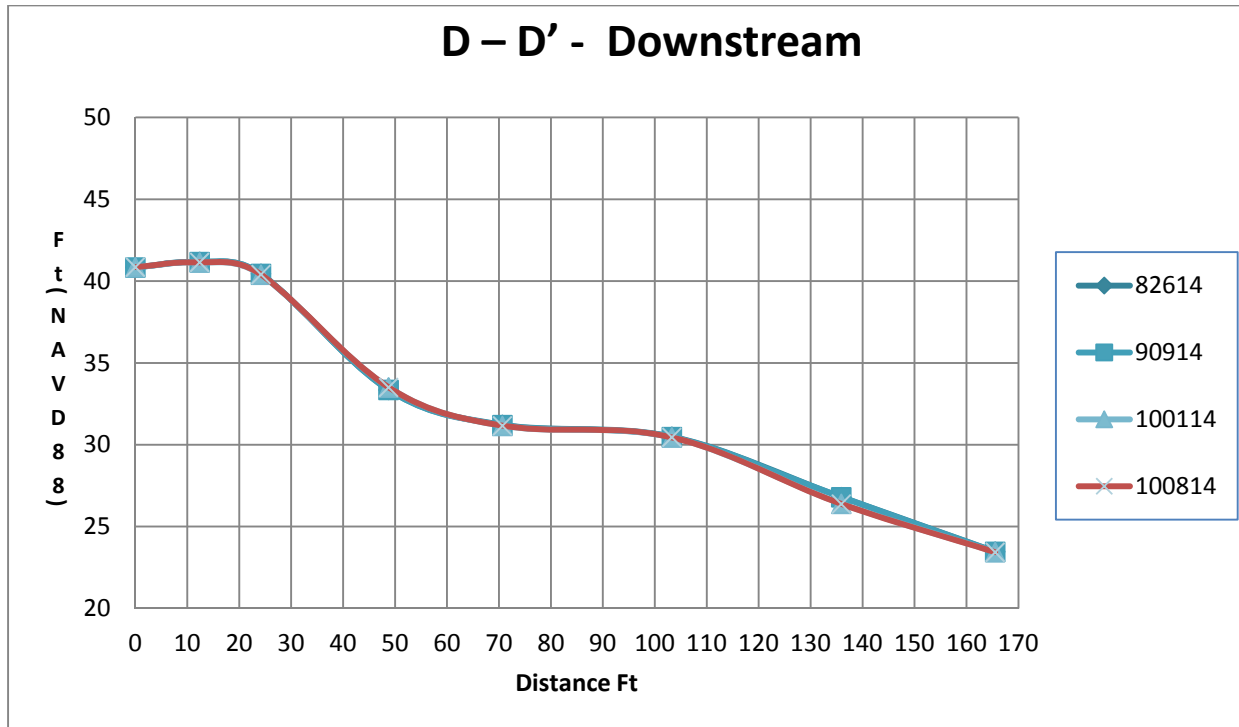
Figure 4.15. Total station survey profile for downstream levee section (location roughly corresponds to geologic cross section D-D') showing levee and bank geometry, and the absence of appreciable movements between survey periods 26 Aug to 8 Oct 2014 (see Table 4.4).

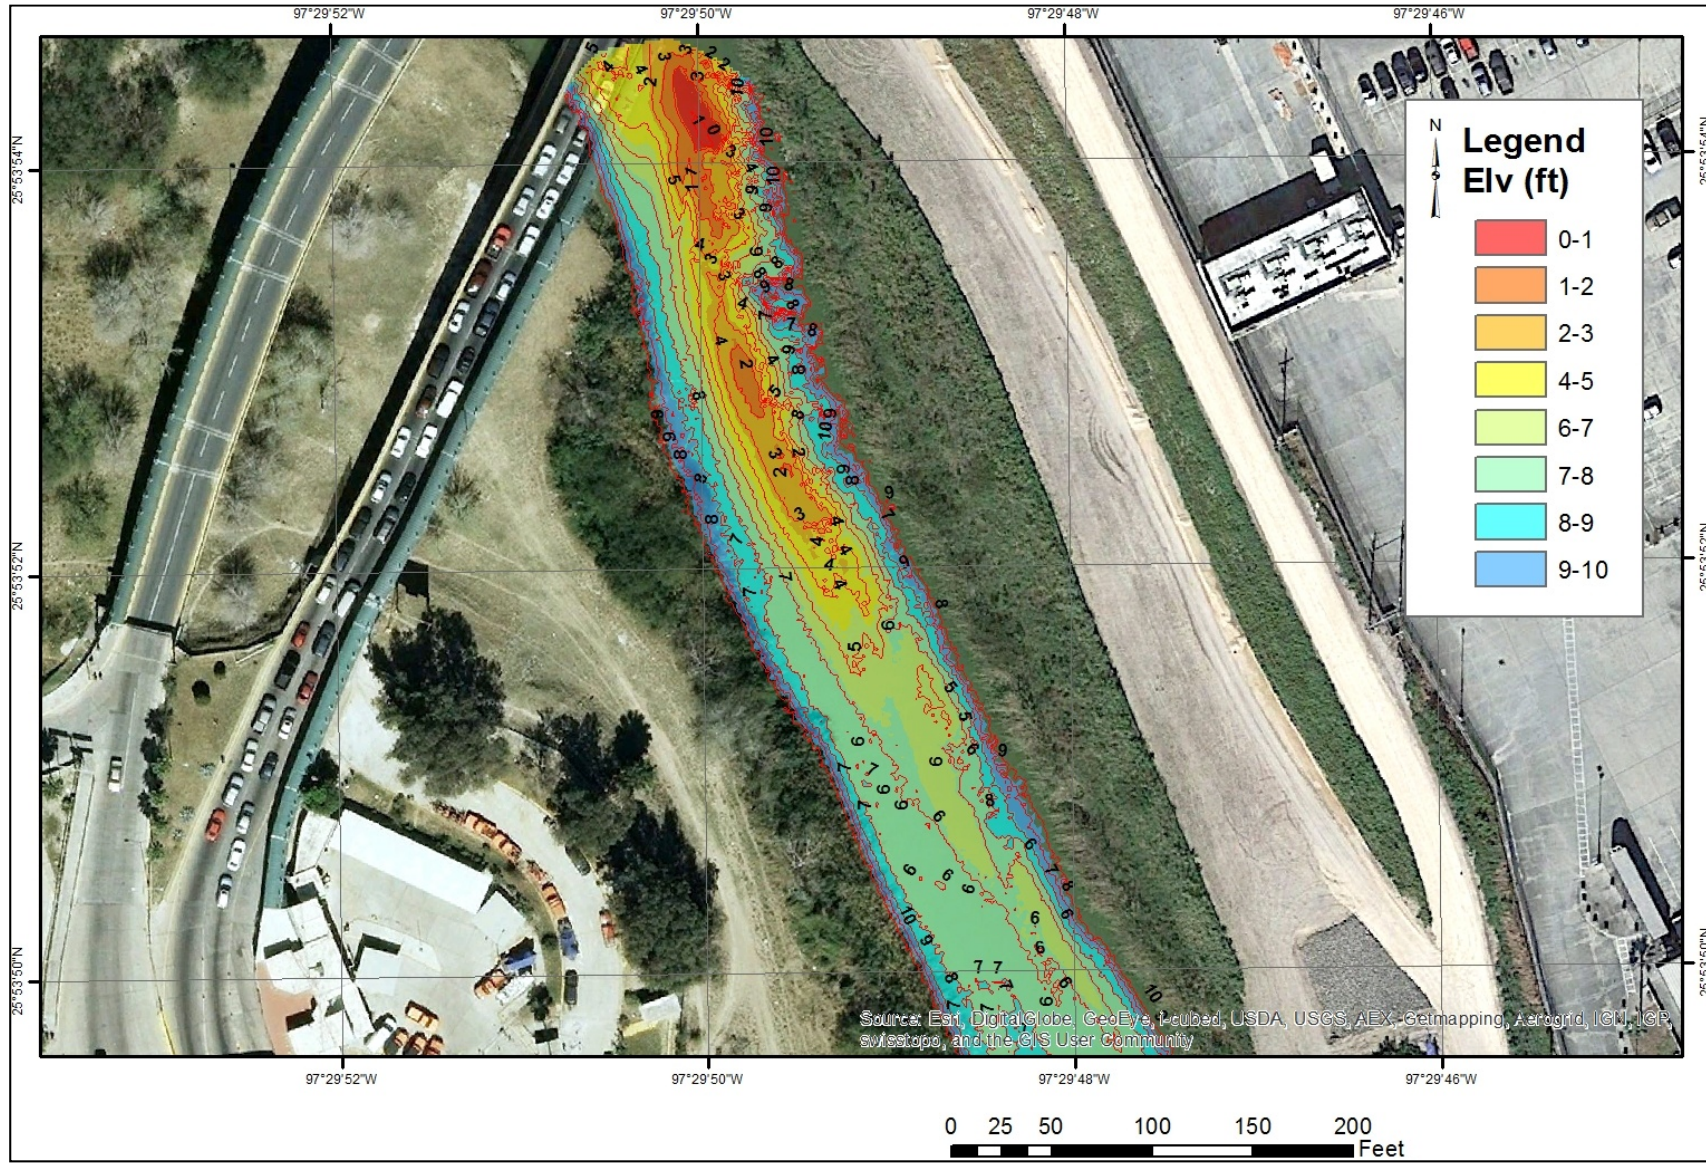
Figure 4.16 presents the bathymetry data collected from the study area taken 10 to 12 September 2014. Elevation data from this survey identify a deep scour hole present in the bendway, extending downstream of the bridge, and with an elevation of less than 1 ft NGVD. The thalweg (deepest point in the river) then crosses toward the Mexico side of the river, where the channel bottom elevation begins to rise to between 2 and 4 ft NGVD. Further downstream the elevation is between 6 and 7 ft NGVD. Also noticeable in this figure is the hummocky topography of the U.S. channel bank, which displays a scallop outline and indicates a history of past bank slumping activity. Bank slumping was noted by ERDC personnel during field visits to the site in 2014 (Figure 4.17).

Figure 4.16. Bathymetry data showing elevation of the channel bottom. Bathymetry data were collected on 10 to 12 Sep 2014. Note the jagged U.S. bank line and scallop topography below the water surface.

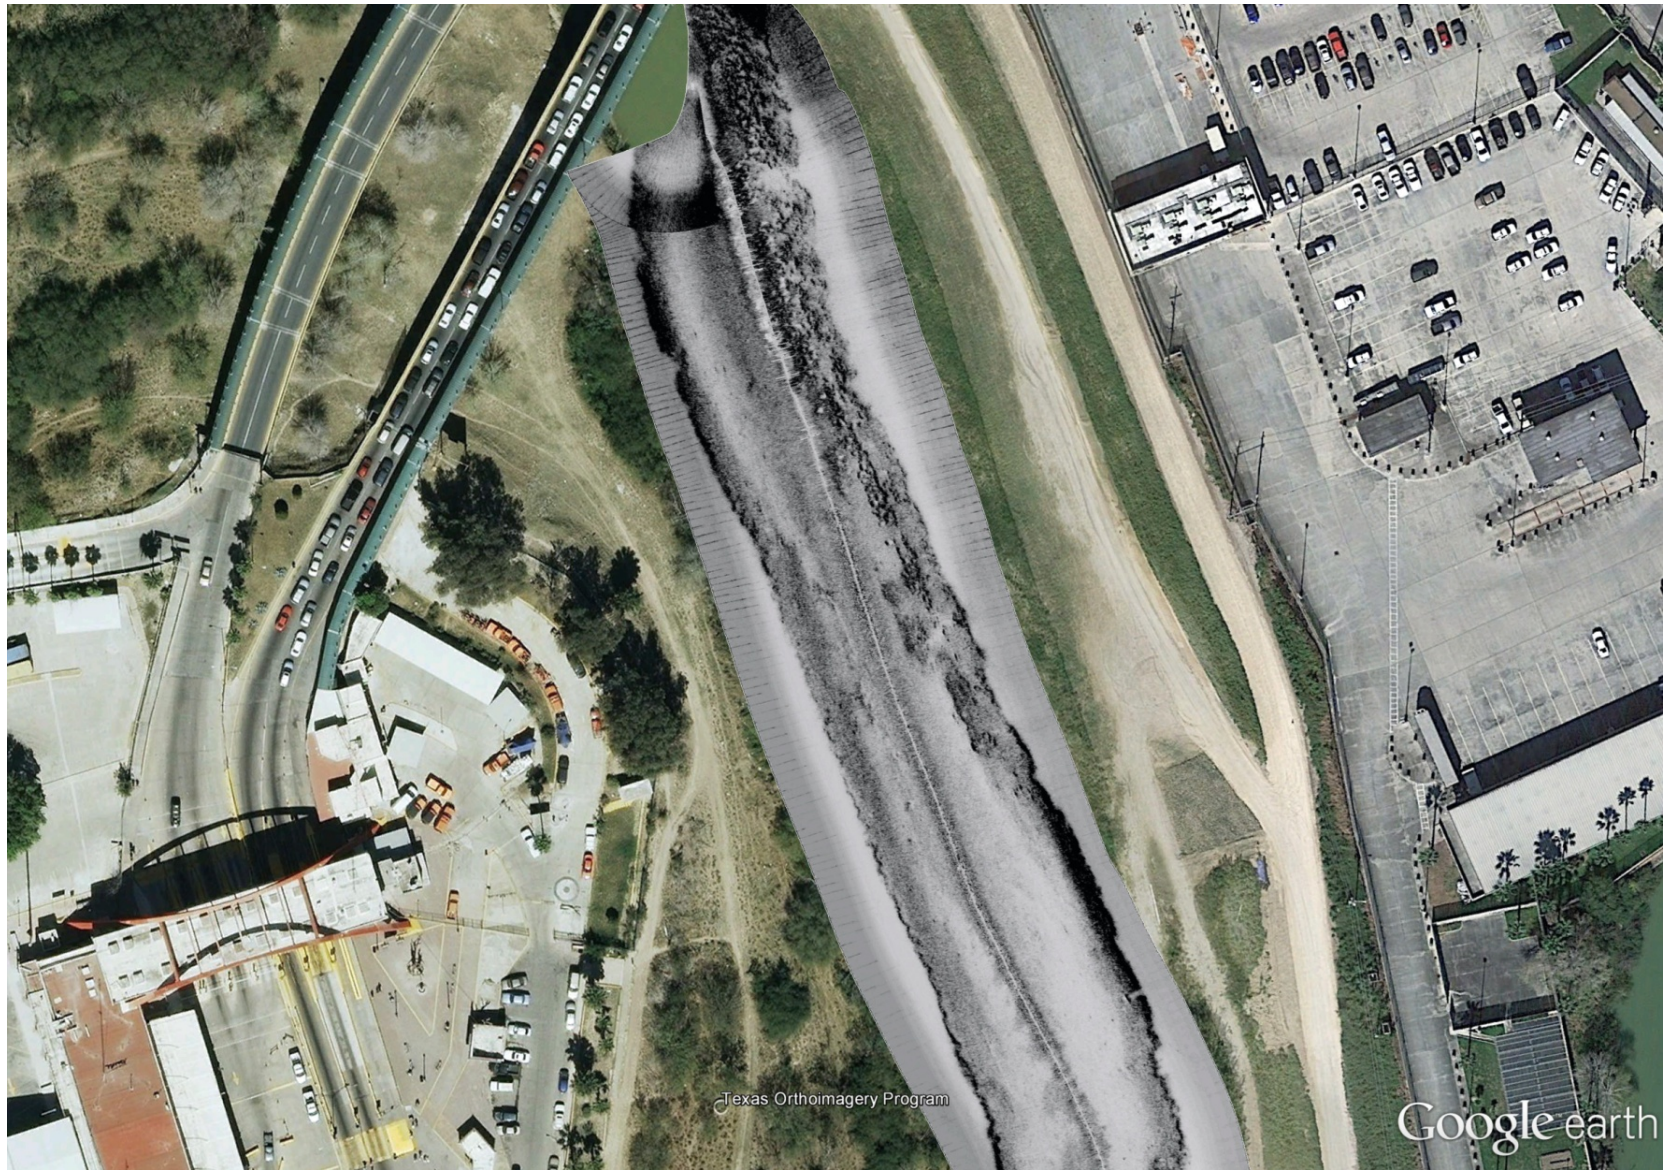
The rough nature of the U.S. bank is apparent in the side scan sonar images in Figures 4.18 and 4.19. The northern part of the study area shows a channel containing displaced bank material at the edge of the channel, as compared to the southern end where the submerged bank slope is generally devoid of any in-channel debris. The thalweg (deepest point in the channel) crosses toward the Mexico side of river downstream of the bridge.

Figure 4.18. Side scan sonar image overlain on 2014 Google image showing the channel of the Rio Grande through the study area. Close-up view presented in Figure 4.19 with prominent features noted.

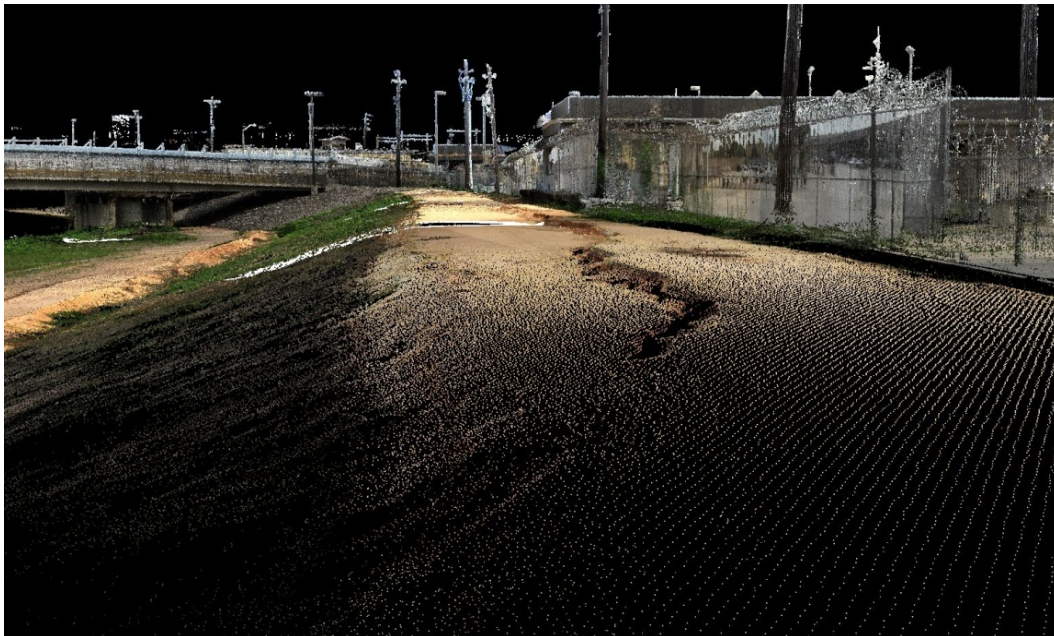
Two images of the LiDAR data are presented in Figures 4.21 and 4.22. The first view is from the levee crest, looking upstream from the south end of the study area. The image captures 0.5 to 0.7 ft of displacement along the scarp at the roadway crest. The second view is looking downstream from the levee toe, approximately midway in the study area and shows the wide crack at the levee toe, which cuts across the gravel ridge and parallels the levee toe upstream from the viewer's perspective (note the upstream extent of the blue crack in Figure 1.1).

Figure 4.21. LiDAR image looking upstream and showing 0.5 to 0.7 ft of down slope displacement of the crest road.

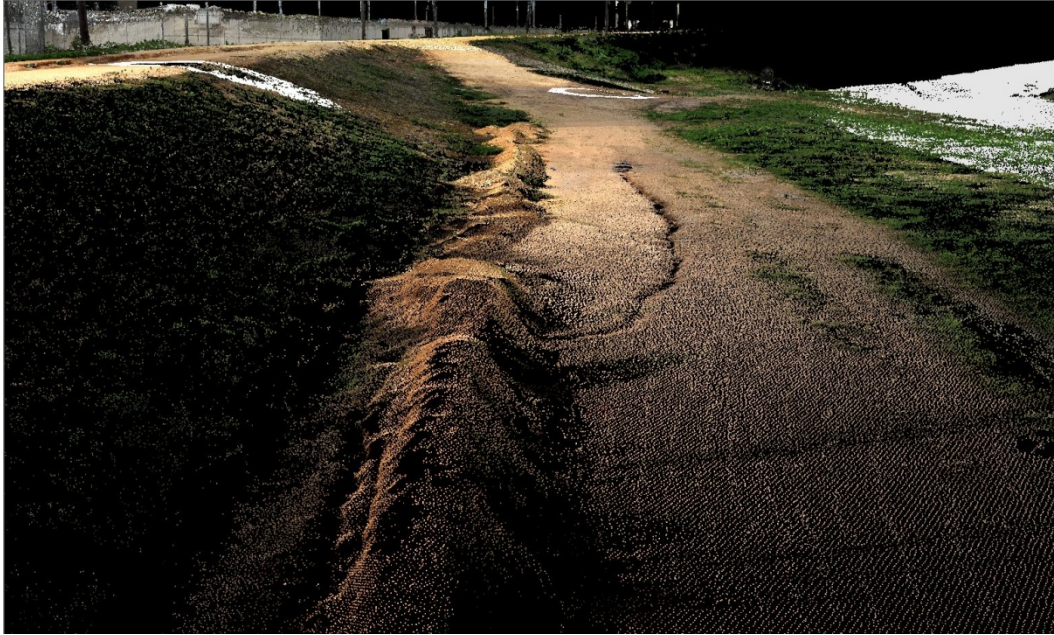
Figure 4.22. LiDAR image looking downstream showing the large crack separation at the toe, the crack crossing the gravel mound, and continuing upstream toward the viewer. White circular features in the image are the LiDAR stations where the instrument was placed to conduct the scan of the bank.

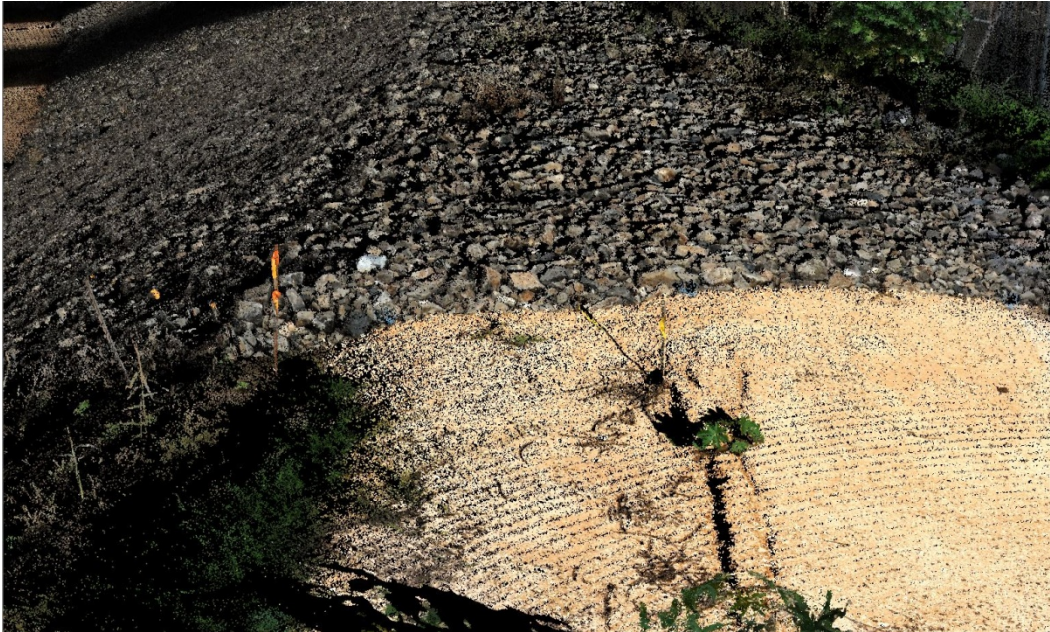
downstream of the bridge. Coarse stone used to armor the slope prevents the Terrestrial LiDAR from measuring minor elevation changes that possibly reflect the continuation of the crack (Figure 4.23).

Figure 4.23. LiDAR image of the crack at the levee crest. Rip-rap at the upstream end of study area prevents examination of the ground surface to verify the upstream crack extent. LiDAR data does not provide additional resolution because of the coarse nature of the stone.
