## **Geotechnical Evaluation of the Brownsville Levee Cracking and Partial Slope Failure**

Lucas A. Walshire, Joseph B. Dunbar, Isaac J. Stephens,  
Maureen K. Corcoran, Carla Roig-Silva, and Julie R. Kelley

July 2015

Final report

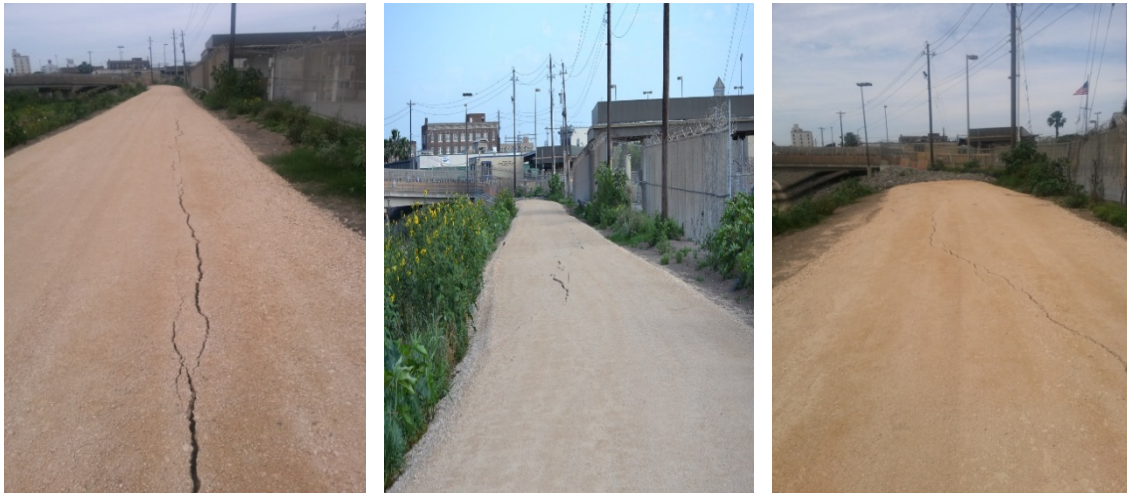
The next low water period occurred from 4 to 6 May 2014. USIBWC personnel photographed the extent of cracking at the levee crest and toe on 6 May 2014 (Nunez 2014). This series of photographs is presented as an Appendix J to this report for a record of the time line. Selected photographs of the crest are shown in Figure 5.14.

The large scale displacements at the levee crest observed in early July 2014 (see Figures 1.2 and 1.3) are not present at this time. High water discharges of greater than 25 cms occur during the period 11 to 20 May 2014, followed by another low period with discharges below 1 cms between 7 and 14 June 2014. It is suspected that the 7 to 14 June 2014 period culminated with the large crest displacements observed by ERDC personnel from 1 to 3 July 2014. The maximum displacements observed at this time were between 0.5 and 0.7 ft at the levee crest.

Figure 5.14. Photographs of levee cracking on 6 May 2014.

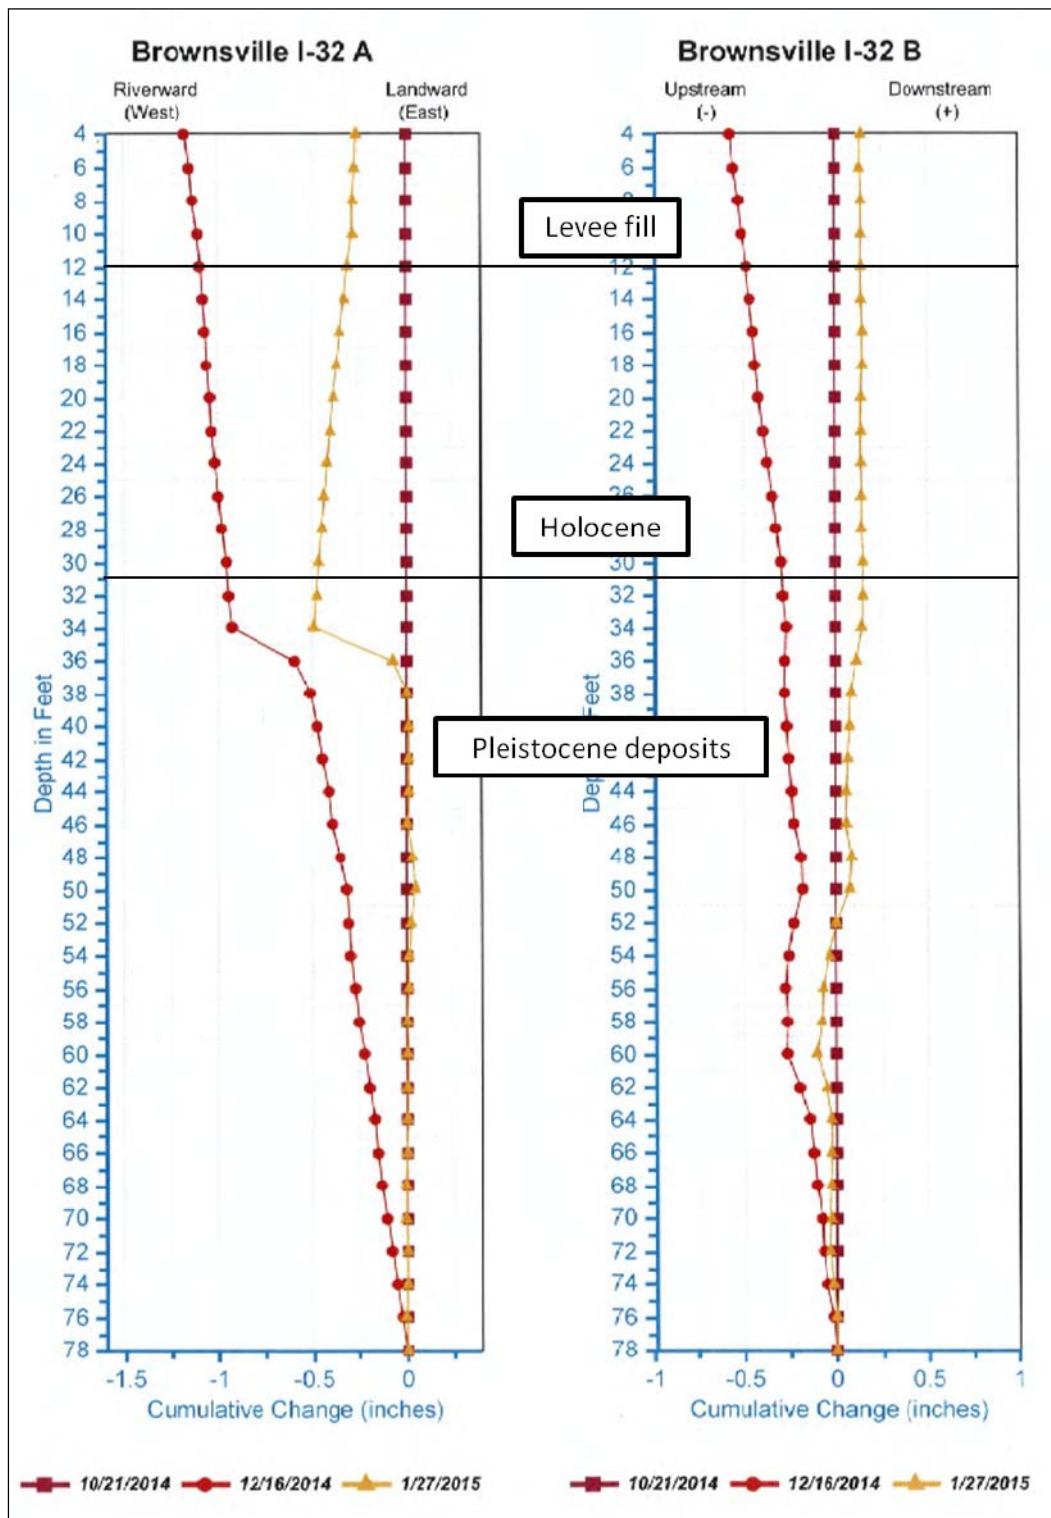
What is surprising is the interval where deflection begins to occur in relation to the basic stratigraphy. At the levee crest, 32I deflection starts in the upper Pleistocene stratigraphy between 34 and 36 ft. At the levee toe, 33I deflection occurs at the contact between the historic fill and the

Figure 5.15. Inclinomometer data with basic stratigraphy as of 27 Jan 2015 for I32.

These data suggest the Pleistocene surface is behaving as a stiff layer compared to the overlying soft sediments comprised of historic fill and Holocene alluvium. The sharp deflection within the upper Pleistocene sediments is thought to correspond to a hinge point or zone because of the deformation that is occurring in the overlying, younger, and softer sediments. A simple analogy is the inclinometer casing is acting much like a common soda straw, which is being pushed with one hand near the top of the straw, while firmly holding the straw at its midpoint with the other hand.

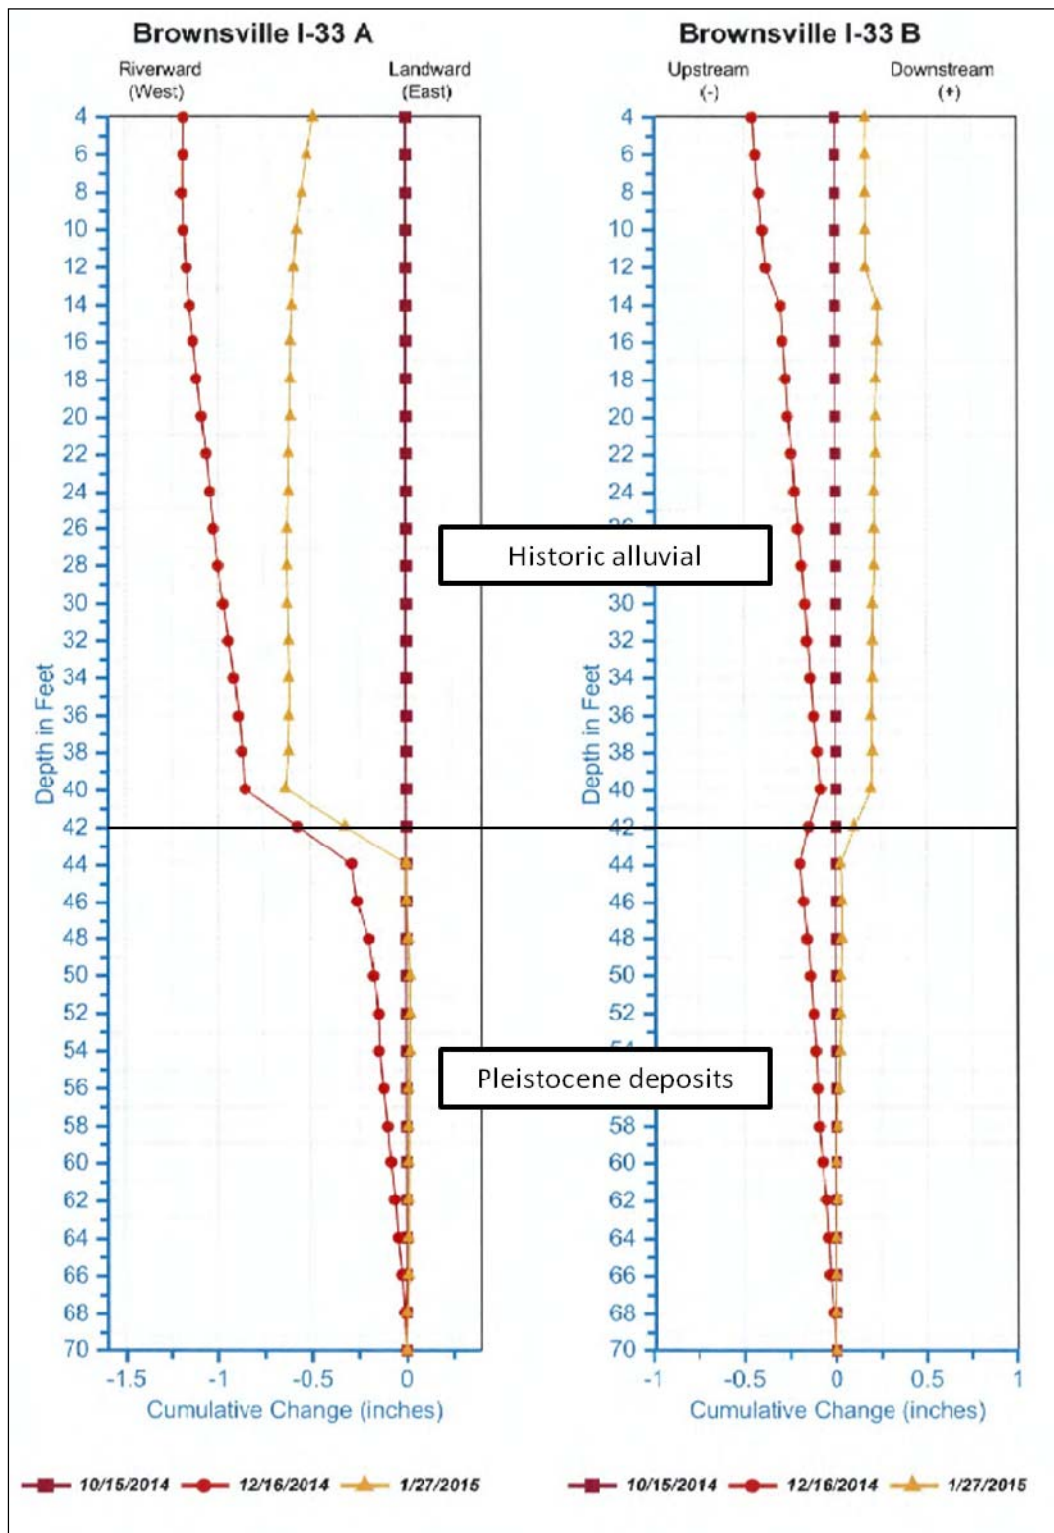
Figure 5.16. Inclinator data with basic stratigraphy as of 27 Jan 2015 for I33.

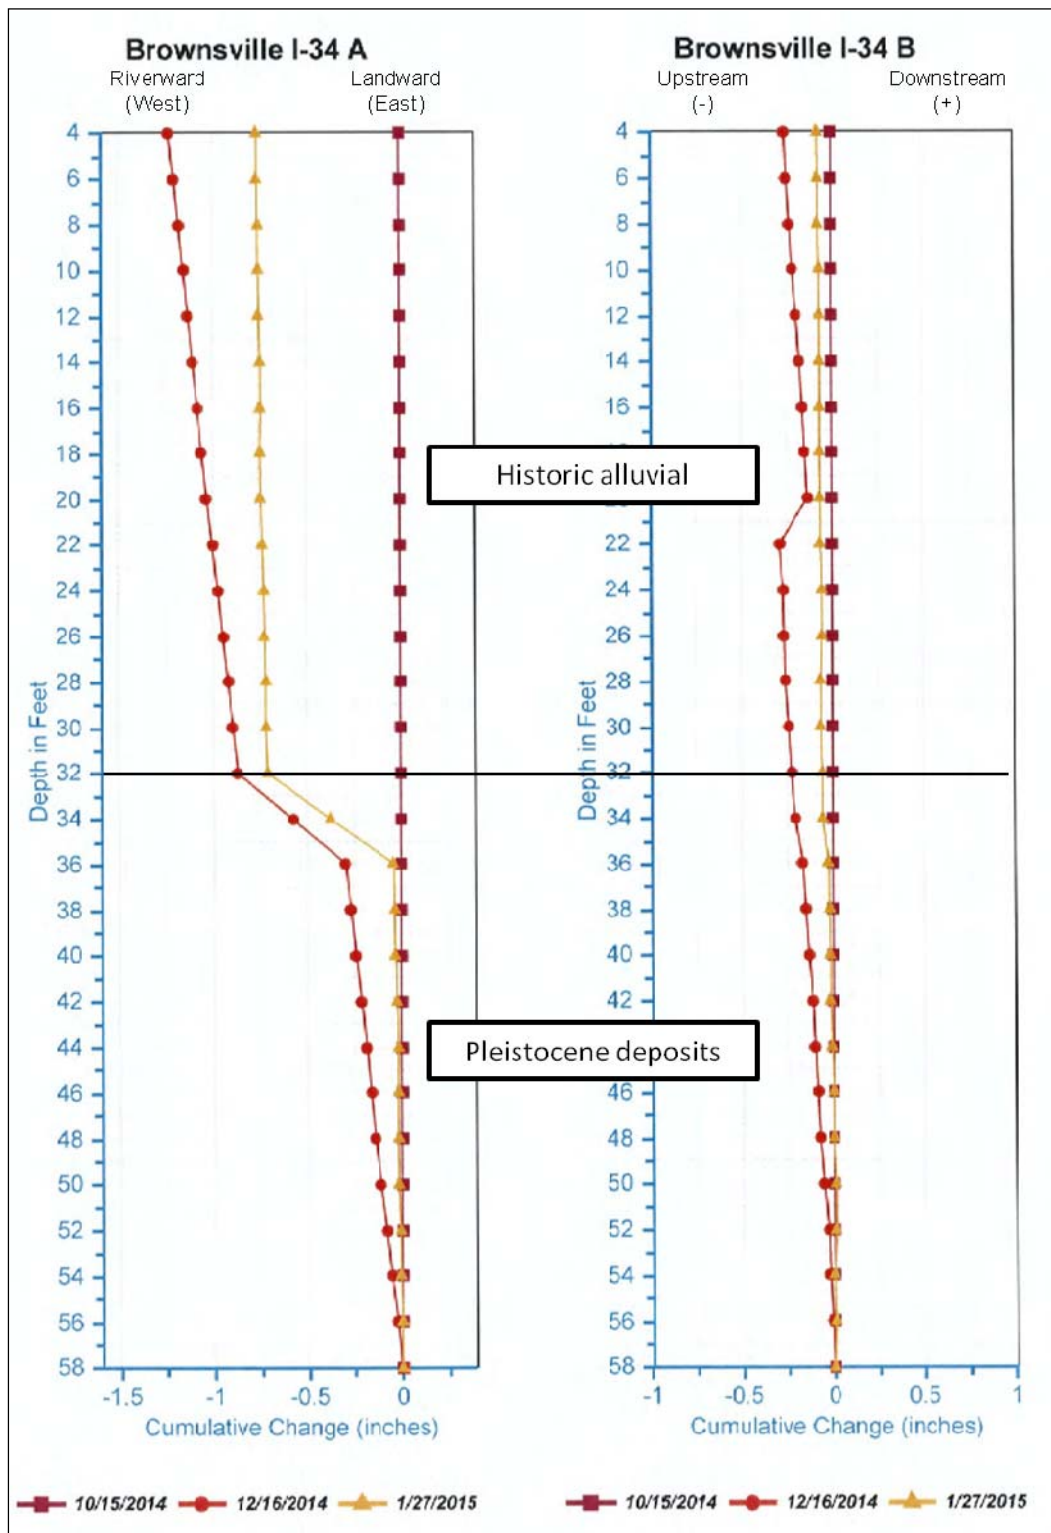
Figure 5.17. Inclinator data with basic stratigraphy as of 27 Jan 2015 for I34.

Pleistocene surface. Near the river at 34I, the deflection interval starts below the Pleistocene contact between 32 and 36 ft.

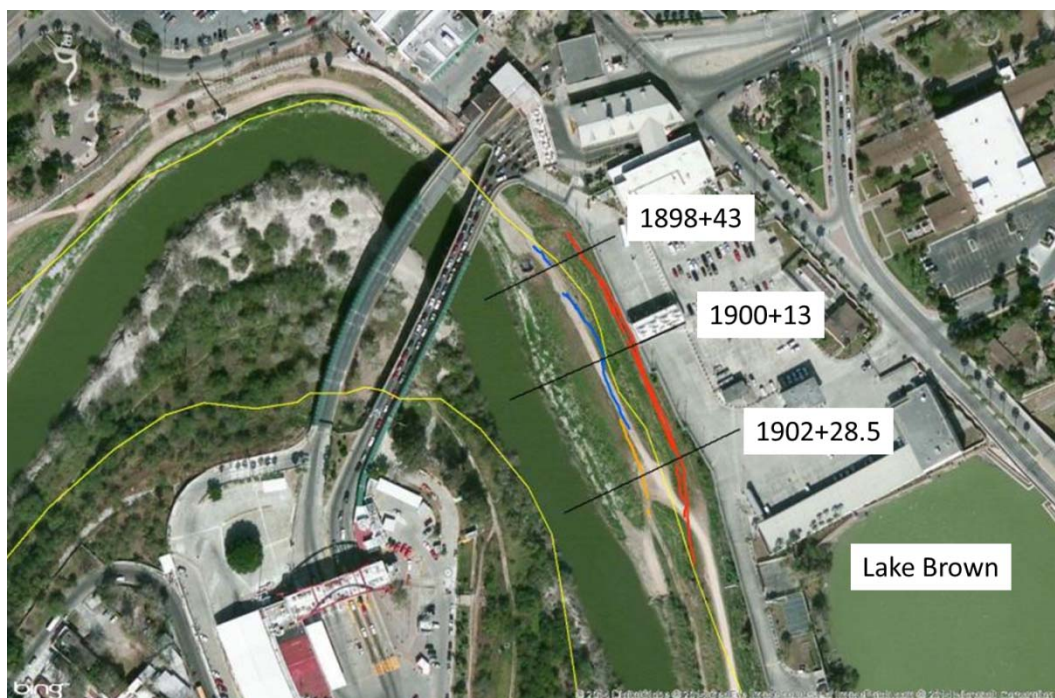
Figure 6.2. Section and cracking locations; see Figure 3.10 for old channel limits (yellow line).

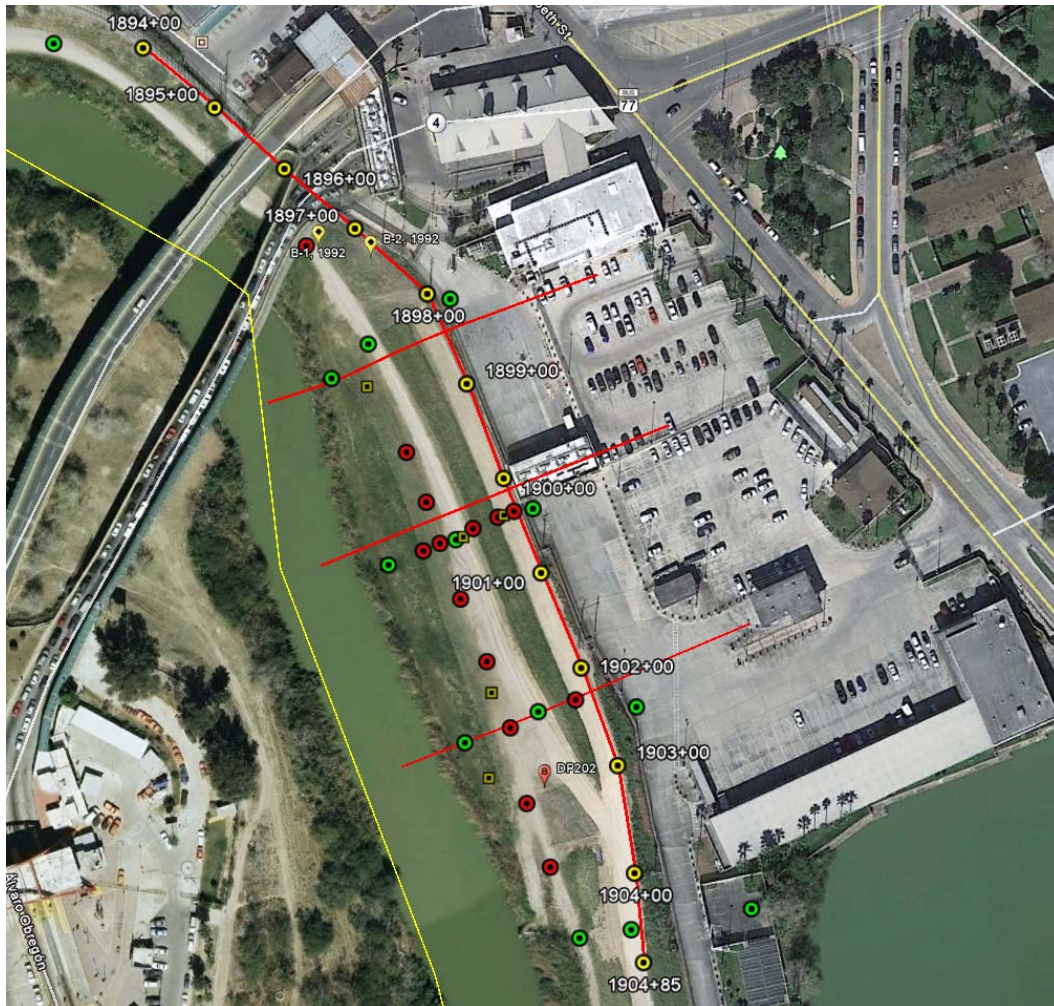
Figure 6.3. CPT boring locations with regard to three cross sections.

Three cross sections were evaluated and are located at the upstream edge (Station 1898+43), middle (Station 1900+13), and downstream edge (Station 1902+28.5) of the levee cracking as shown in Figure 6.2. Figure 6.3 shows the cross sections with regard to the CPT and soil boring data.

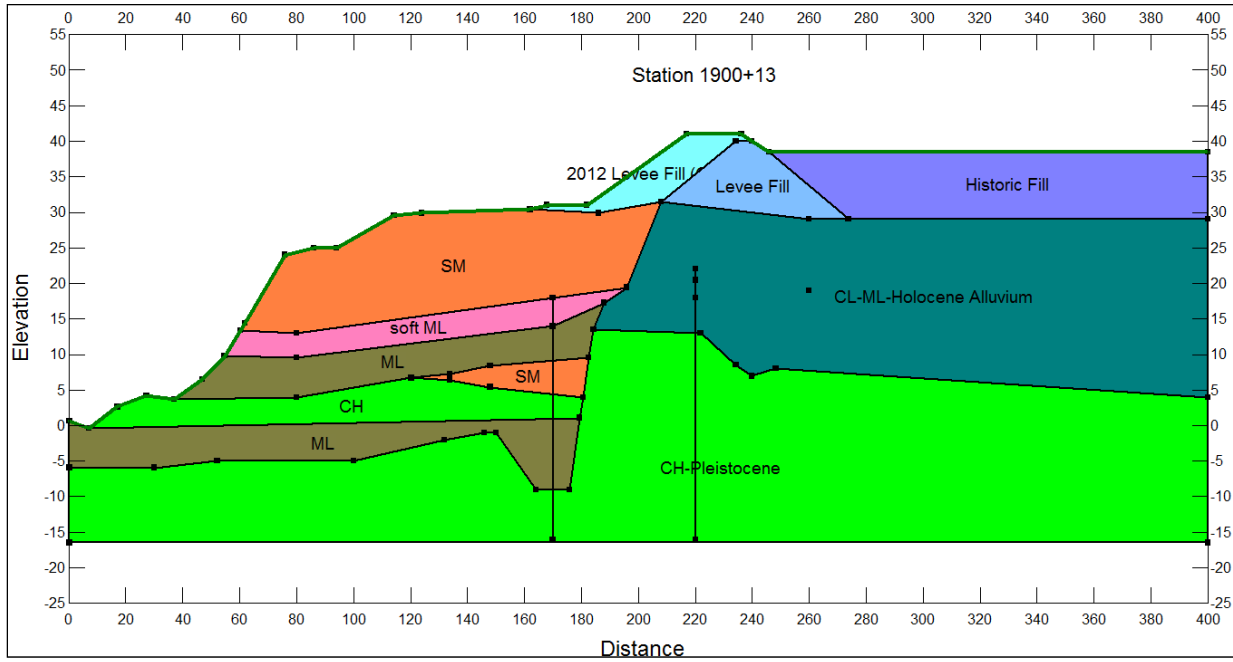
Figure 6.4. Cross section at Station 1900+13.

The cross section at Station 1900+13 is shown in Figure 5.7; the model cross section is shown in Figure 6.4. The material located on both sides of the levee differs in age and behavior. A weak zone (labeled "soft ML") is located near elevation 12 ft. The crest of the levee in this section is located at elevation 41.2 ft, and the top of the riverbank is at elevation 24 ft. The ground surface was obtained from 2011 LiDAR data and 2014 survey data. The bank of the river and channel was obtained from the 2002 HEC-RAS

model data presented in the 2012 Design Report by Tetra Tech (2012). The slope of the riverbank is 1.92H:1V.

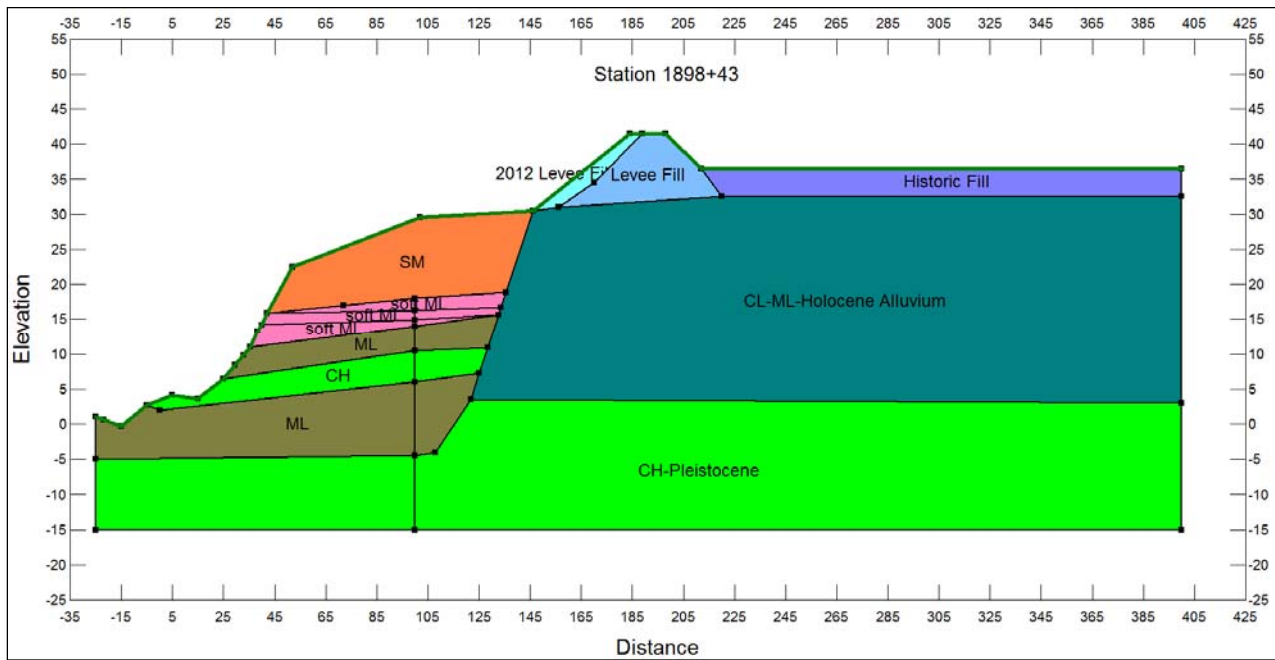
Figure 6.5. Cross section at Station 1898+43.

Figure 6.5 shows the cross section used in the analysis of Station 1898+43. The section at this station exhibits the same general type of stratigraphy of that in Station 1900+28.5 with more recent alluvial deposits on the water-side of the levee. The top of the riverbank is at elevation 24 ft, and the slope of the bank is 2.25H:1V.

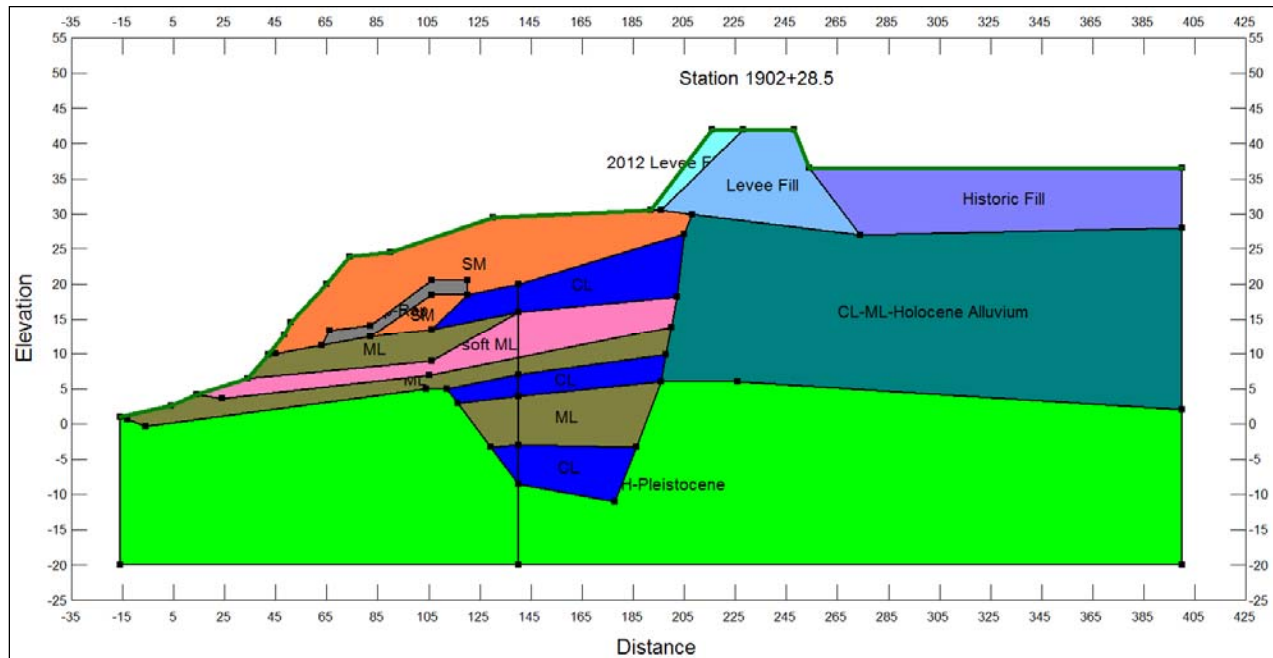
Figure 6.6. Cross section at Station 1902+28.5.

Figure 6.6 shows the section analyzed at Station 1902+28.5, the farthest section downstream. This section is different when compared to the other two sections; the weak zone is lower in elevation, and there is a zone of riprap and a low plasticity clay layer (CL). The elevation of the top to the riverbank is 22.54 ft, and the slope of the bank is approximately 1.95H:1.0V.

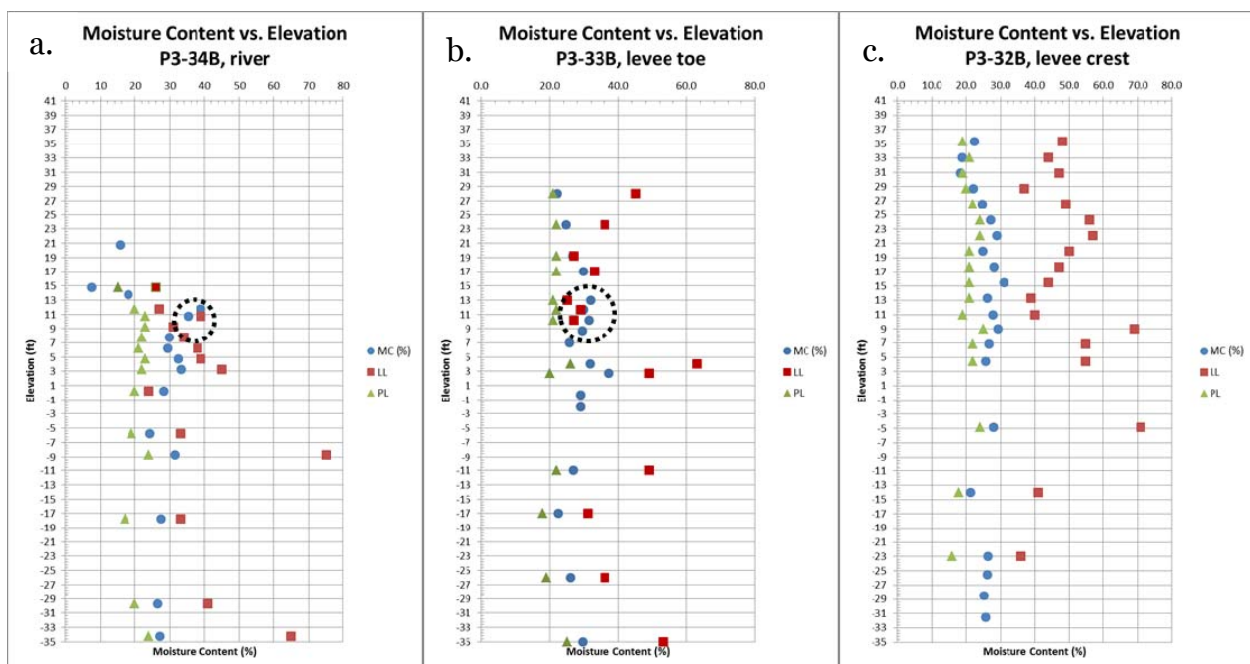
Moisture content profiles at Station 1900+13 are shown in Figure 6.7; encompassing boring P3-34B is located near the river, and P3-33B is located on the waterside toe of the levee and P3-32B at the crest. The red squares represent the value of the liquid limit (LL), the green triangles represent the value of the plastic limit (PL), and the blue circles represent the natural water content of the soil. The difference between the LL and the PL is the range of water contents that the soil will behave plastically is known as the plasticity index (PI). If a soil's natural moisture content is closer to the plastic limit, larger magnitude shear strength would be expected compared to if the soil was near its liquid limit. Wroth and Wood (1978) found that a soil at its plastic limit would have near 100 times the shear strength of a same soil at its liquid limit.

Profiles a and b, shown in Figure 6.7, exhibit smaller plasticity indices compared to the profile c indicating that there is a material difference. This difference supports a change between the Holocene alluvium and the younger alluvial materials in the soil cross section.

Figure 6.7. Moisture content profiles at station 1900+13.

The natural moisture content is larger than the liquid limit between elevation 9 and 13 ft in both profiles A and B, indicating a zone of lower shear strength. This lower shear strength could be due to a failure surface passing through this zone. Another possibility is that the material could have mobilized and softened due to displacements that occurred during the levee instability.

The failure zone is estimated to be above elevation 7 ft on the riverside toe and likely bisects through the levee embankment. The shear surface is highlighted by the high water contents shown in Figure 6.7 and the weak shear strengths illustrated in Figure 6.8. The full depth of cracking is unknown, but likely deeper than 1 ft. Initial cracking was noted early April 2014; the photo shown in Figure 6.20 was taken in July 2014. IBWC staff noted that the cracks were much deeper. When ERDC staff arrived on site, there had been several rain events that washed debris into the cracks.

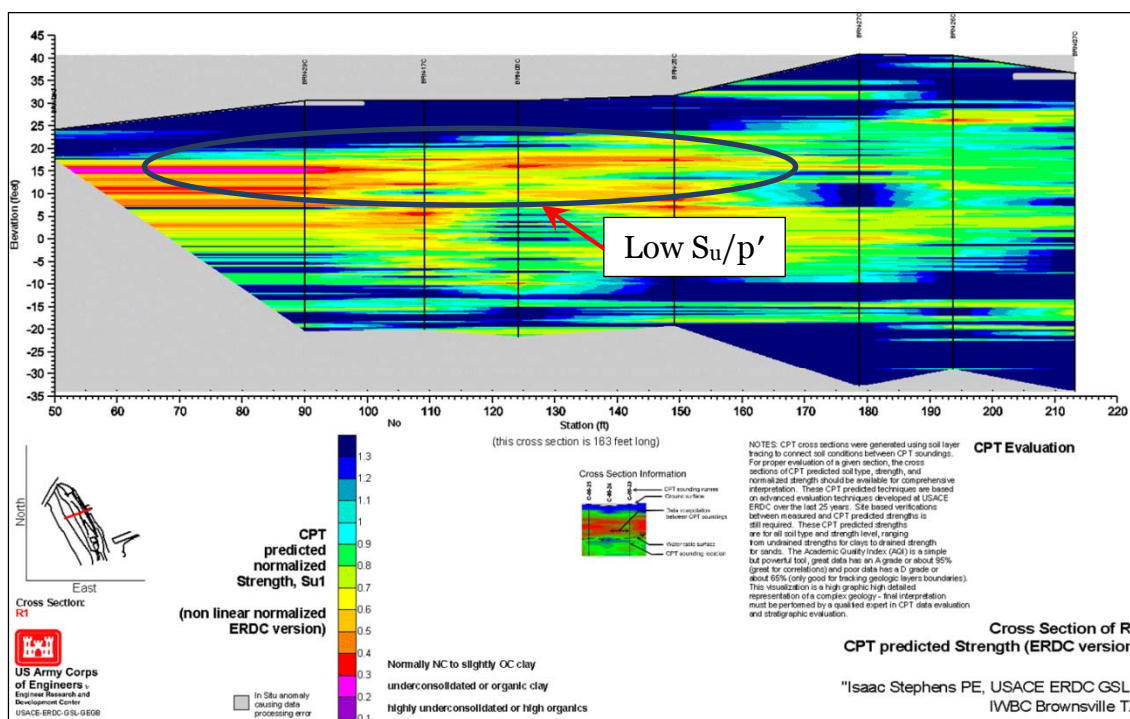
A CPT cross section showing undrained strength ( $S_u$ ) normalized with effective confining pressure ( $p'$ ) is shown in Figure 6.8. From elevation 10 ft to 17 ft, extremely low  $S_u/p'$  values were identified ranging from 0.2 to 0.4 that start near the levee toe and extends toward the river (see Figure 6.8).

Figure 6.8. CPT predicted undrained shear strength at Station 1900+13.

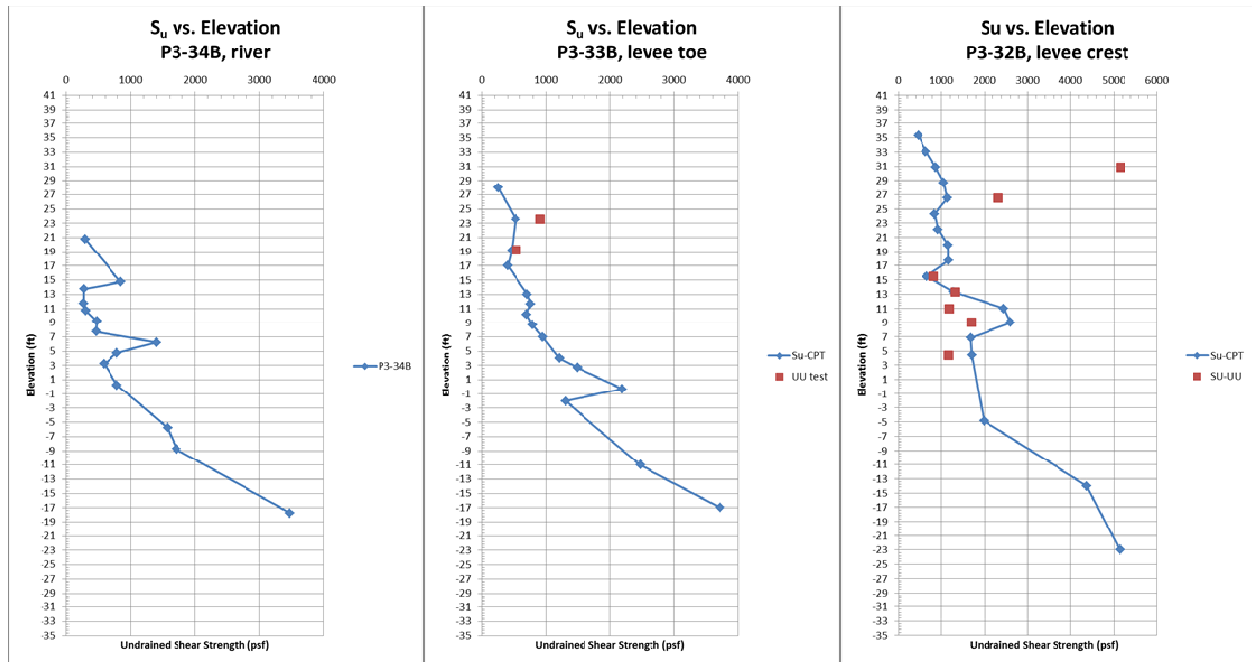
Figure 6.9 shows the undrained strength profiles for the three borings used in the moisture content profiles (Figure 6.7). The undrained strength profiles shown in blue were derived from the CPT correlations and the red squares represent the results of the UU triaxial testing. Relatively good agreement can be seen between the two tests especially near the zone where the high LL and low  $S_u/p'$  values were found. In areas above and below the weak zone, the CPT values under and over predict the value of the undrained shear strength compared to the results of the UU tests.

Figure 6.9. Undrained shear strength profiles, CPT and UU test.

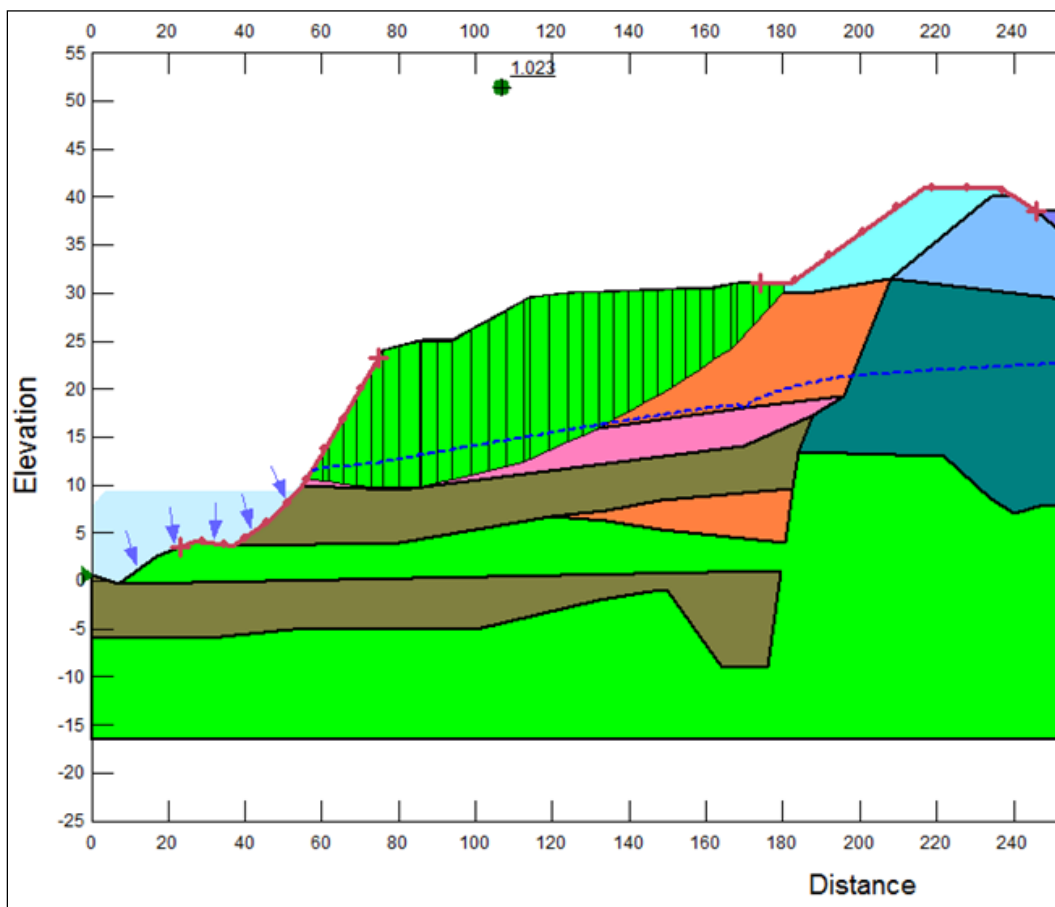
Figure 6.14 shows the results of both the transient seepage and stability analyses conducted at Station 1900+13. The factor of safety was calculated to be 1.02 and occurred at a time of  $1.64e6$  sec after the hydrograph peak. The undrained shear strength assigned to the weak zone was 150 psf. Figure 6.15 shows the river elevation on the left vertical axis plotted against time and the factor of safety calculated at discrete points (right vertical axis).

Figure 6.14. Results of stability analysis Station 1900+13, hydrograph loading  $t = 1.64E7s$ .

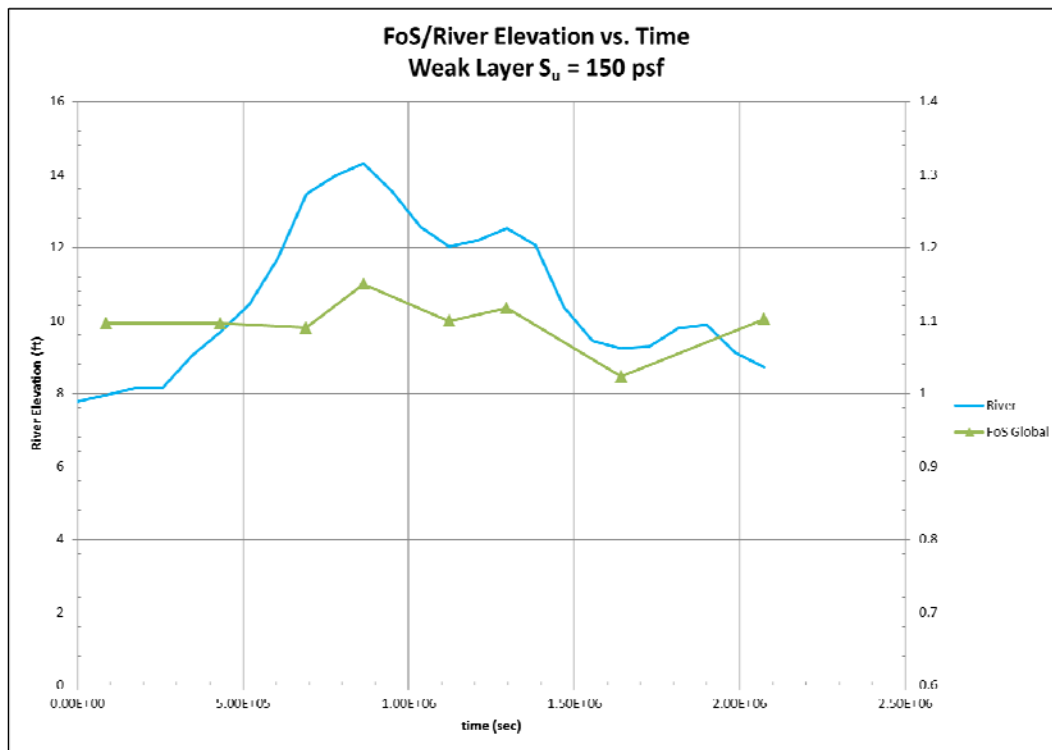
The factors of safety shown in Figure 6.15 were as expected. As the hydrograph peak was occurring, the highest factor of safety (1.15) was calculated (1.15) because of the stabilizing effect of the water weight against the riverbank. Once the river stage drops, the factor of safety decreases with a slight increase due to a second smaller increase in river elevation then the factor of safety decreases rapidly enough that the materials above and below the soft ML layer do not have time to dissipate the pore pressures generated during the flood loading. There is an increased weight associated with the excess pore fluid. The reason the factor of safety decreases after the peak of the hydrograph has been reached is due to the excess weight of the saturated materials with no reinforcing effect of the water.

Figure 6.15. Results of transient seepage/stability analysis at Station 1900+13; FoS = Factor of safety.

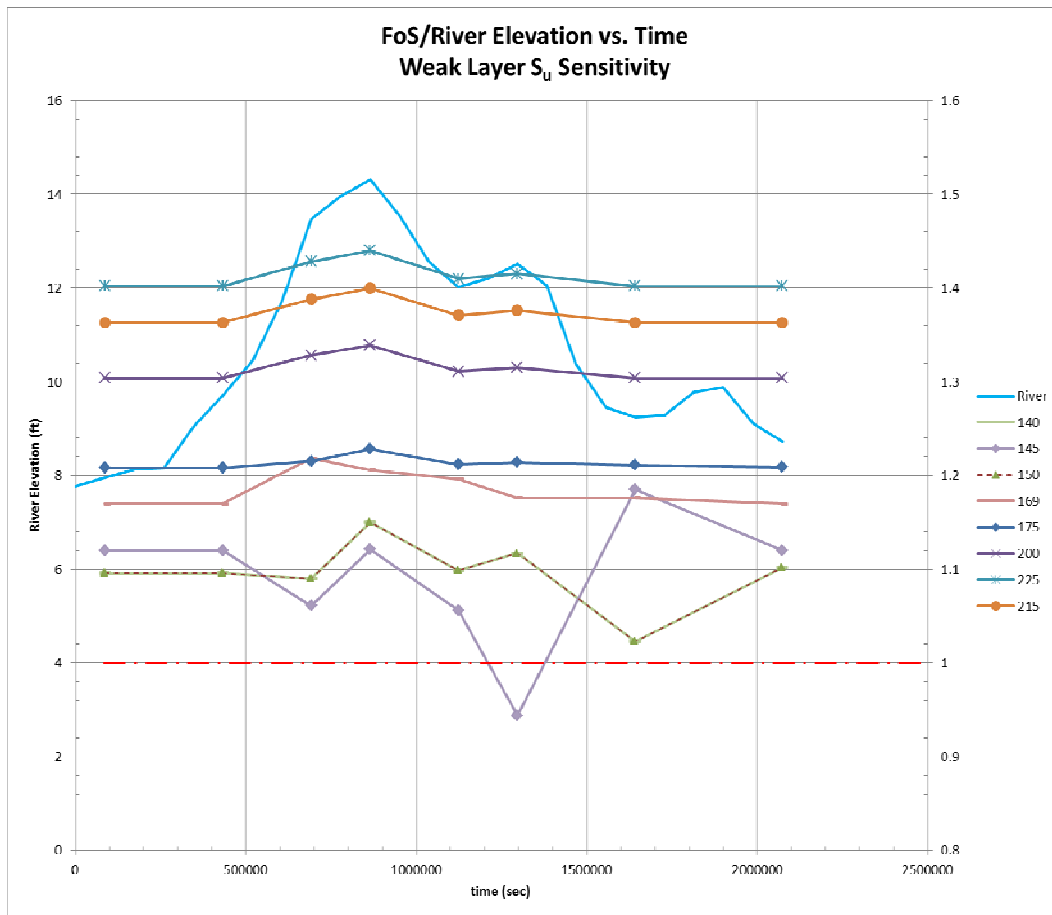
A sensitivity analysis of the undrained shear strengths in the soft ML material was conducted to better understand the response of the levee to the drawdown event that seemed to have triggered the levee cracking. Figure 6.16 shows the result of this sensitivity study. The undrained shear strength of the soft zone was varied from 140 to 225 psf. The same general trend of increasing factor of safety with increasing river stage until the peak of the hydrograph occurs is found for all the shear strength values

Figure 6.16. Results of sensitivity analysis on Station 1900+13.

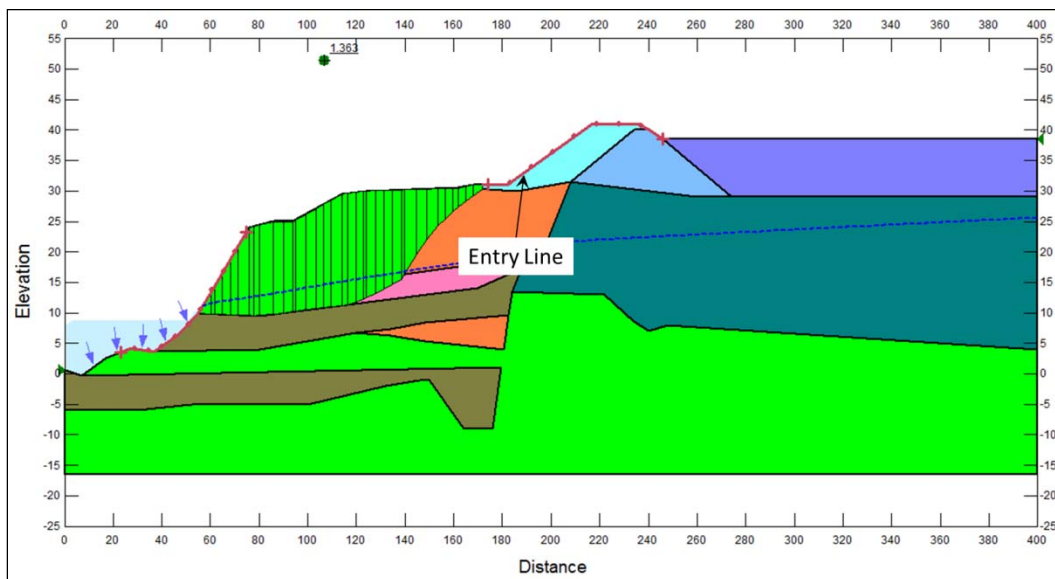
used. The trend skews when a value of 169 psf or less is used. This is due to a change in failure surface geometry. Figure 6.17 show the failure surface with the soft ML assigned a shear strength value of 215 psf. The same failure surface search limits are used as for the rest of the sensitivity analysis. In this case, the entry and exit limits of the search are defined as well as the minimum tangent for the circle. When the failure surface intercepts the end of the entry line (red line segment with crosses at the beginning and end), it means that the minimum surface may be located outside the bounds of the current search. In order to find the minimum, either another search method can be used or the entry line must be relocated. When another search method (block search method) was applied, it revealed that the minimum surface was located closer to the river.

Figure 6.17. Station 1900+13 with weak zone shear strength at 215 pcf.

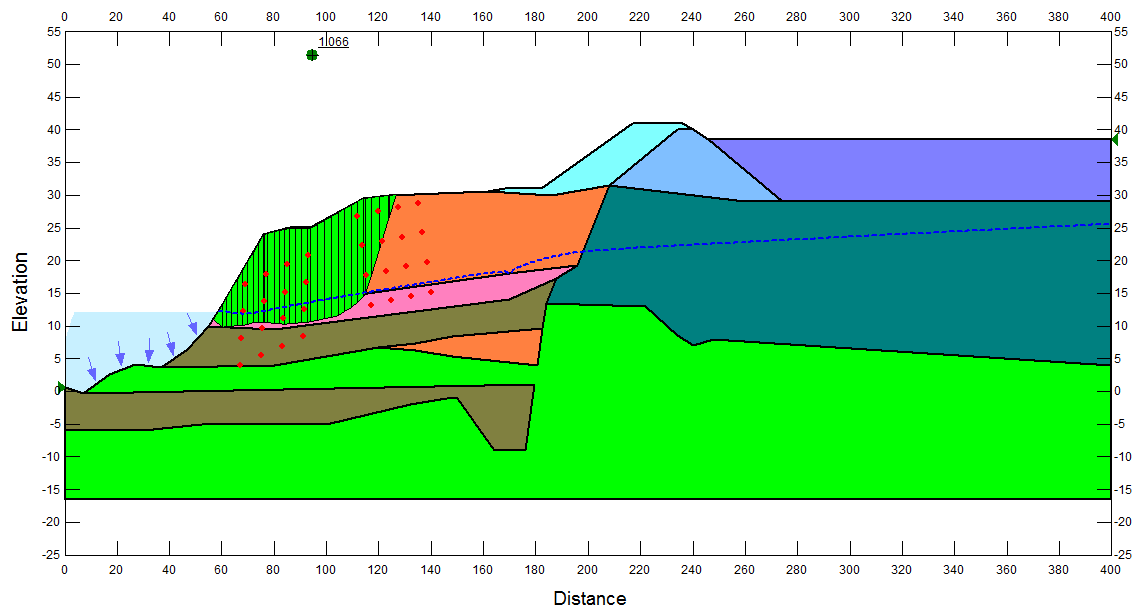
When the block search method was employed, a minimum failure surface that was close to riverbank and the minimum factor of safety was 1.07 in this case at  $t = 1.12e6 s$ . If the search was set closer to the bank of the river,

an infinite failure mode was obtained. This is a product of the SM material not having a cohesion value and the steepness of the riverbank. Factors of safety for infinite slope analysis were less than 1.0 indicating that the bank should not be that steep and may be actively failing or that the friction angle for the SM material was set too low. Observations made during a December 2014 visit by ERDC indicate that the bank is sloughing due to its steepness and possible river undercutting (see Figure 6.19). The higher factor of safety was reported in Table 6.3 to provide continuity between search methods and failure modes.

Figure 6.18. Failure surface at station 1900+13, riverbank failure.

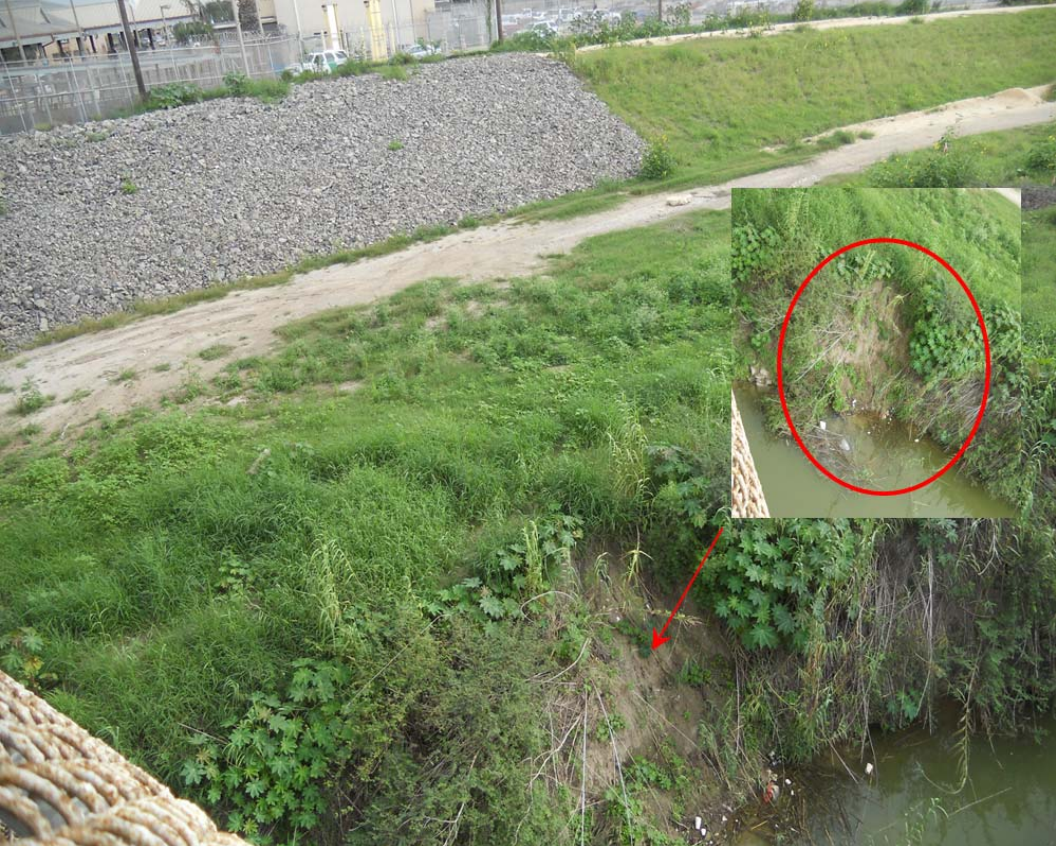
Figure 6.19. Minor riverbank sloughing in December 2014.

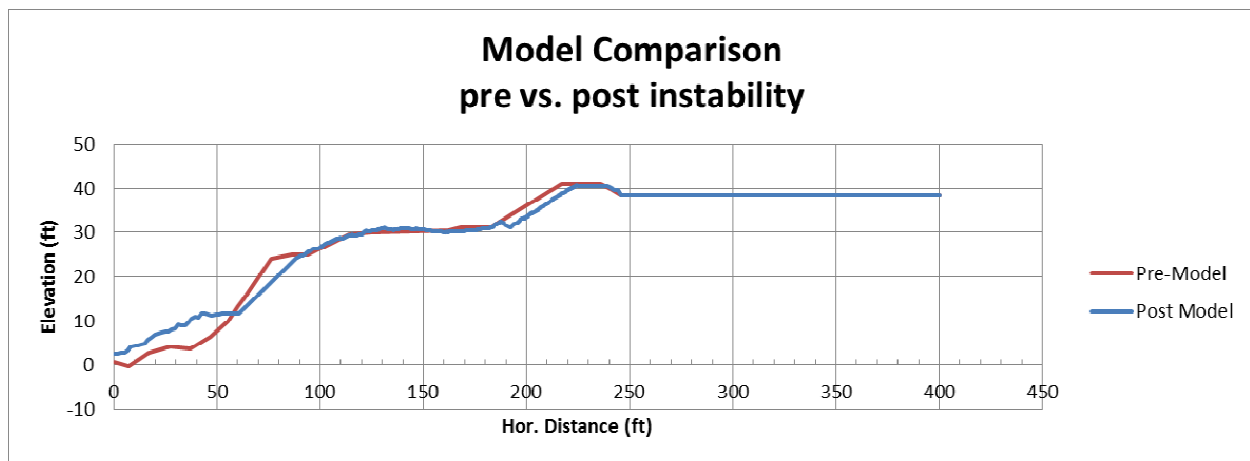
factor of safety at the Brownsville Levee. This analysis was conducted using the bathymetric and LiDAR data collected by ERDC in September of 2014 to define the surface of the model. The stratigraphy was the same as that used in the stability models performed earlier in this study. Figure 8.1 shows how the surface changed from before to after the levee instability occurred. Major changes occurred in the channel, with material sloughing off the riverbank and into the channel.

Figure 8.1. Model surface data comparison before and after levee instability.

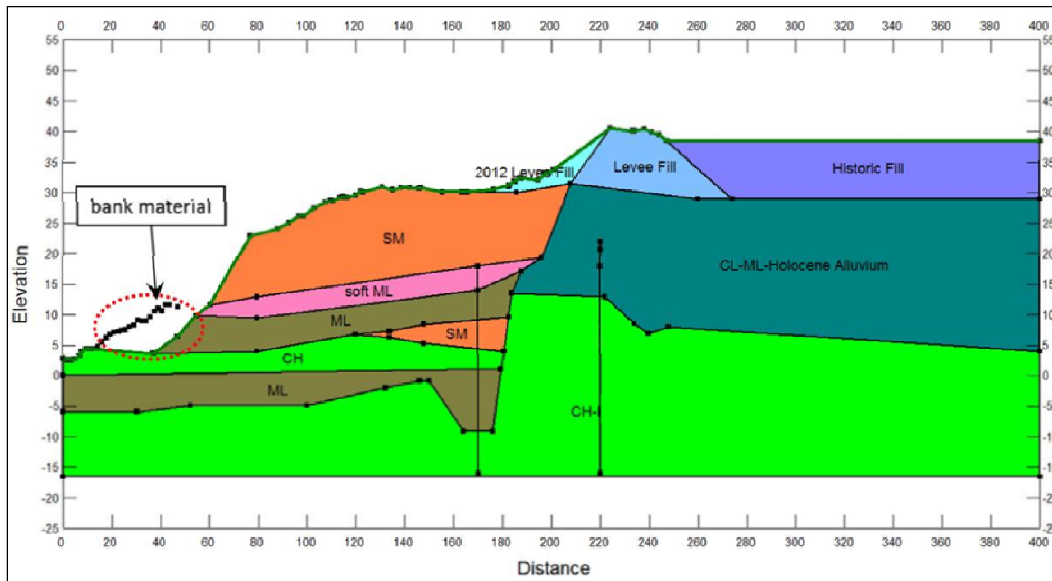
Figure 8.2 shows the model geometry used to evaluate the existing conditions. The difference between the surface shown in Figure 8.1 and that used in Figure 8.2 was any material that was considered to be sloughing material was left out of the analysis. This removal was done, because in a high water event, river velocities in this part of the channel would likely wash this material away.

Figure 8.2. Post-levee instability model.

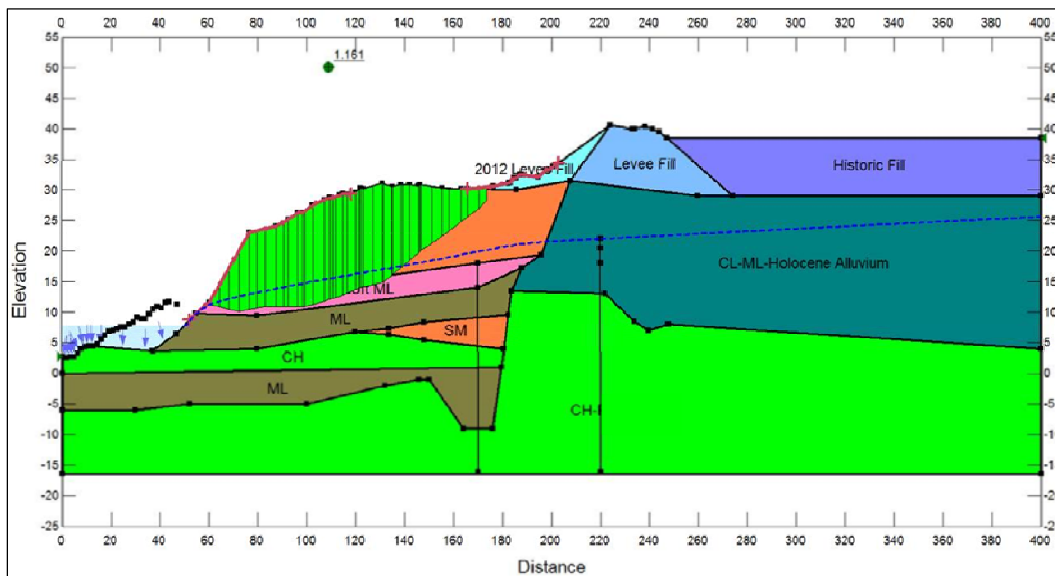
Figure 8.3. Results of the steady state loading condition, river elevation 7.77 ft.

Results of this type of analysis indicate the riverbank requires reinforcing so that the levee system would be brought to a stable state with an increased factor of safety. In addition to reinforcing the riverbank, in situ

modification of the softer bank materials along the river could add additional stability improvements.

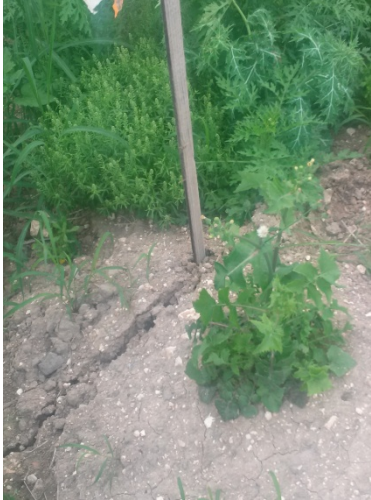
1.

An area on the USIBWC Upper Brownsville Levee Rehabilitation Project , from the East side of Sta. 1904+85 to the riprap area at Sta. 1898+00, has started to subside and there are cracks starting from the river bank east of Sta. 1904+50 that traverse up to the top of the levee. These cracks terminate at the CBP Fence Foundation (See Attached Photo Log Exhibits 1, 2, 3, 4, & 28).
