## **Geotechnical Evaluation of the Brownsville Levee Cracking and Partial Slope Failure**

Lucas A. Walshire, Joseph B. Dunbar, Isaac J. Stephens,  
Maureen K. Corcoran, Carla Roig-Silva, and Julie R. Kelley

July 2015

Final report

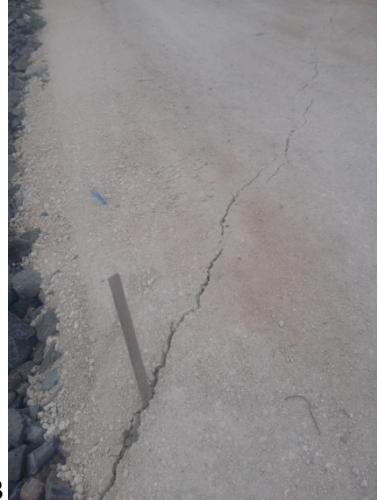
3.

An area on the USIBWC Upper Brownsville Levee Rehabilitation Project , from the East side of Sta. 1904+85 to the riprap area at Sta. 1898+00, has started to subside and there are cracks starting from the river bank east of Sta. 1904+50 that traverse up to the top of the levee. These cracks terminate at the CBP Fence Foundation (See Attached Photo Log Exhibits 1, 2, 3, 4, & 28).

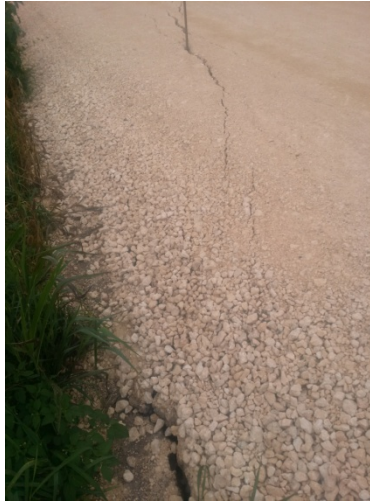
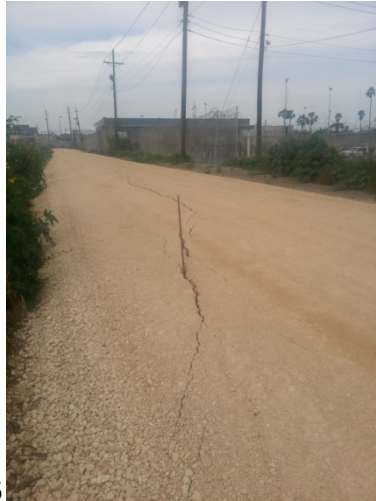
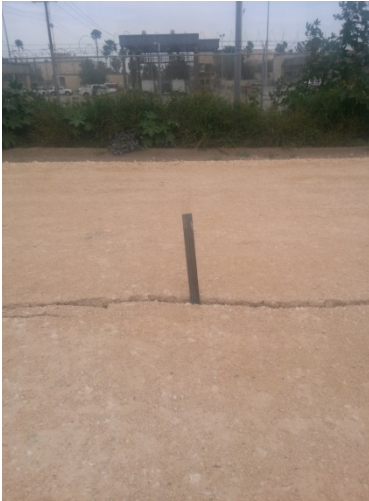
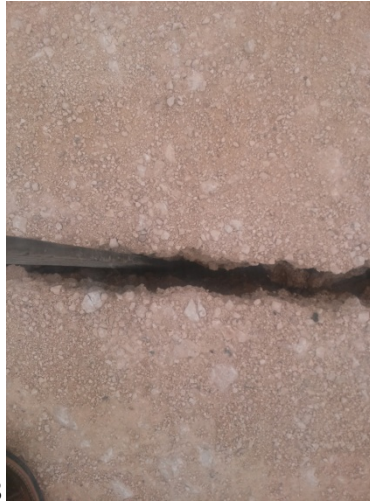
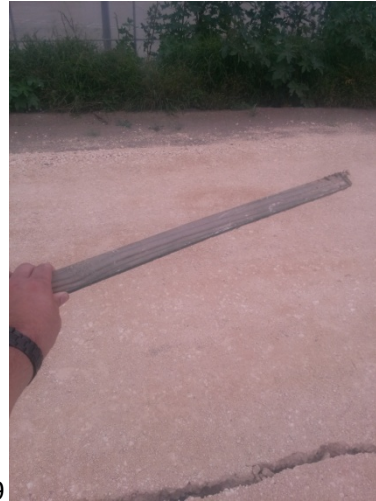
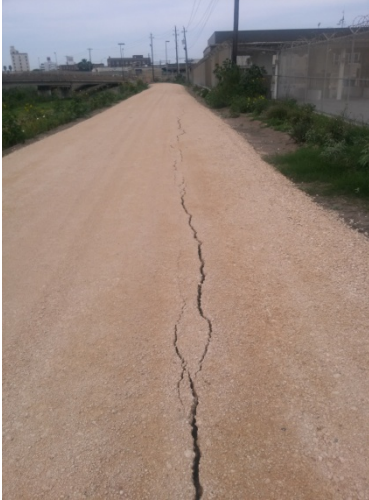
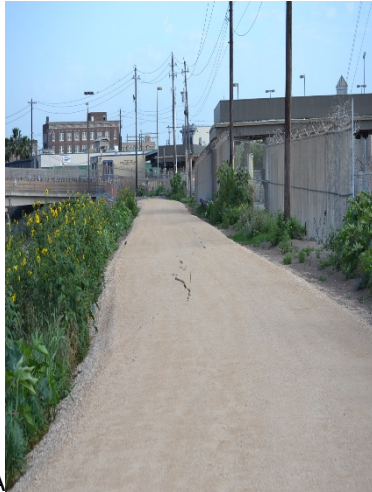
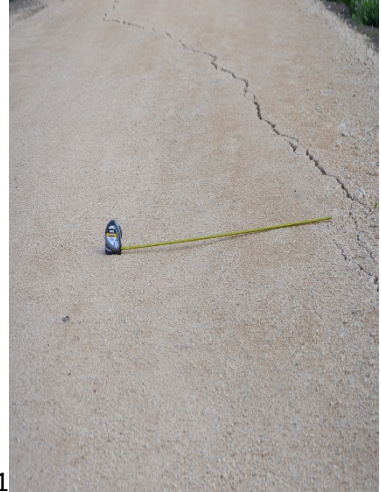
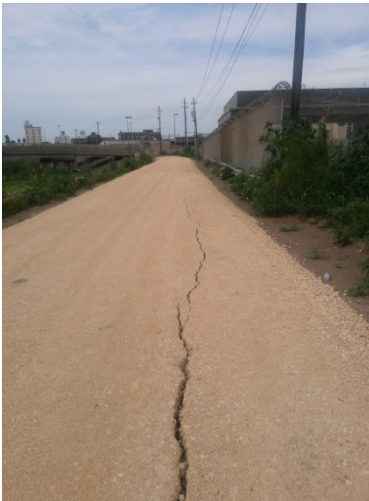
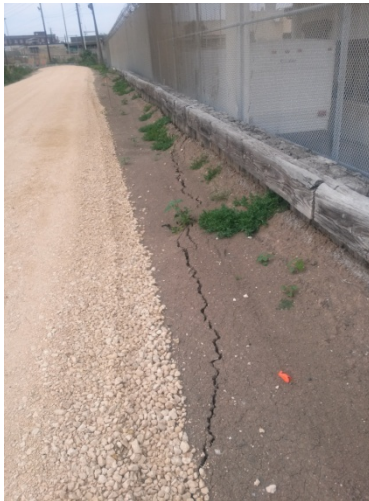
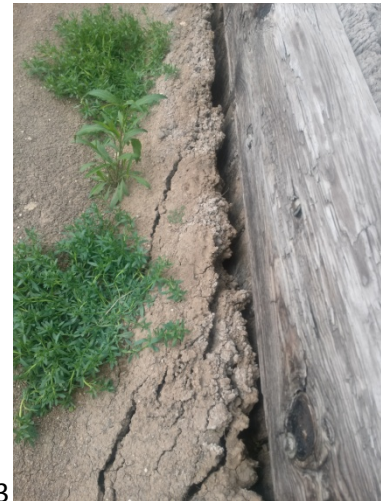
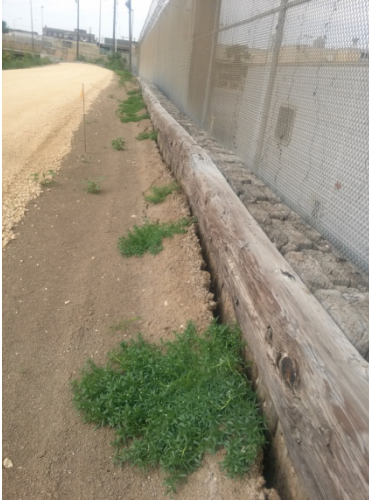
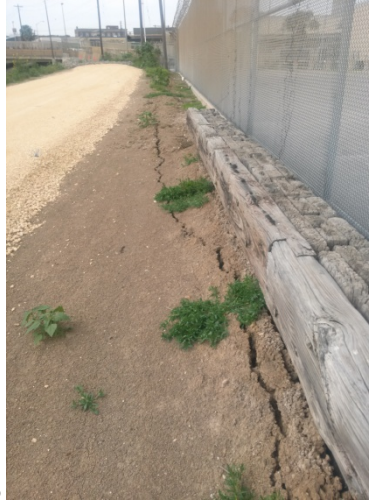
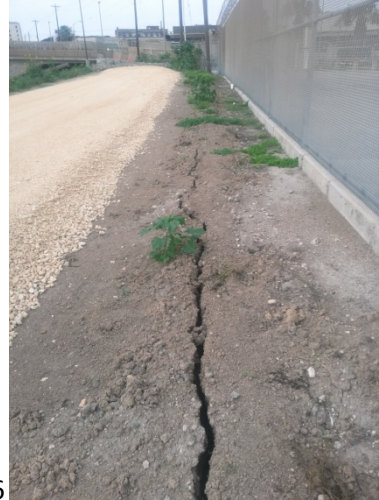
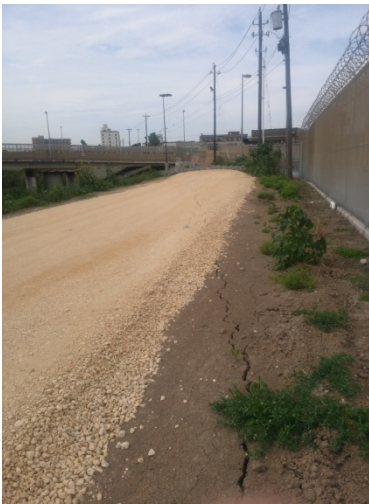
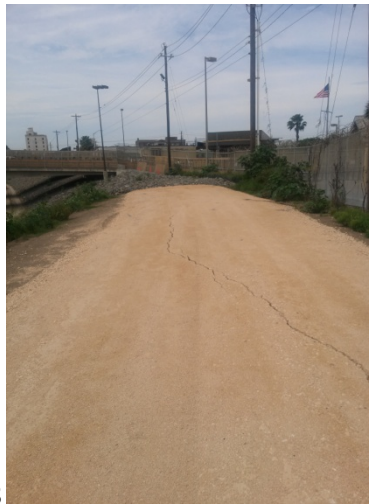
The cracking continues down this foundation wall, back onto the top of levee over to the riprap area at Sta. 1898+00. There are indications that the cracking may continue under the riprap area towards the North Bound P.O.E. Bridge Abutment. (See Attached Photo Log Exhibits 5 through 19).

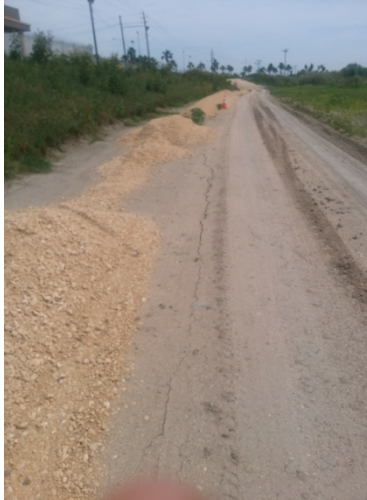
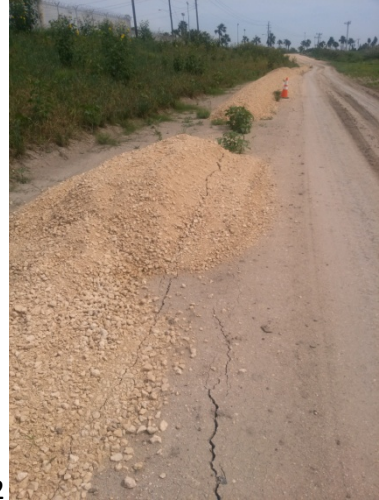
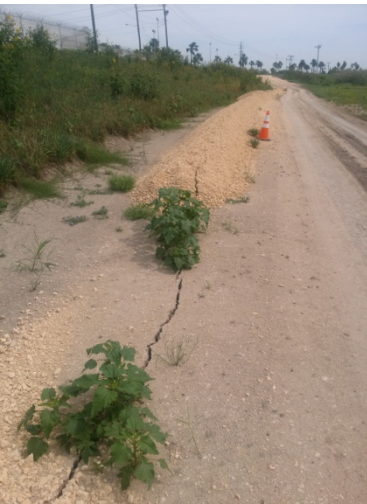
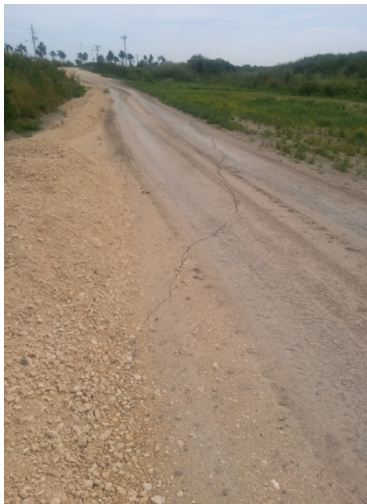
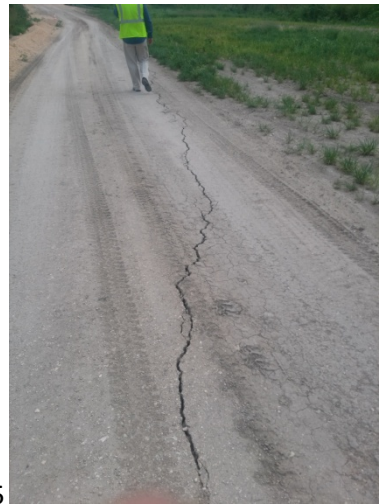
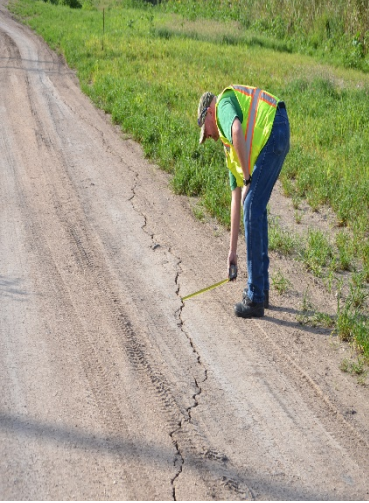
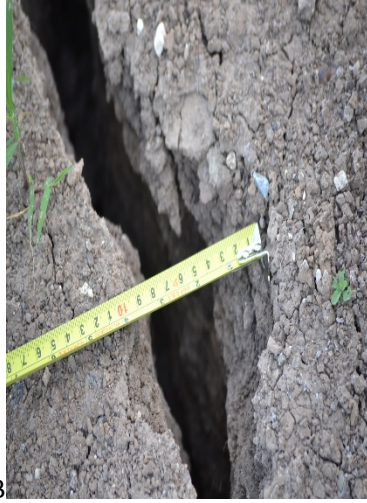
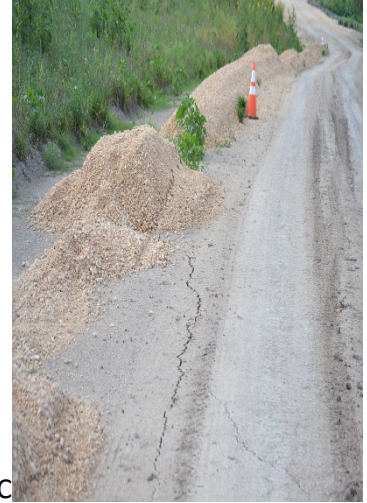
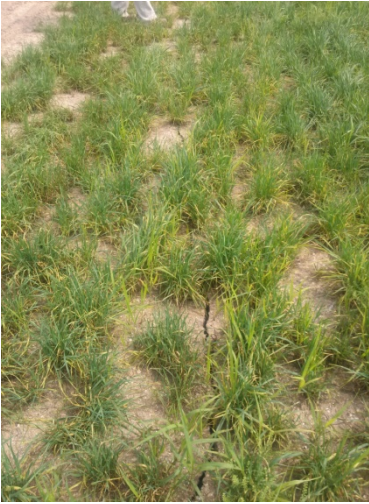
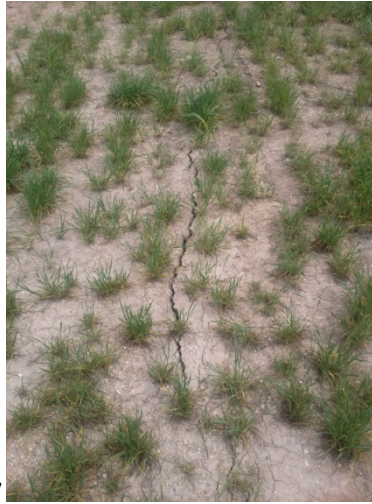
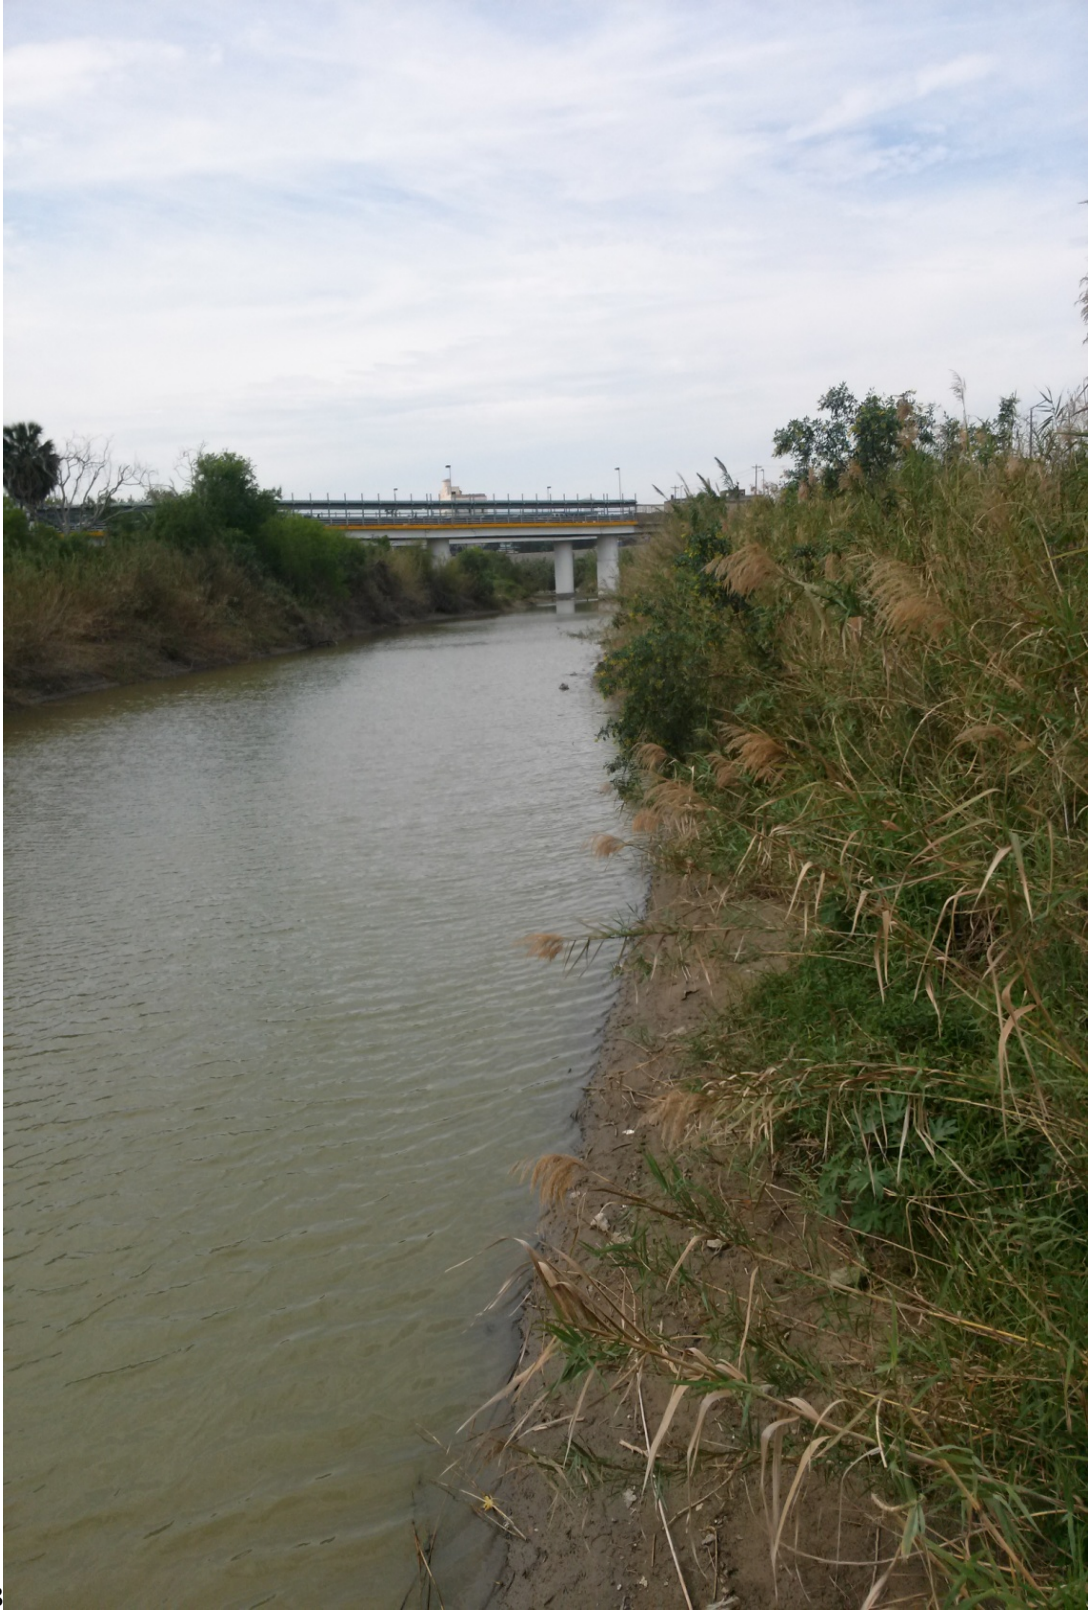
There is a second set of cracks that originate at the Rio Grande River Bank from Sta. 1896+50 heading East to Station 1903+50 (See Attached Photo Log Exhibits 20 through 27).

The material between these cracks appears to be moving towards the Rio Grande River. There are indications that the cracks are growing in width and signs of up to three inches of torsional subsidence is visible. It appears the cracks are increasing in width by one inch per day. This is based on initial measurements that were taken on 3/29/14 (date when USIBWC was notified of this issue) through today.

A meeting was held today with USIBWC and DHS, both parties agreed the protection of life / limb and the protection of the area from further damage was necessary. It was agreed to by all parties the best course of action was to barricade the access roads in this levee section until a remedy has been determined to fix the problem.

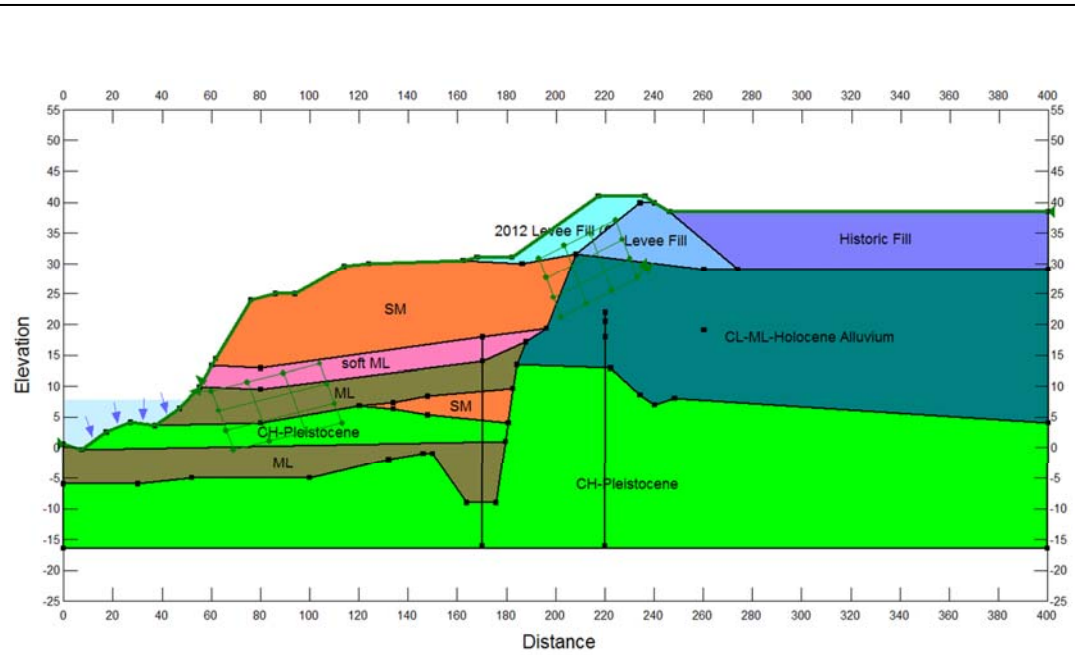
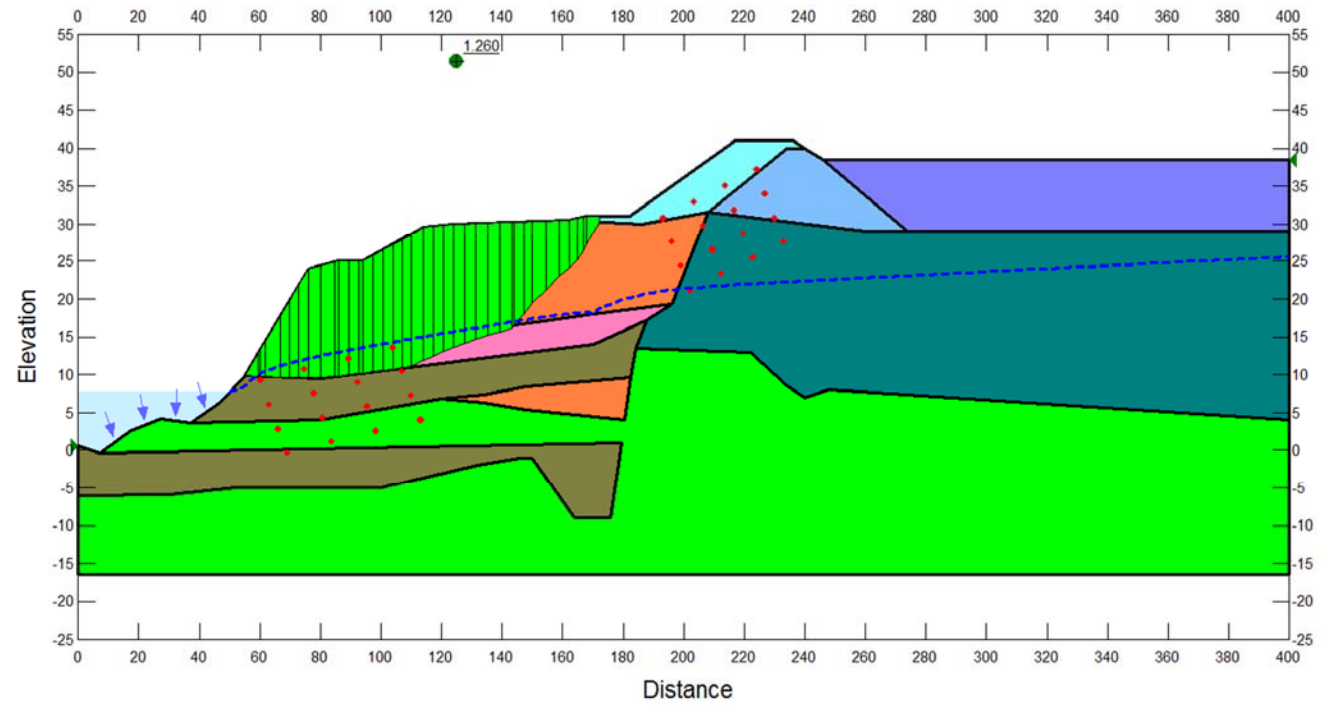
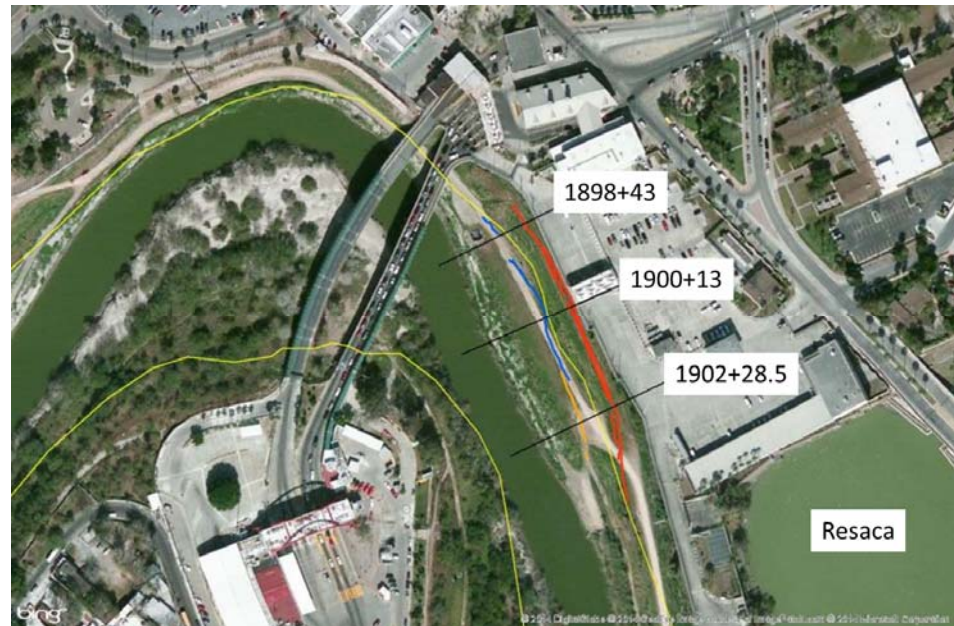
<b>U.S. ARMY CORPS OF ENGINEERS</b> <b>ERDC-GSL</b>
	<i>IBWC-BROWNSVILLE LEVEE</i> <i>STABILITY MODEL</i>
<b>STEADY STATE FOS(WSE 7.77 FT)</b> <b>STATION 1900+13</b>	
<b>FEB-2015</b>	<b>PLATE - 2</b>

Minimum factor of safety (FoS): 1.26

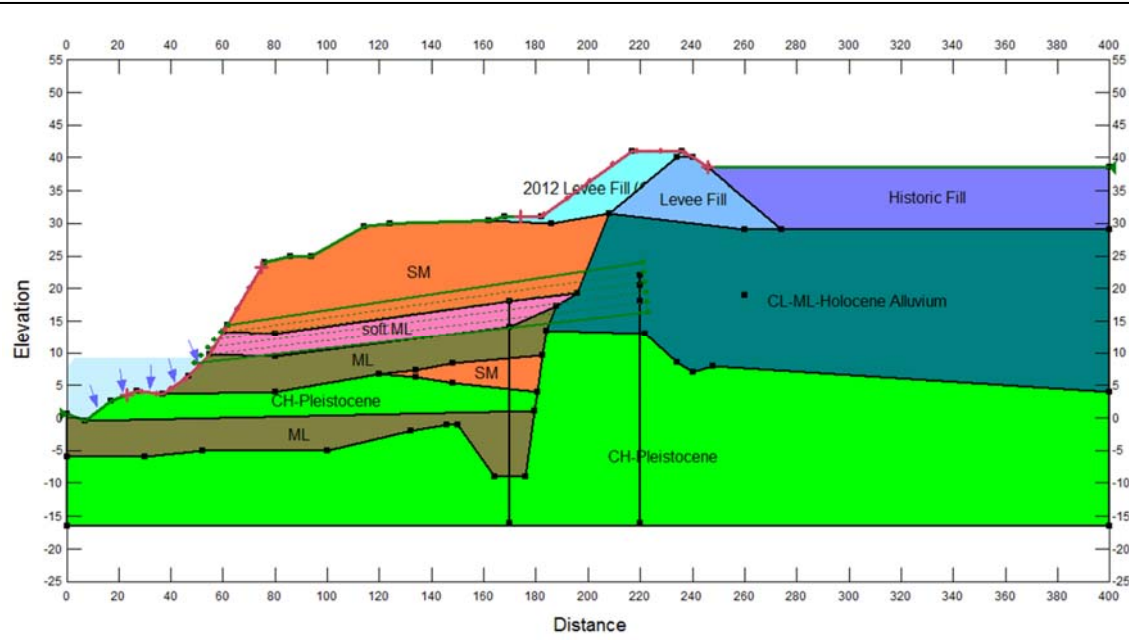
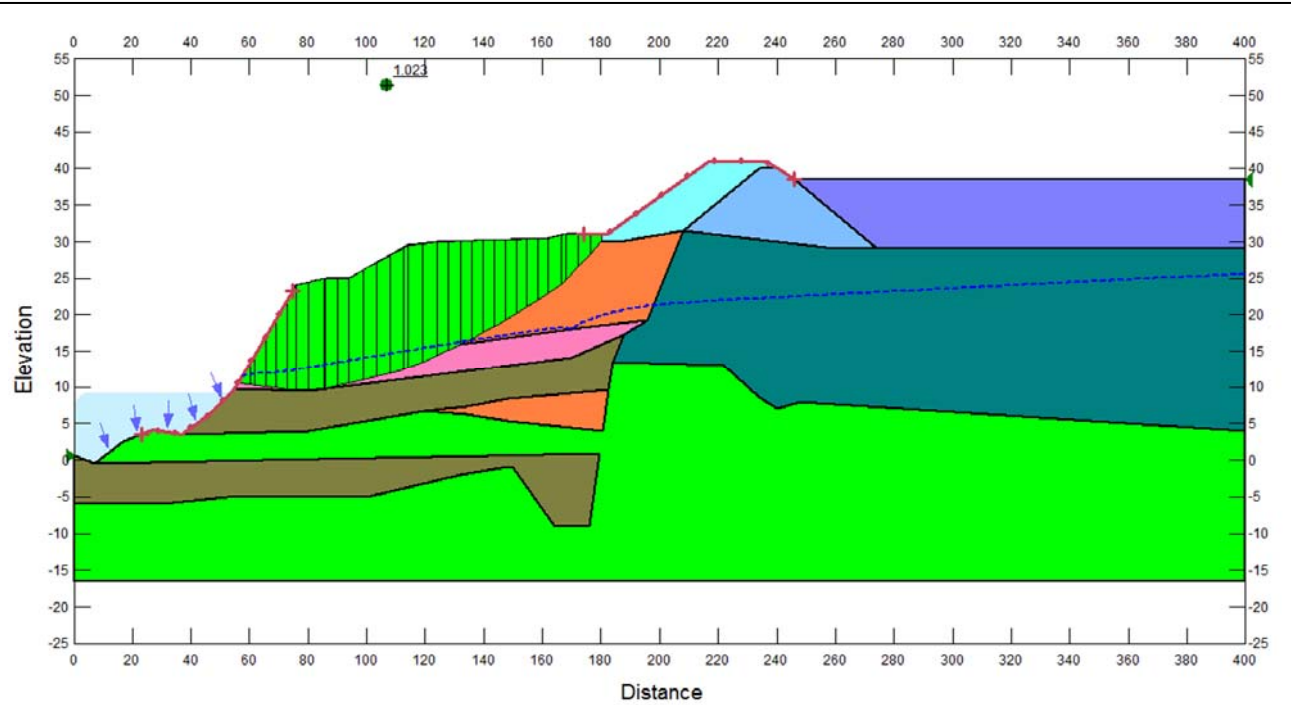
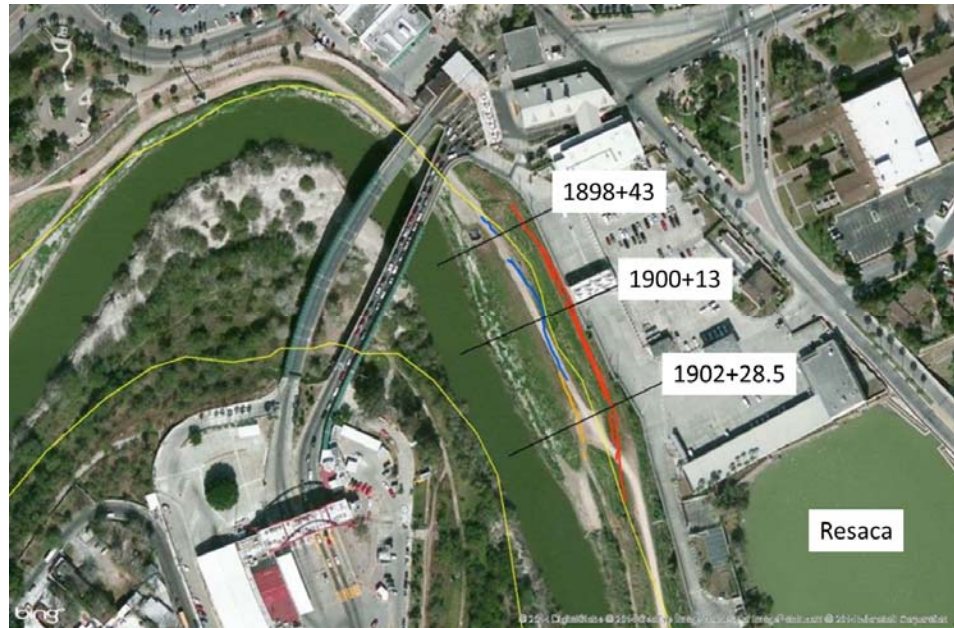
PLATE - 7

Minimum factor of safety (FoS): 1.02

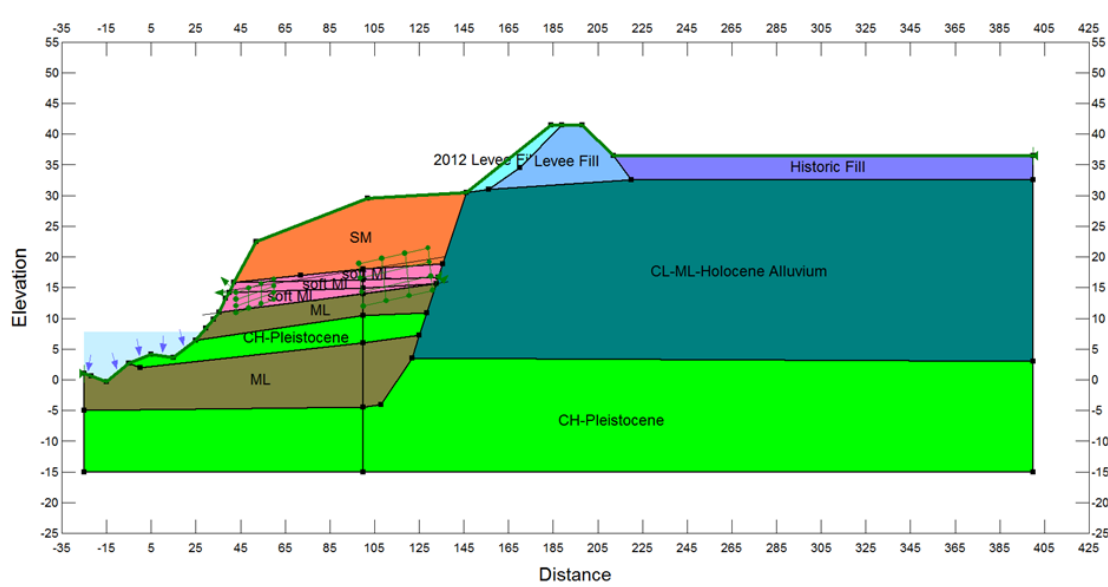
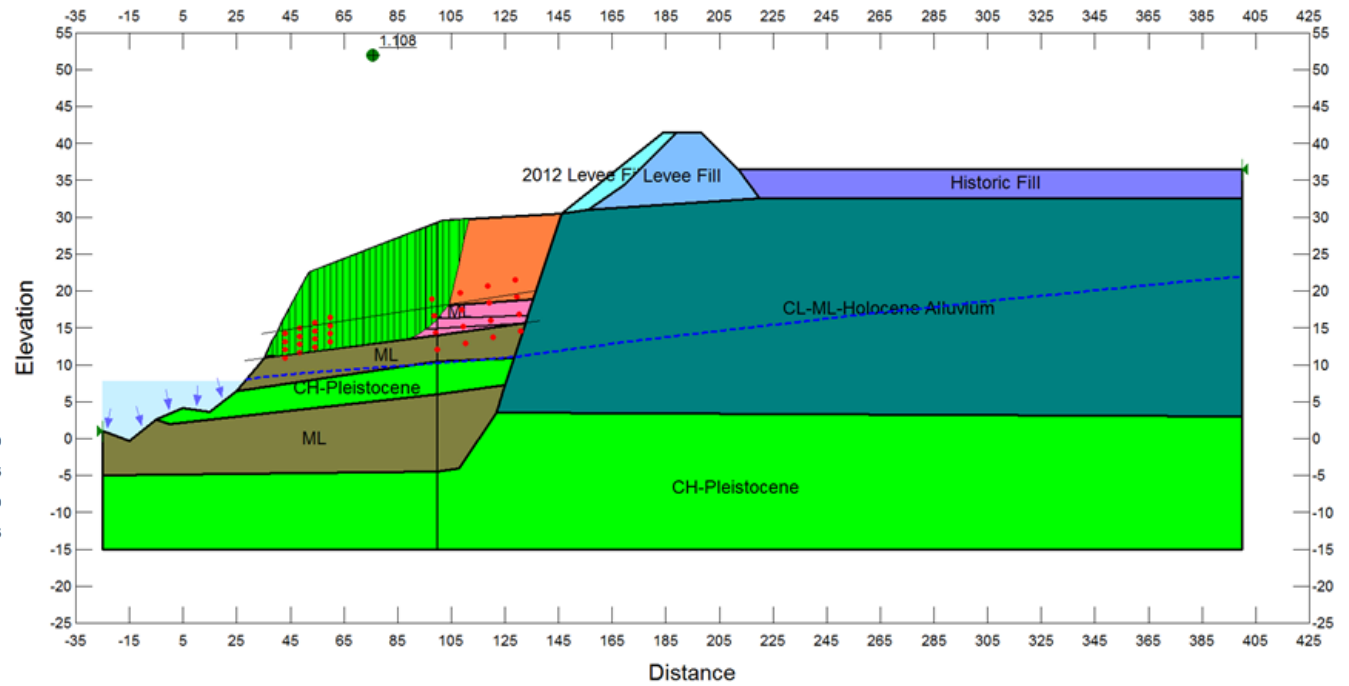
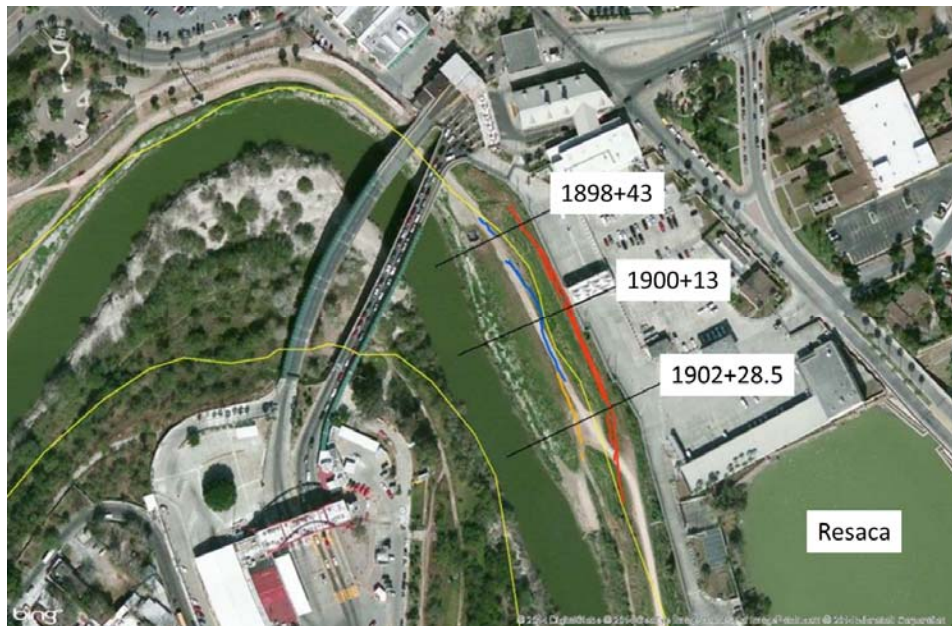
<b>U.S. ARMY CORPS OF ENGINEERS</b> <b>ERDC-GSL</b>
	<i>IBWC-BROWNSVILLE LEVEE</i> <b>STEADY STATE SEEPAGE, SATURATED MODEL</b>
<b>STEADY STATE SEEPAGE (WSE 7.77 FT)</b> <b>STATION 1898+43</b>	
<b>FEB-2015</b>	<b>PLATE - 9</b>

Minimum factor of safety (FoS): 1.11

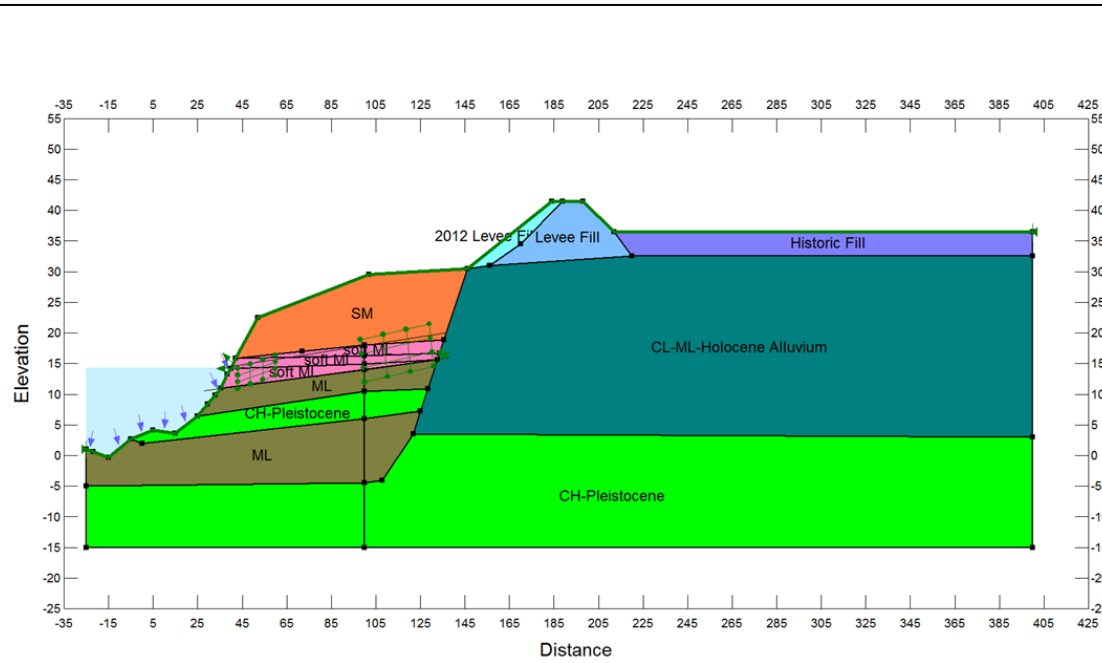
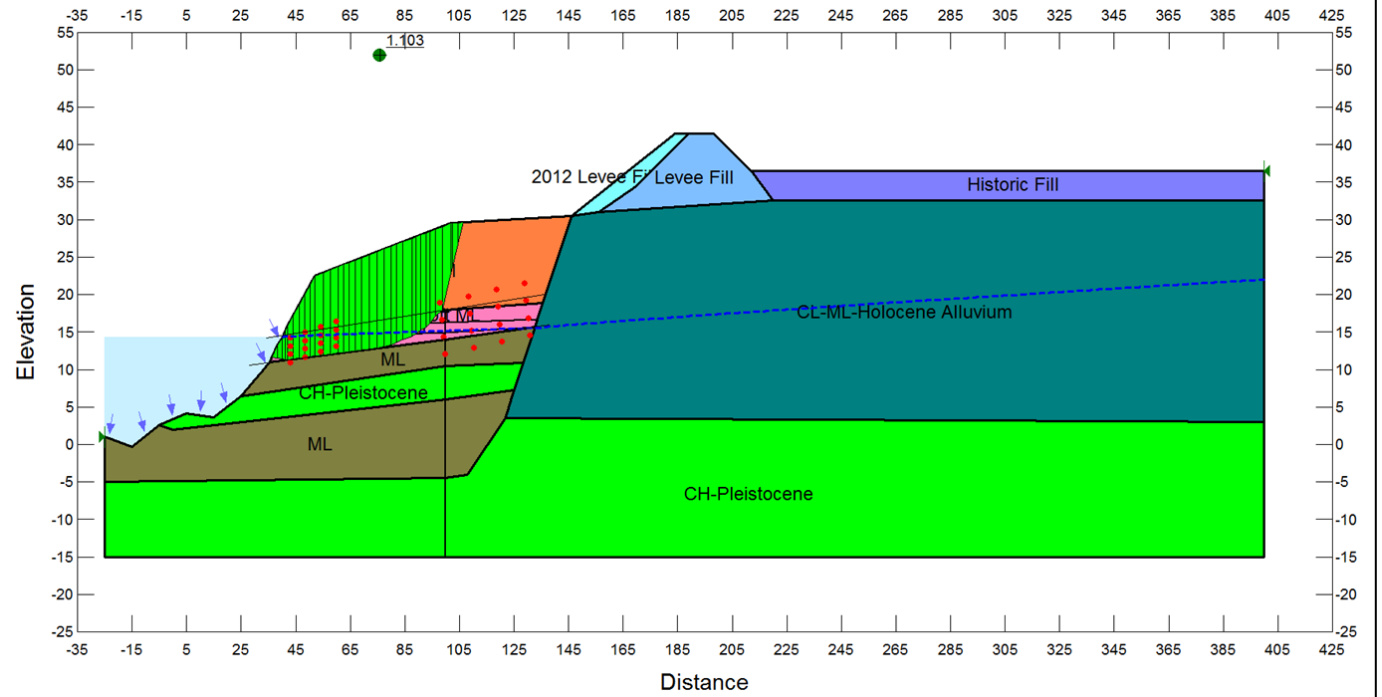
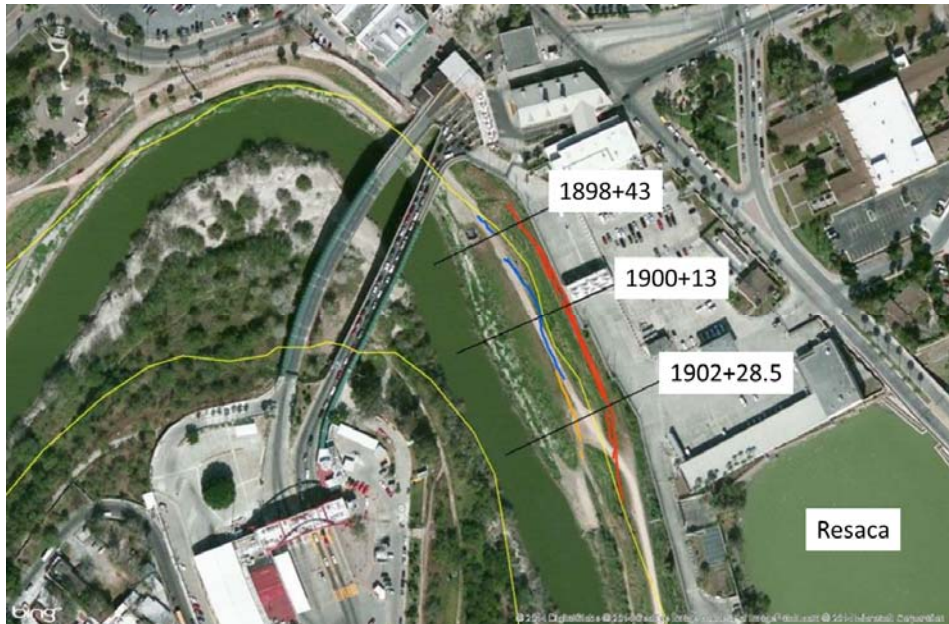
<b>U.S. ARMY CORPS OF ENGINEERS</b> <b>ERDC-GSL</b>
	<i>IBWC-BROWNSVILLE LEVEE</i> <i>STEADY STATE SEEPAGE, SATURATED MODEL</i>
<b>STEADY STATE SEEPAGE (WSE 14.31 FT)</b> <b>STATION 1898+43</b>	
<b>FEB-2015</b>	<b>PLATE - 11</b>

Minimum factor of safety (FoS): 1.10

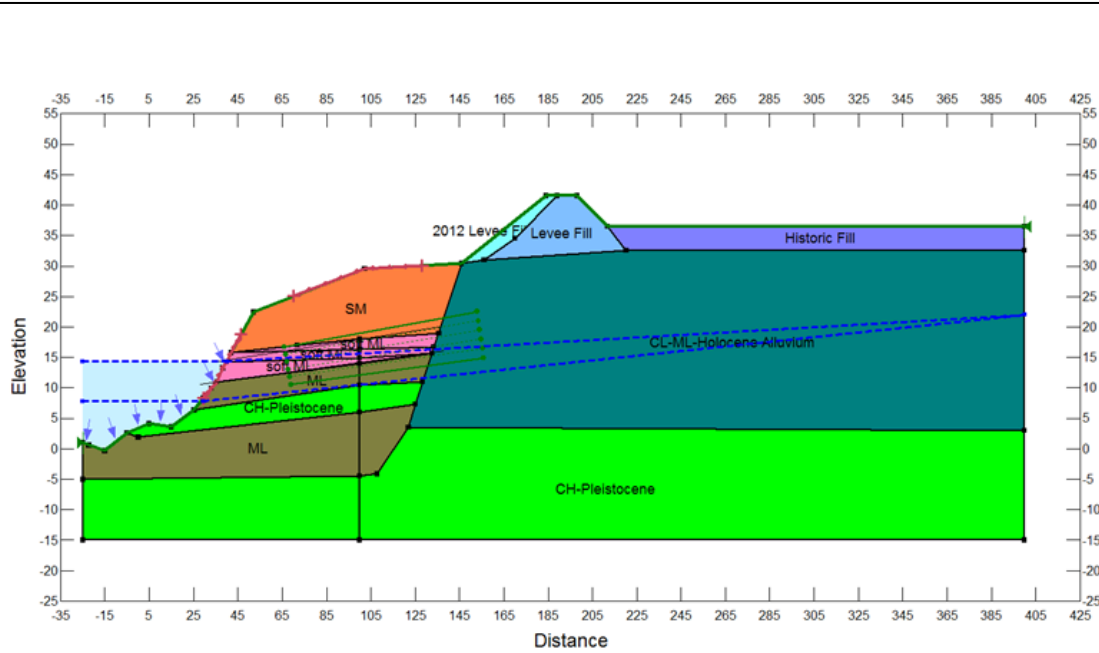
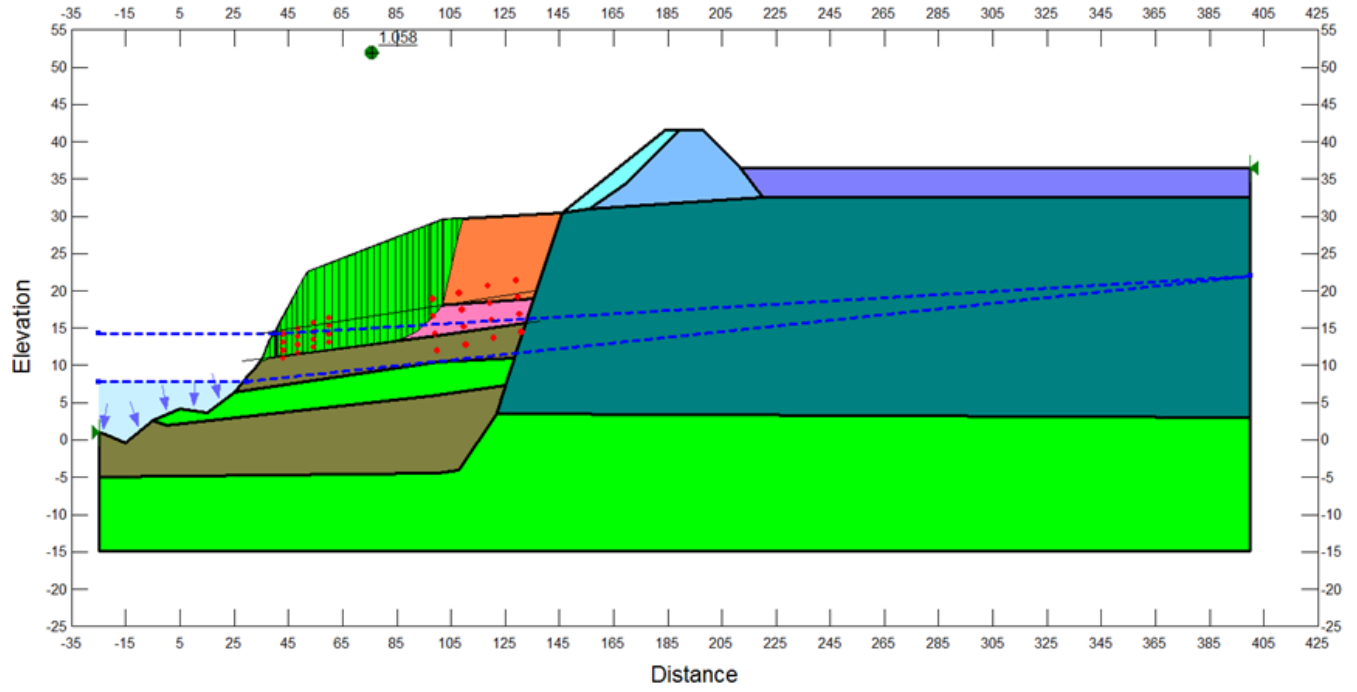
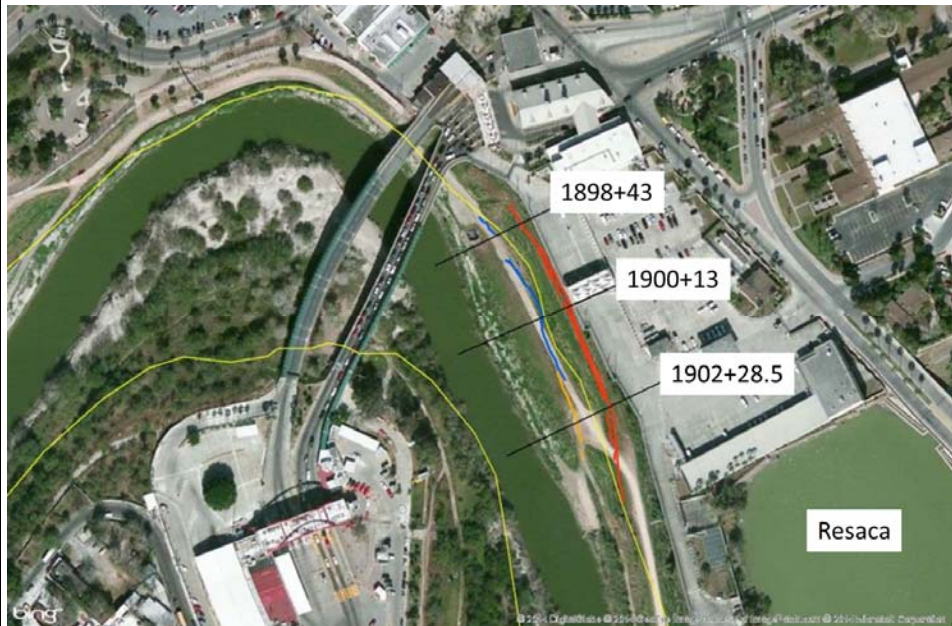
<b>U.S. ARMY CORPS OF ENGINEERS</b> <b>ERDC-GSL</b>
	<i>IBWC-BROWNSVILLE LEVEE</i> <i>STABILITY MODEL</i>
<b>STEADY STATE FOS(WSE 14.31 FT)</b> <b>STATION 1898+43</b>	
<b>FEB-2015</b>	<b>PLATE - 12</b>

Minimum factor of safety (FoS): 1.06

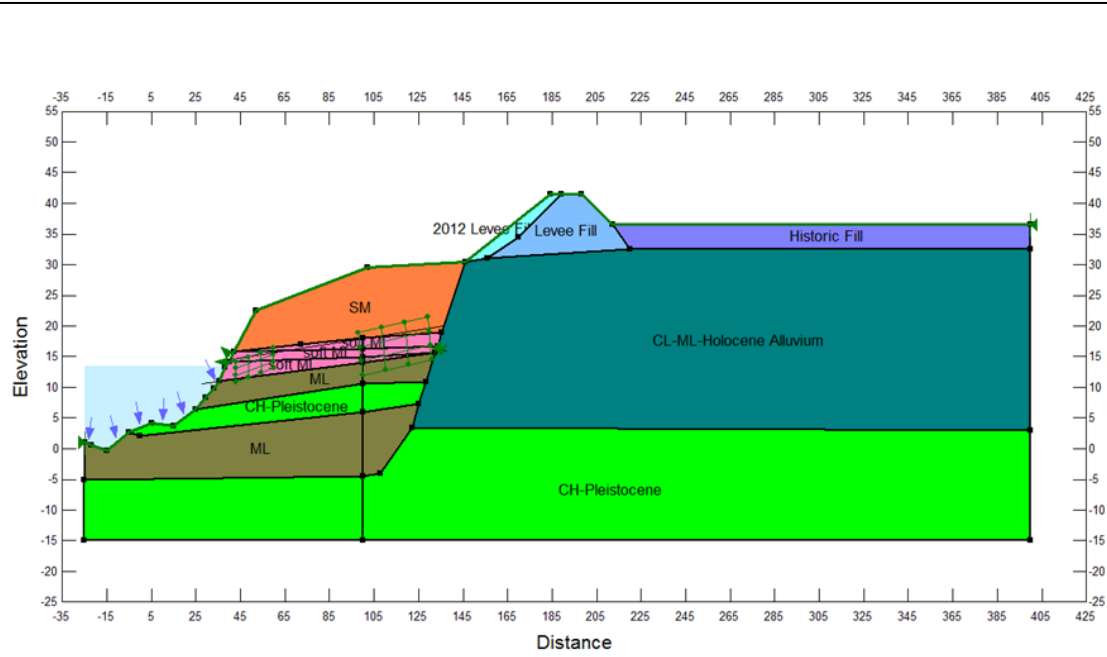
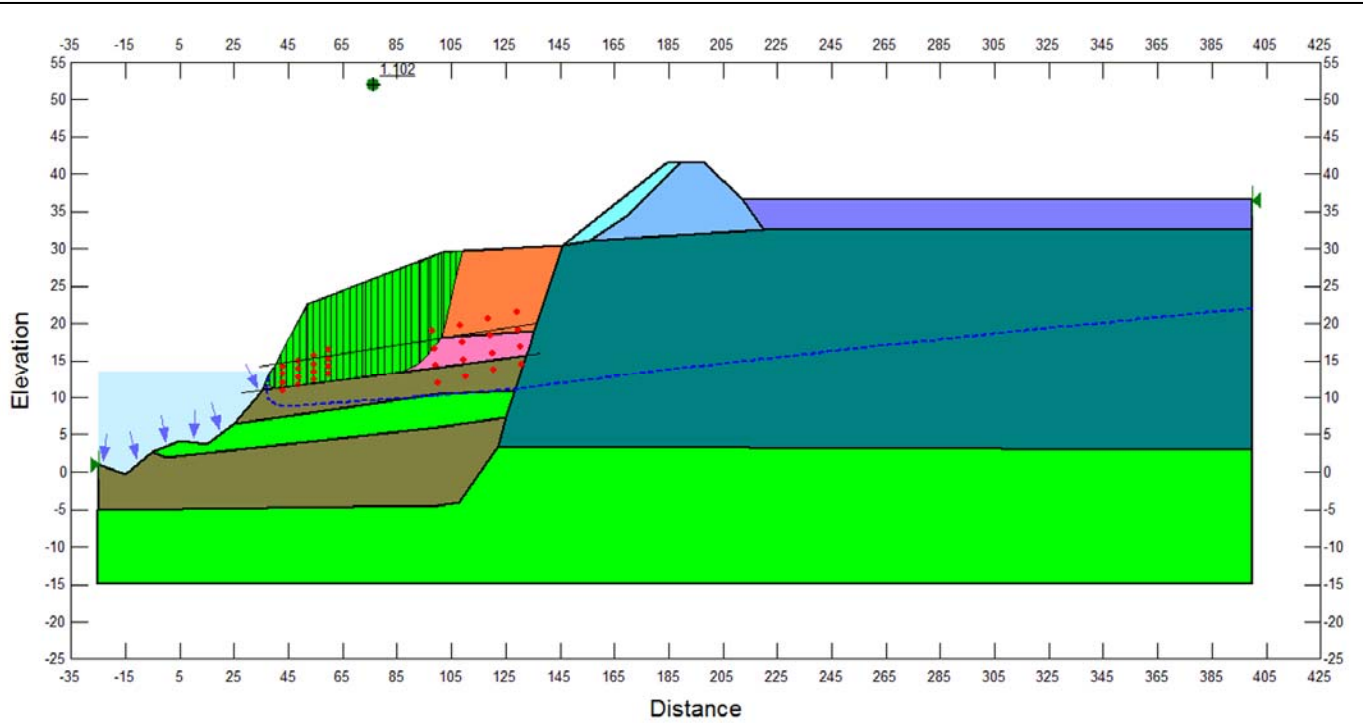
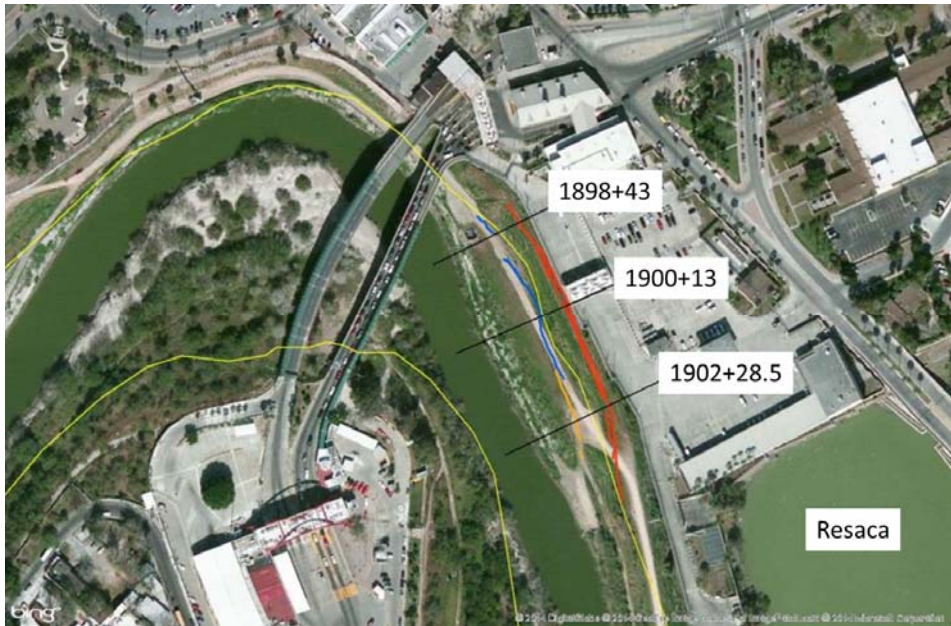
<b>U.S. ARMY CORPS OF ENGINEERS</b> <b>ERDC-GSL</b>
	<i>IBWC-BROWNSVILLE LEVEE</i> <i>STABILITY MODEL</i>
<b>TRANSIENT FOS (HYDROGRAPH)</b> <b>STATION 1898+43</b>	
<b>FEB-2015</b>	<b>PLATE - 15</b>

Minimum factor of safety (FoS): 1.10
