## **Geotechnical Evaluation of the Brownsville Levee Cracking and Partial Slope Failure**

Lucas A. Walshire, Joseph B. Dunbar, Isaac J. Stephens,  
Maureen K. Corcoran, Carla Roig-Silva, and Julie R. Kelley

July 2015

Final report

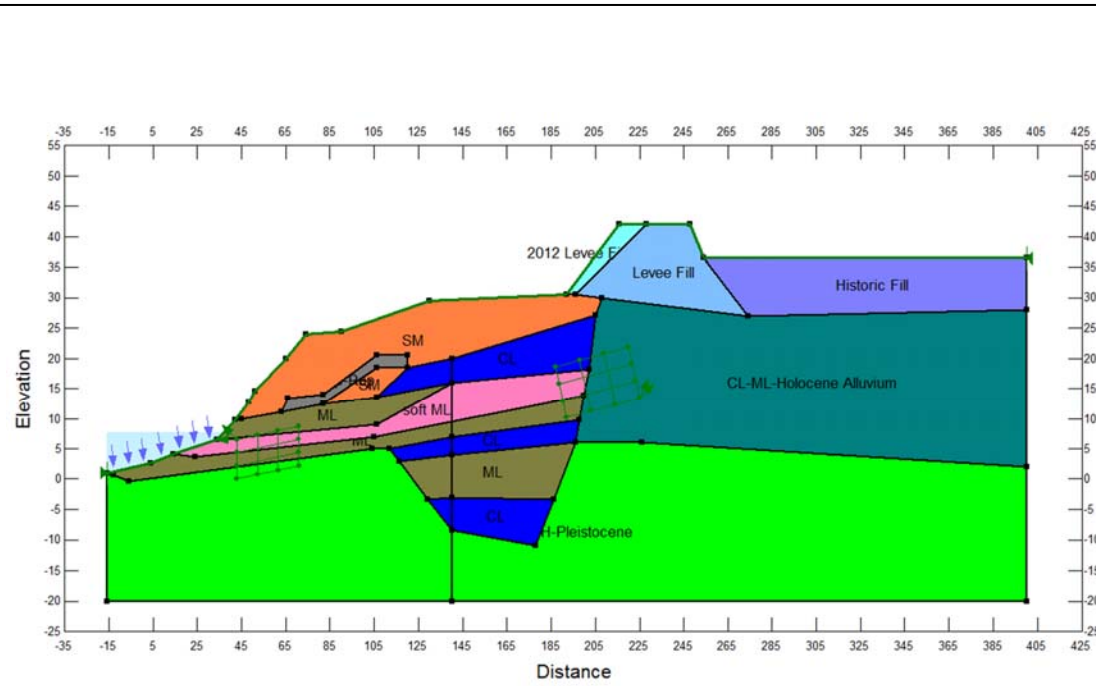
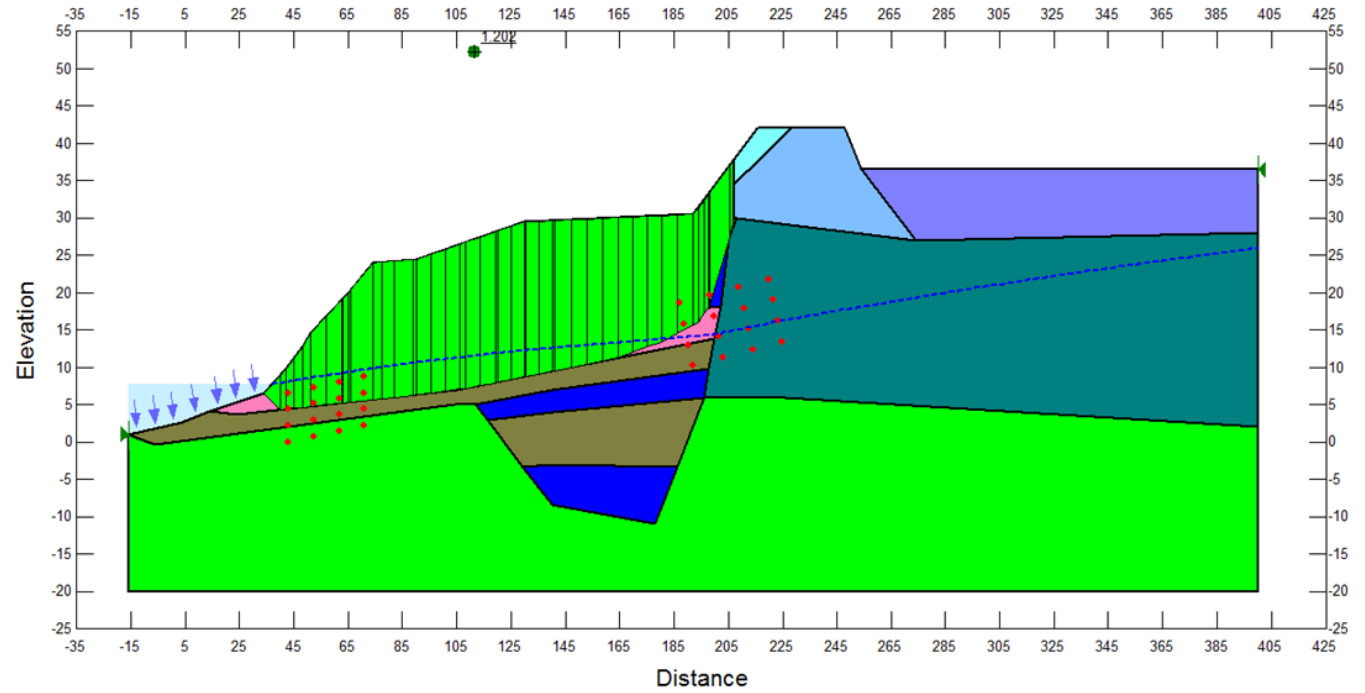
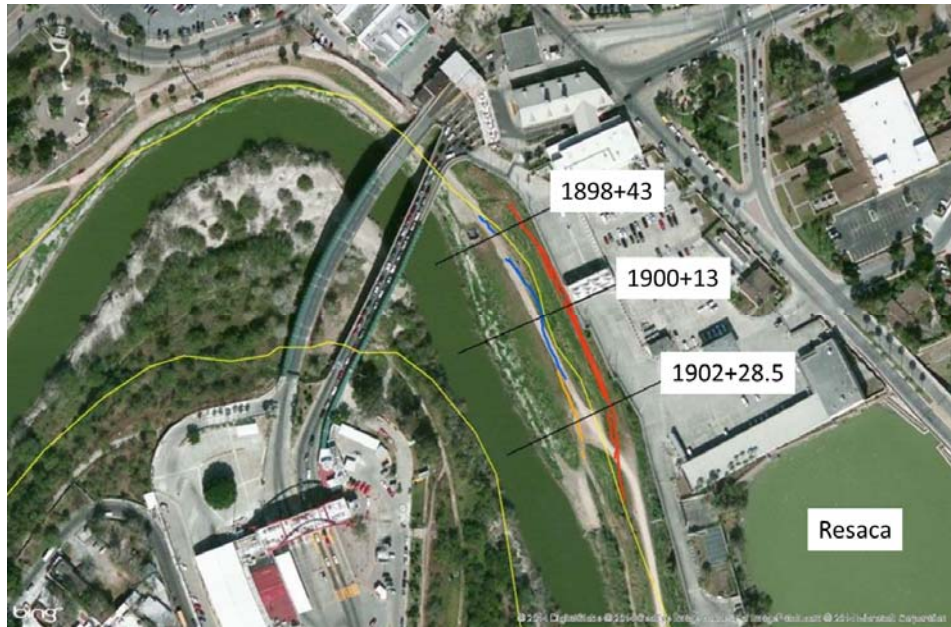
<b>U.S. ARMY CORPS OF ENGINEERS</b> <b>ERDC-GSL</b>
	<i>IBWC-BROWNSVILLE LEVEE</i> <b>STABILITY MODEL</b>
<b>STEADY STATE FOS(WSE 7.77 FT)</b> <b>STATION 1902+28.5</b>	
<b>FEB-2015</b>	<b>PLATE - 17</b>

Minimum factor of safety (FoS): 1.20

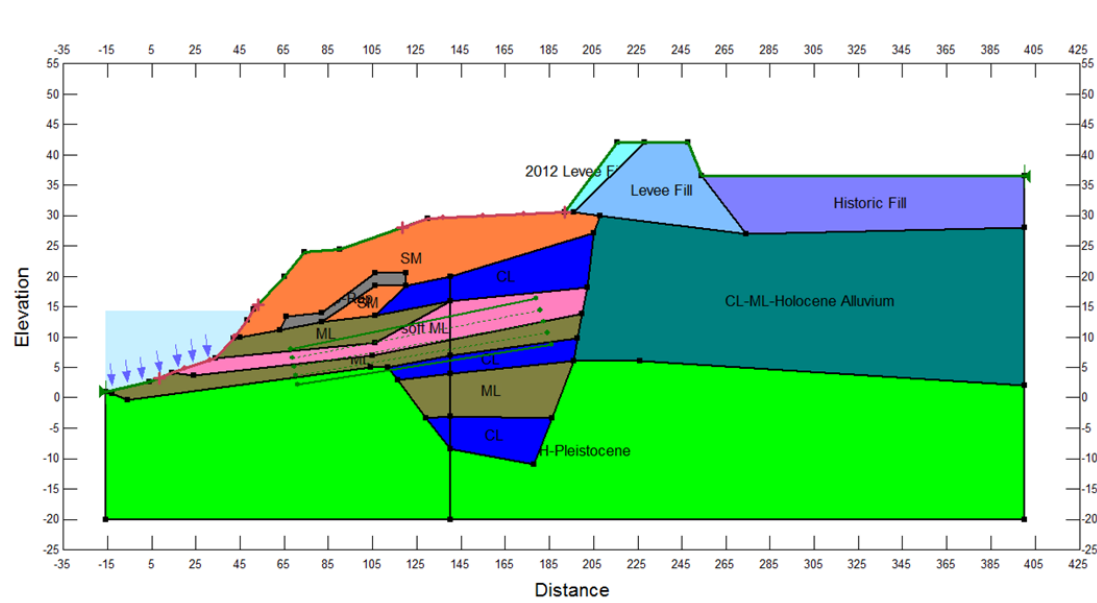
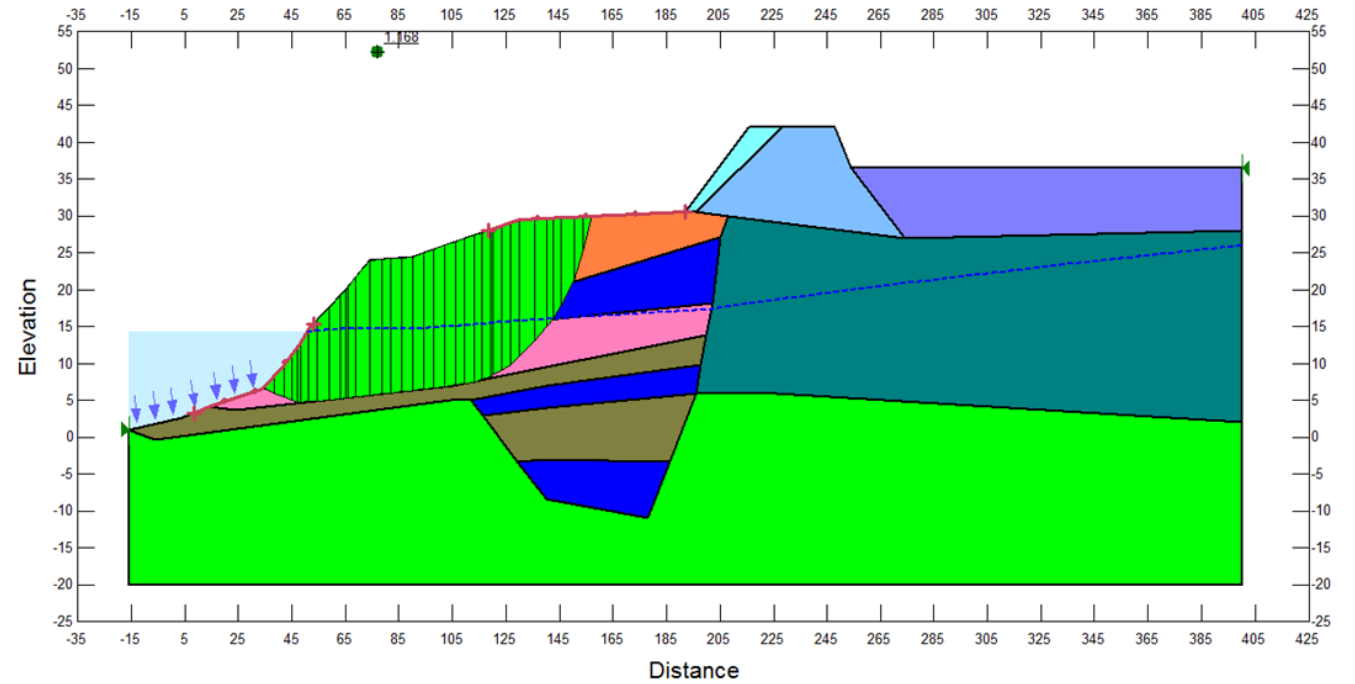
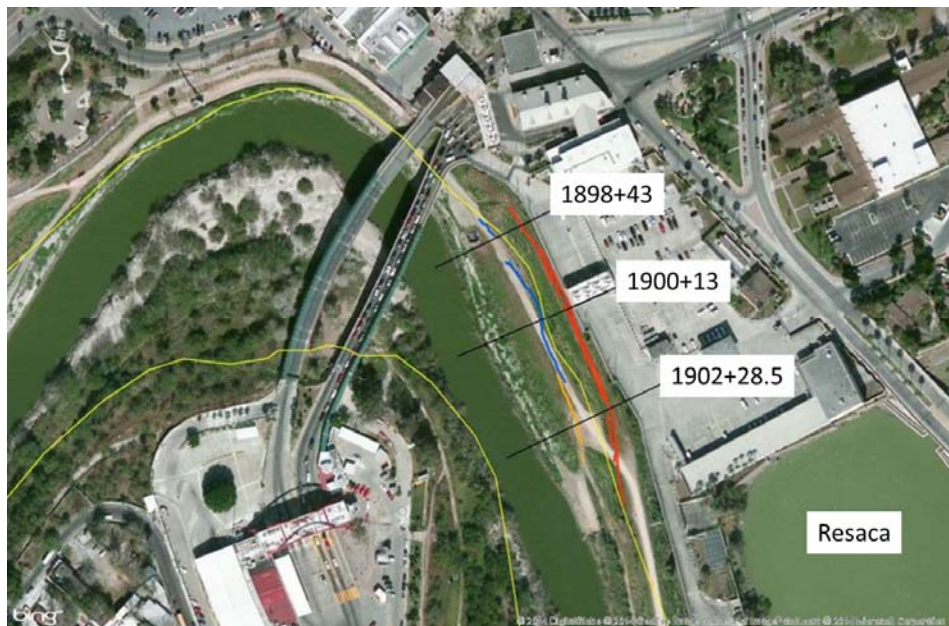
<b>U.S. ARMY CORPS OF ENGINEERS</b> <b>ERDC-GSL</b>
	<i>IBWC-BROWNSVILLE LEVEE</i> <i>STABILITY MODEL</i>
<b>STEADY STATE FOS(WSE 14.31 FT)</b> <b>STATION 1902+28.5</b>	
<b>FEB-2015</b>	<b>PLATE - 19</b>

Minimum factor of safety (FoS): 1.17

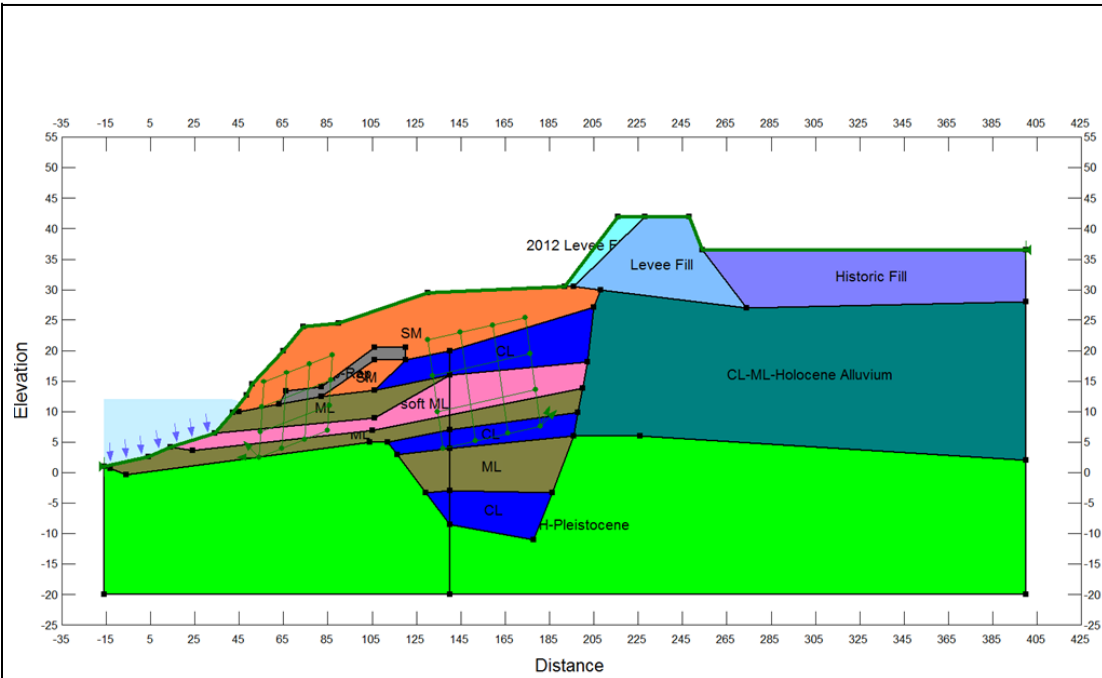
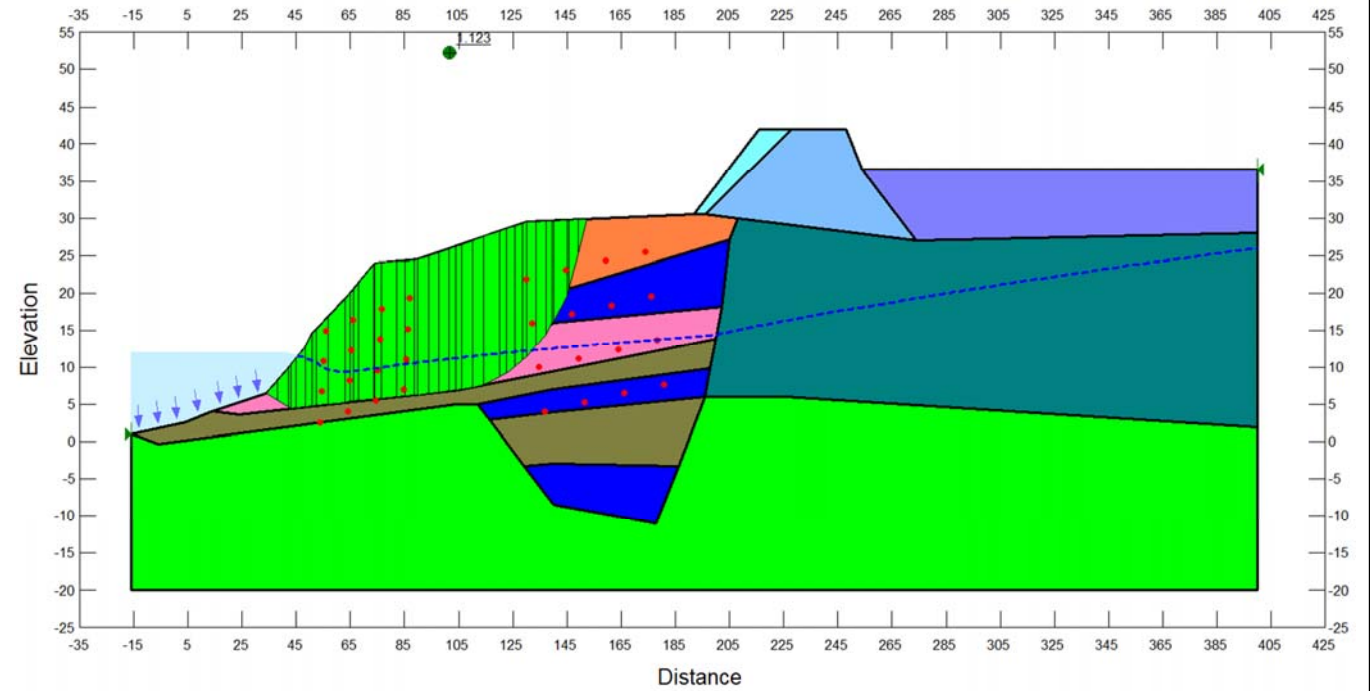
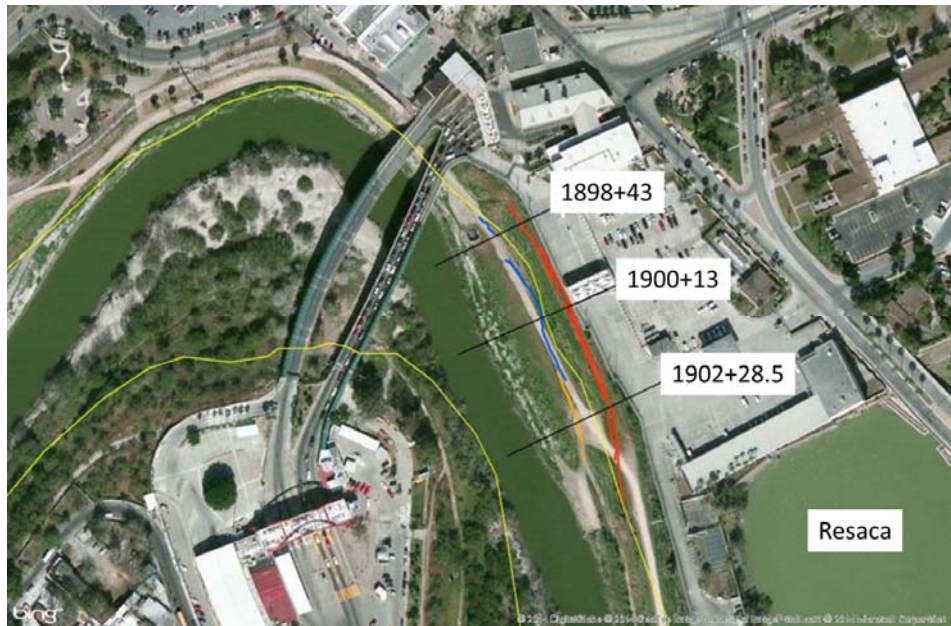
<b>U.S. ARMY CORPS OF ENGINEERS</b> <b>ERDC-GSL</b>
	<i>IBWC-BROWNSVILLE LEVEE</i> <i>HYDROGRAPH, SATURATED MODEL</i>
<b>STEADY STATE SEEPAGE (WSE 14.31 FT)</b> <b>STATION 1902+28.5</b>	
<b>FEB-2015</b>	<b>PLATE - 21</b>

Minimum factor of safety (FoS): 1.12

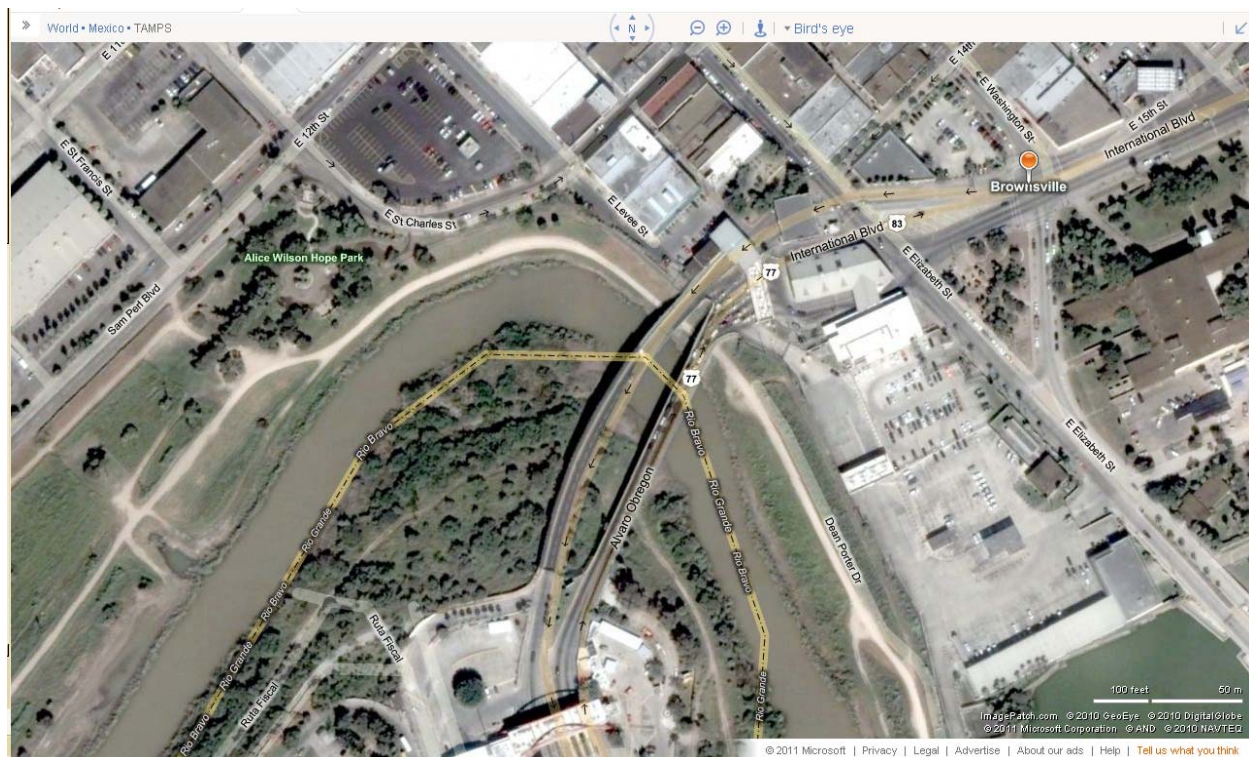
**Figure 1. Gateway International Bridge Crossing of the Rio Grande (flow from left to right)**

As shown in Figure 1, it is noteworthy that there is a zone of vegetation that has established along the left edge of water. This vegetation does not extend up the bank, and characteristics of the vegetation that would affect flow velocity (i.e., height, flexibility, density, root structure) are unknown. While this vegetation may inhibit erosion, given the risk of erosion and the limited access, an erosion protection revetment would be more reliable than assuming the vegetation would prevent erosion.

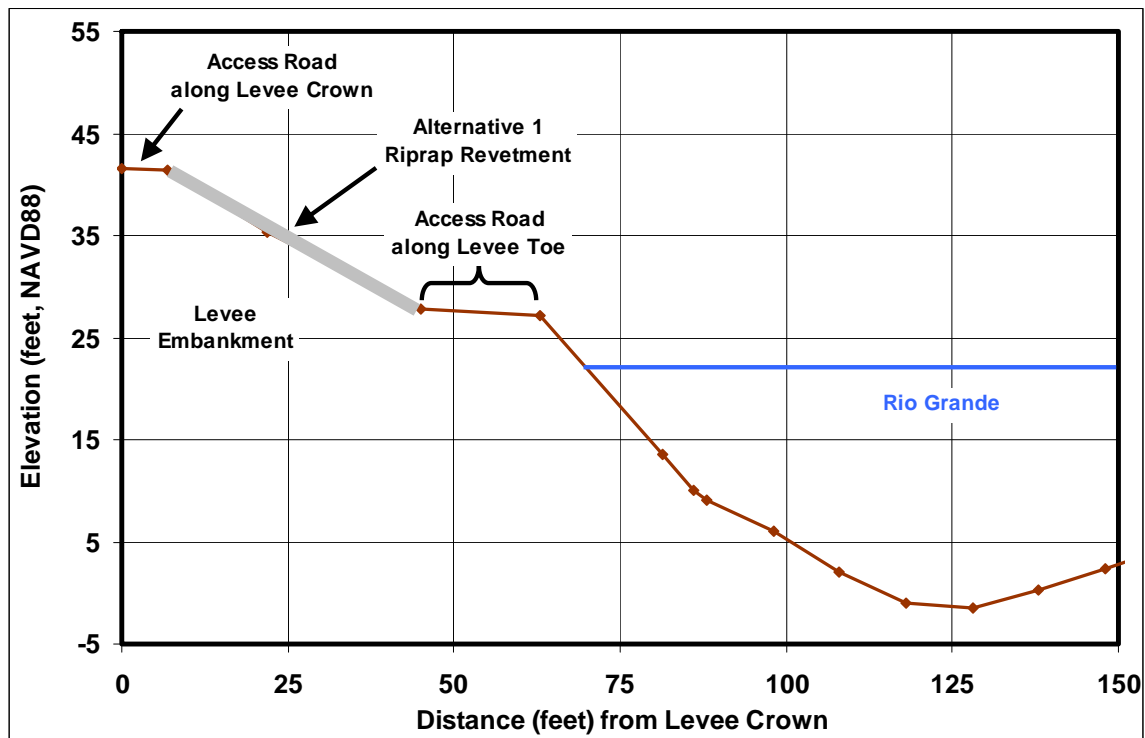
Figure 3. Alternative 1 Embankment Protection – Riprap Revetment on Upper Bank Only

This alternative would provide embankment protection along the upper bank and reduce the potential for vegetation growth along the bank. This addresses the short-term condition but does not address the long-term condition in which the existing bank below the lower access road could begin to scour. Toe scour is probably the most frequent cause of failure of riprap revetments (USACE 1994). As the lower bank is eroded, the progressive erosion of the embankment will undermine the lower access road along the levee toe and the upper bank riprap revetment. This upper bank revetment would then fail and not provide any protection to the embankment.

One alternative means of embankment protection is the construction of a riprap revetment along the upper bank (i.e., between the access road along the toe and the access road along the crown). This is illustrated in Figure 3.
