International Boundary and Water Commission  
United States and Mexico

Report of Transboundary Bypass Flows into the Tijuana  
River

Minute 320 Binational Technical Team

Final Report

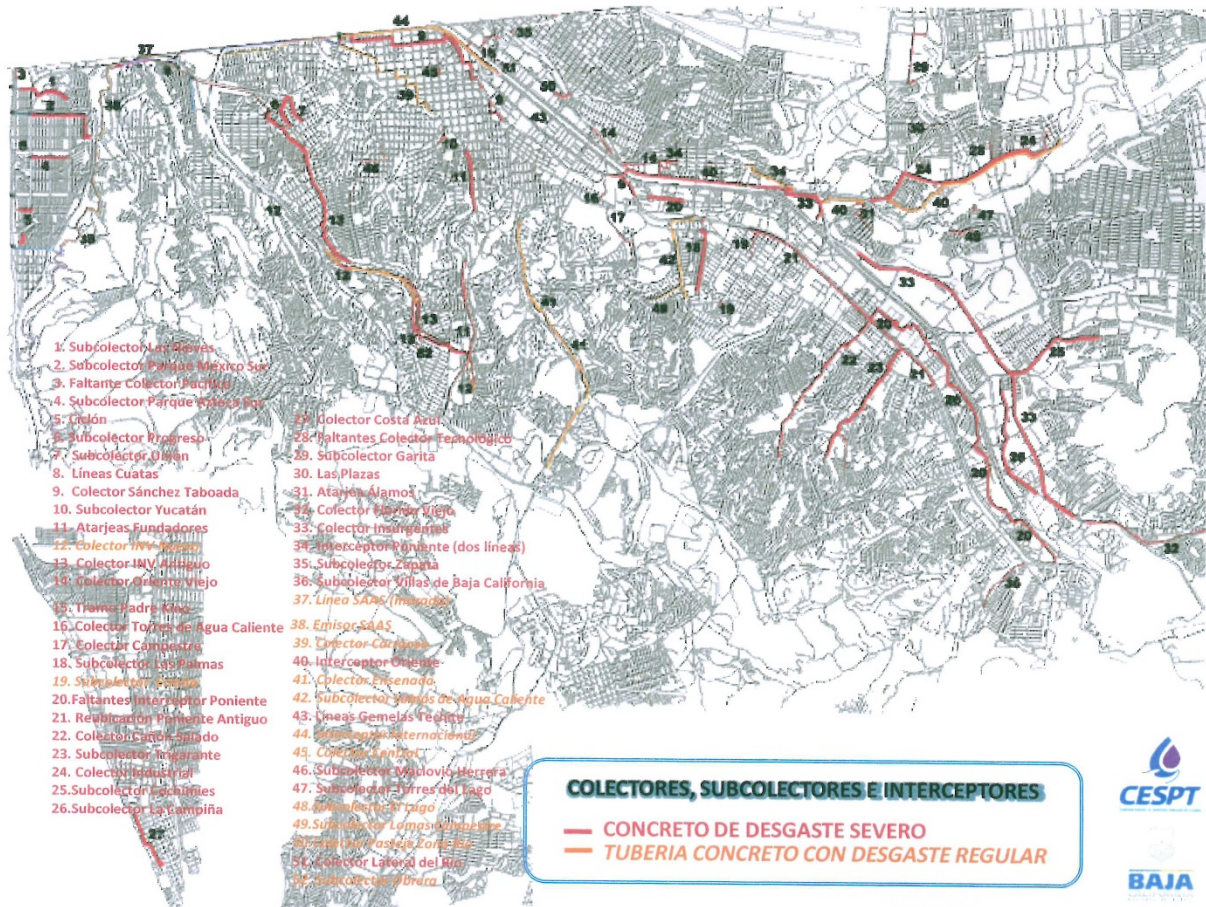
Figure 9 Location map of critical collectors

CESPT noted that they have a 2012 master plan for infrastructure improvements however it needs to be updated as Tijuana has grown significantly. A CESPT consultant will provide the updated 2012 plan with actions and a schedule. CESPT is working with CONAGUA and the governor of Baja California to financially assist in replacing some of the wastewater lines. The following are a location map and two tables showing the immediate needs and near term needs for Tijuana sewerage:

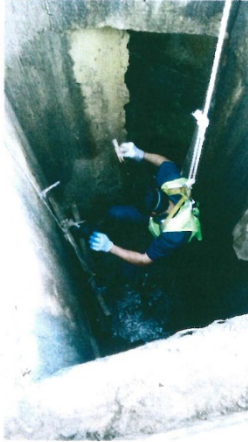
EL DIA 02 DE ENERO DEL 2017, SE TRABAJO EN LA INSTALACION DE UN TAPON INFLABLE DE 24"-48" DE DIAMETRO EN LA CAJA DERIVADORA DEL COLECTOR PONIENTE UBICADA SOBRE EL BOULEVARD FEDERICO BENITEZ ESQUINA CON EL BOULEVARD LAZARO CARDENAS, DE LA COL. LA MESA, EL CUAL SE REALIZO CON EL OBJETO DE ELIMINAR EL 100% DE LAS APORTACIONES CONDUCCIDAS A TRAVES DEL COLECTOR PONIENTE HACIA EL COLECTOR ORIENTE. LO ANTERIOR COMO MEDIDA PREVENTIVA Y PARA EVITAR DERRAMES DE AGUAS NEGRAS HACIA LA CANALIZACION DEL RIO TIJUANA, ORIGINADAS POR EL APARENTE COLAPSO DE UN TRAMO DEL COLECTOR ORIENTE DE 60 PULGADAS DE DIAMETRO.
