**USIBWC Habitat Restoration Sites and Groundwater Monitoring Wells**

**MONITORING NOTES AND PHOTOGRAPHS**

**SUMMER 2023**

**U.S. Section International Boundary and Water Commission**

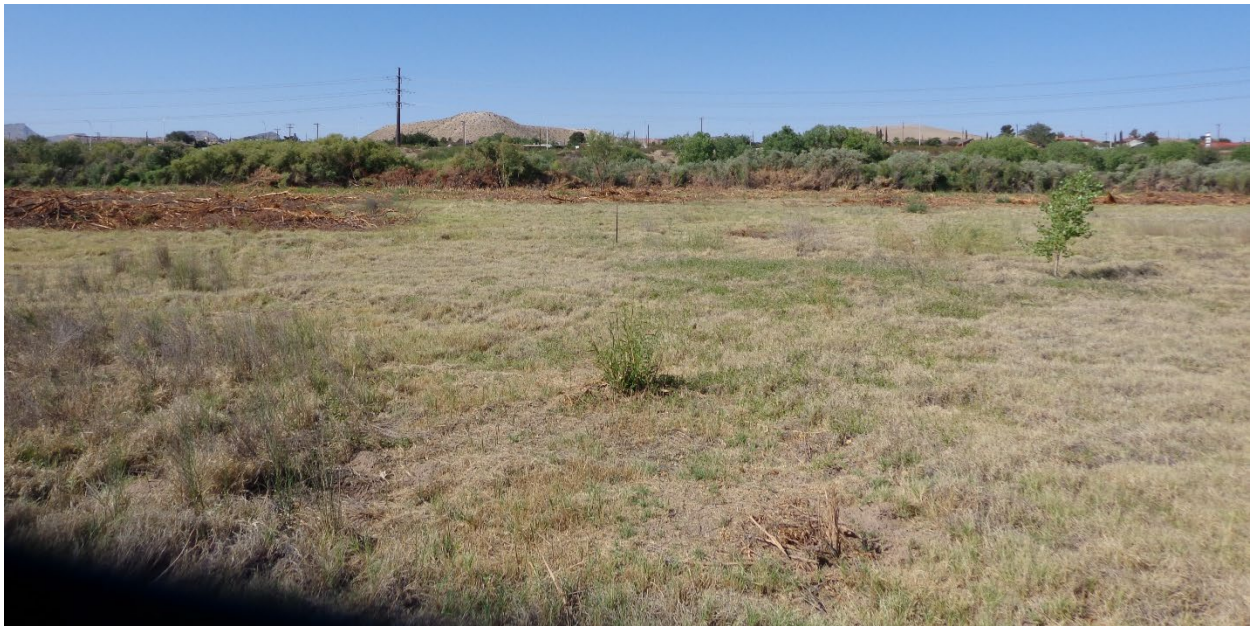
In the middle of this image, you can see a photo point marker for the restoration site. Very little vegetation.

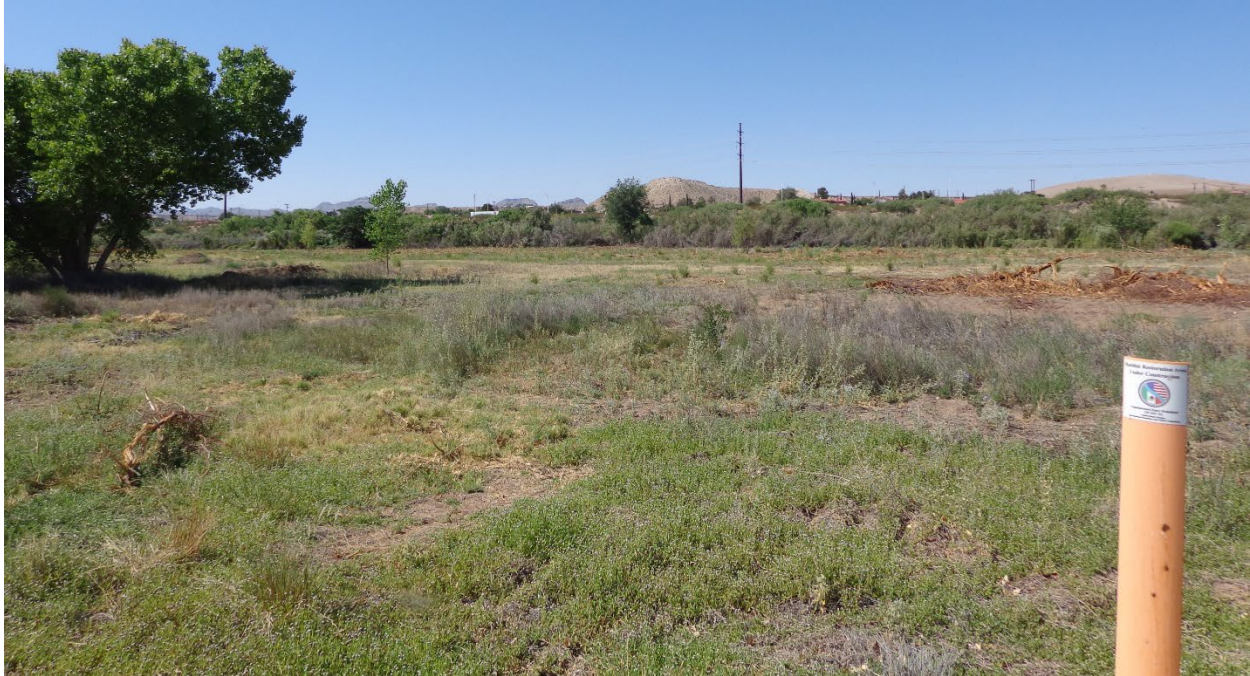
Left side of the restoration site

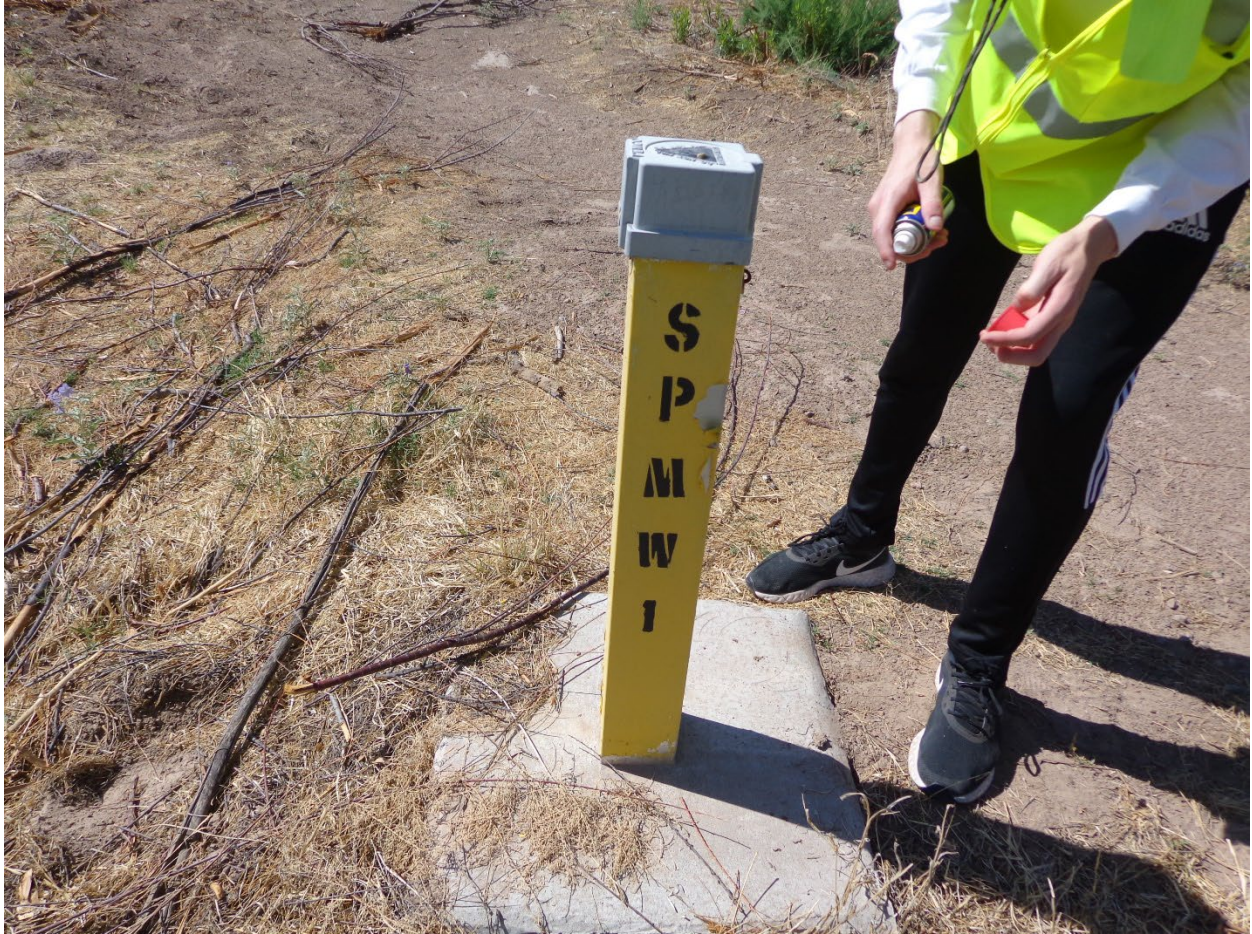
Sunland Park monitoring well, and lettering is in good condition. As compared to years before this area looks completely different compared to 2021.

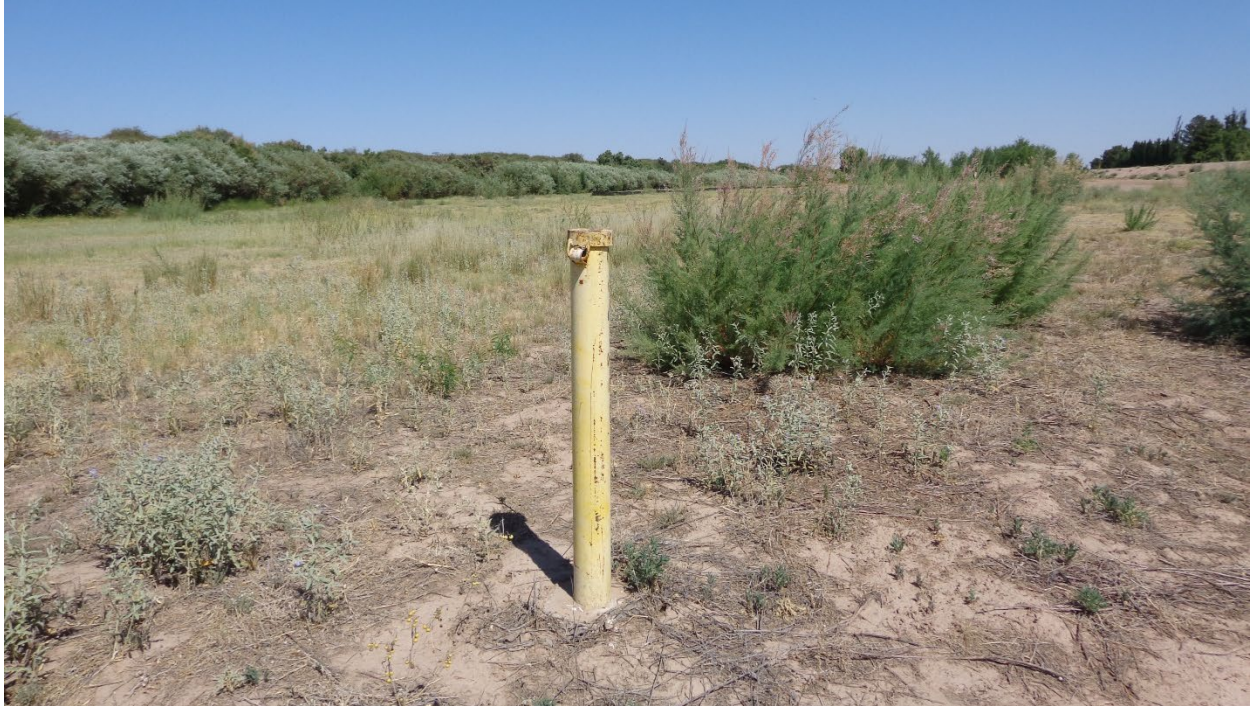
Another side view from CCE-MW-2 Monitoring well in the distance there is not much vegetation with the exception of the riverbank area. Some salt cedar resprouts.

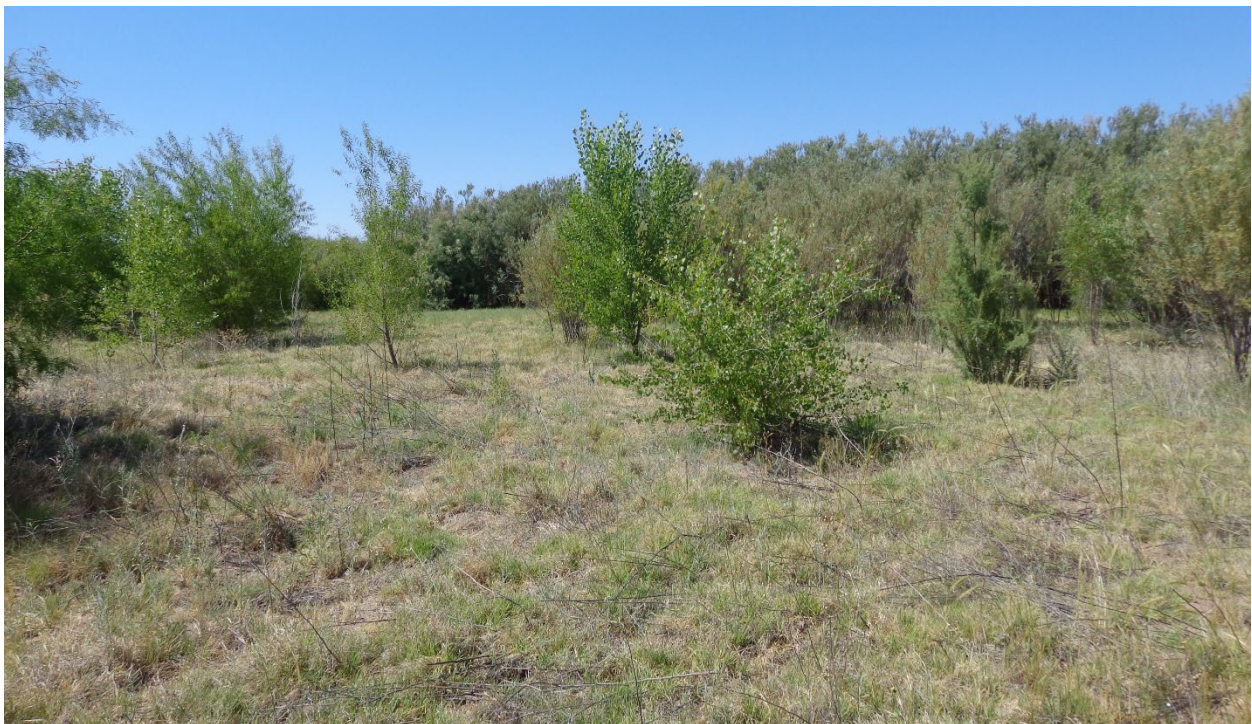
Cottonwoods seem to be doing very good in the southern end located closer to the riverbank. The surrounding plant life is doing very good. We estimated that the plantings had a survival rate of around 80%. Most trees are between 5 and 10 feet tall and had a good number of plantings that are surviving.

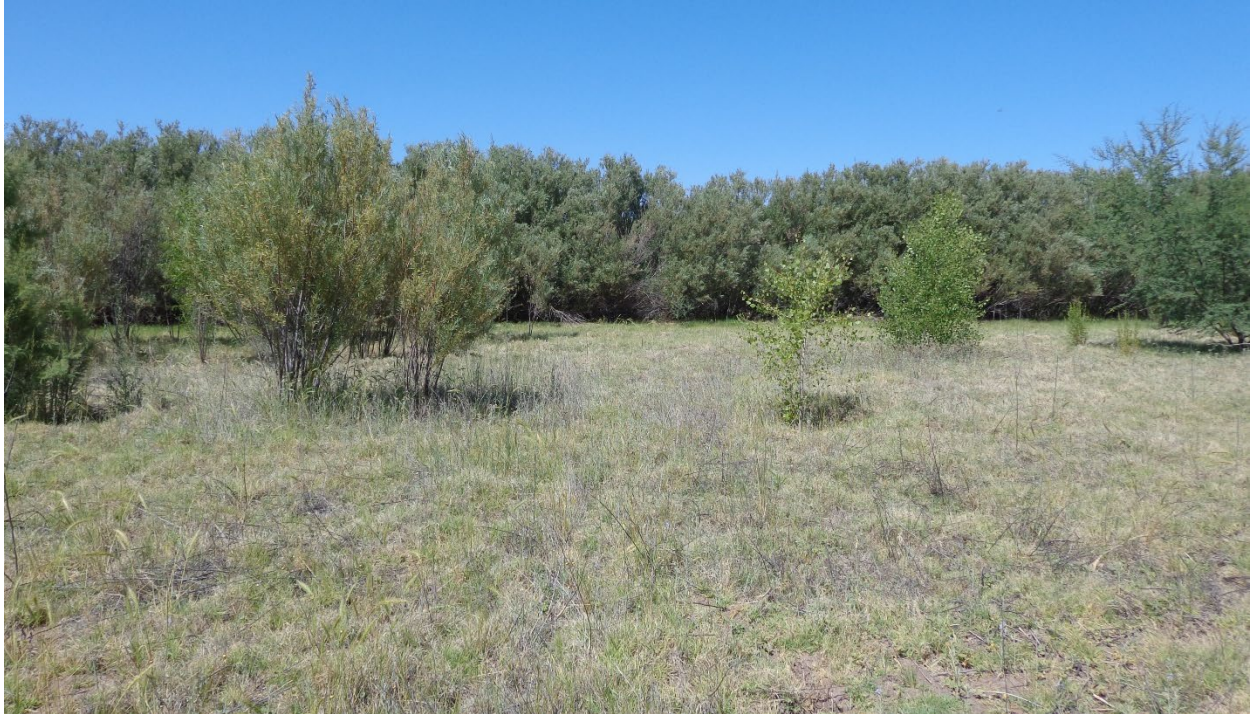
Cottonwoods and Gooding's Willows flourishing at Country Club East restoration Site. Coyote Willow covering the riverbank edge.

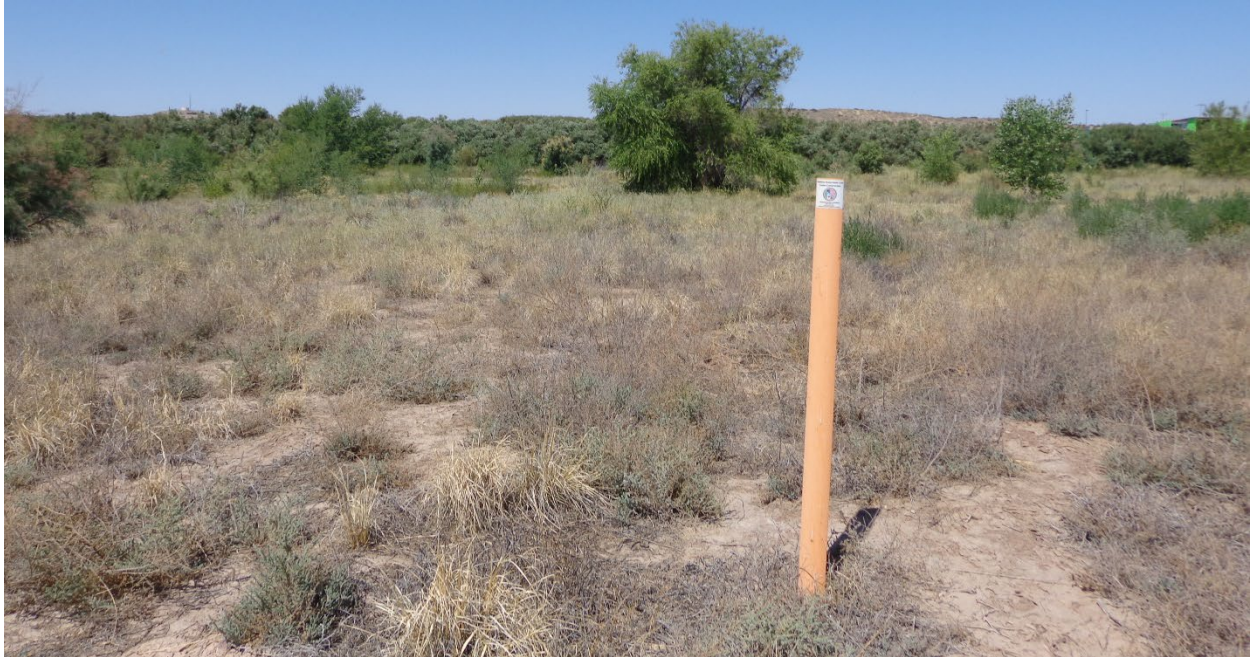
This is further north at the Country Club East site. The floodplain widens and the more upland area near the levees has more scrub habitat. Willows are along the background by the river. The plantings appear to have a high survival rate. No observable wildlife species in this area of the restoration site.

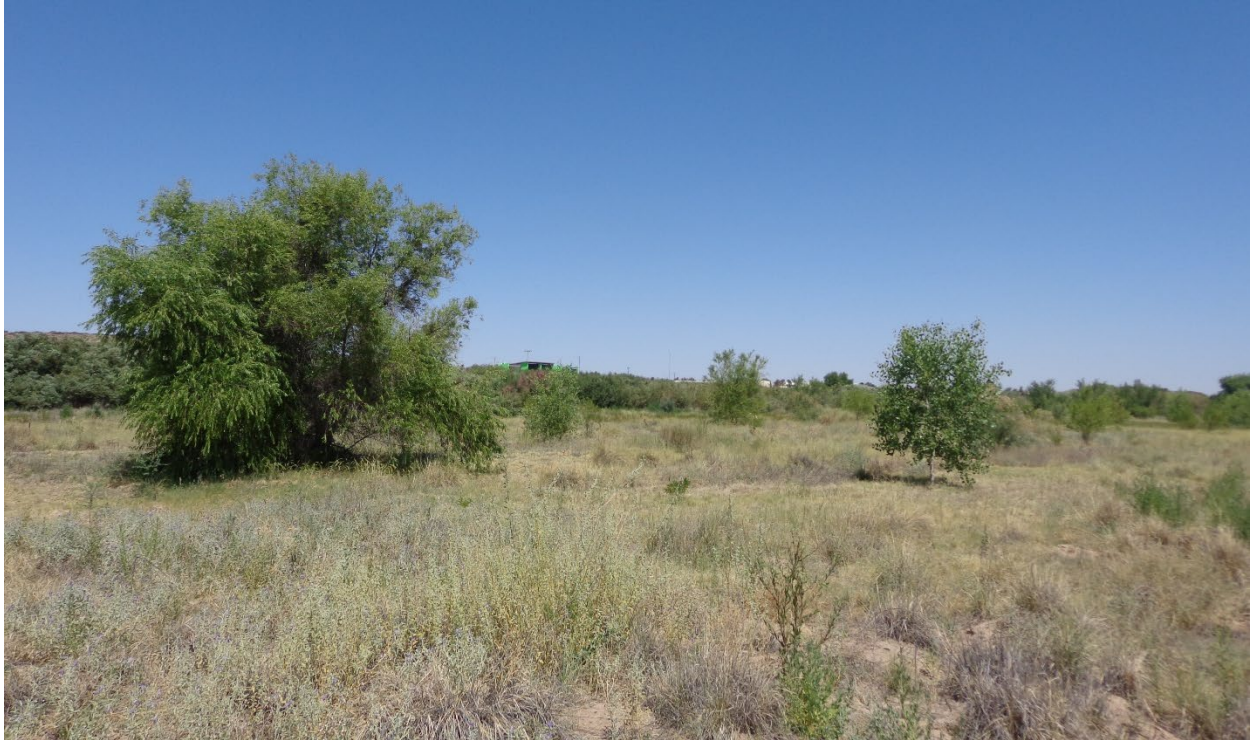
Big mesquite and some cotton woods, survival rate does not look as high, but this is looking north, and the rest of the site looks like it's in good shape.

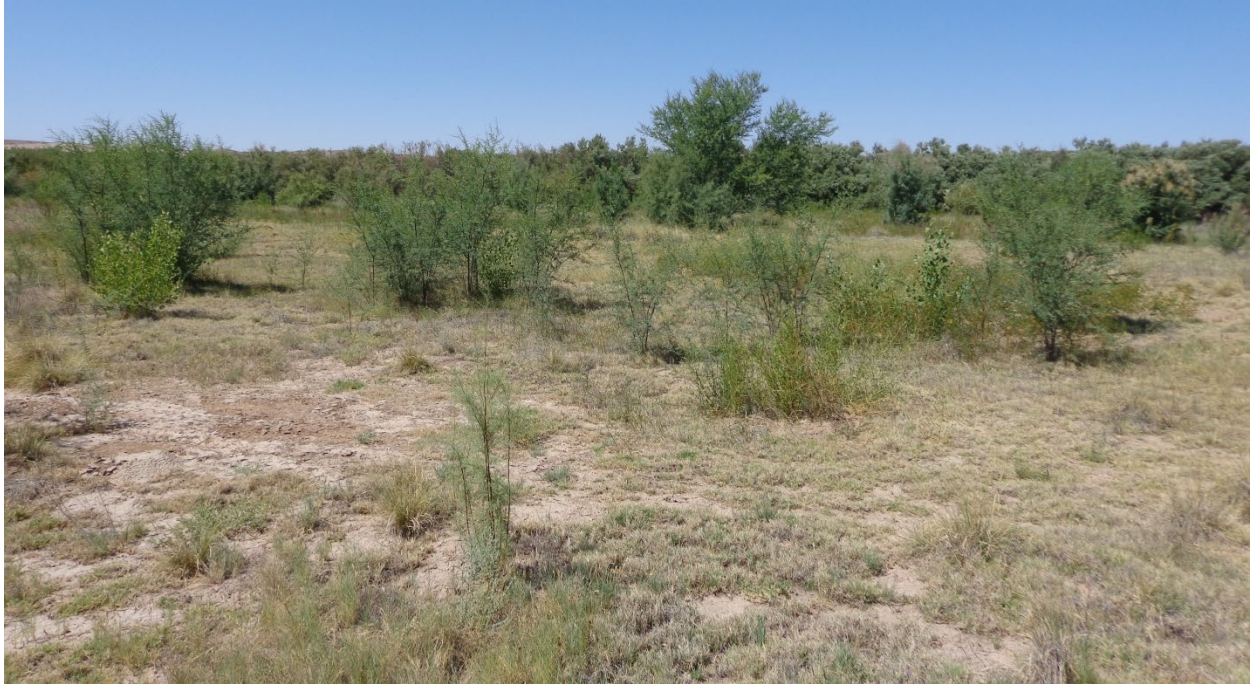
Good vegetation here, including cottonwood plantings, some mesquite, some salt cedar resprouts, and some brush here and there.

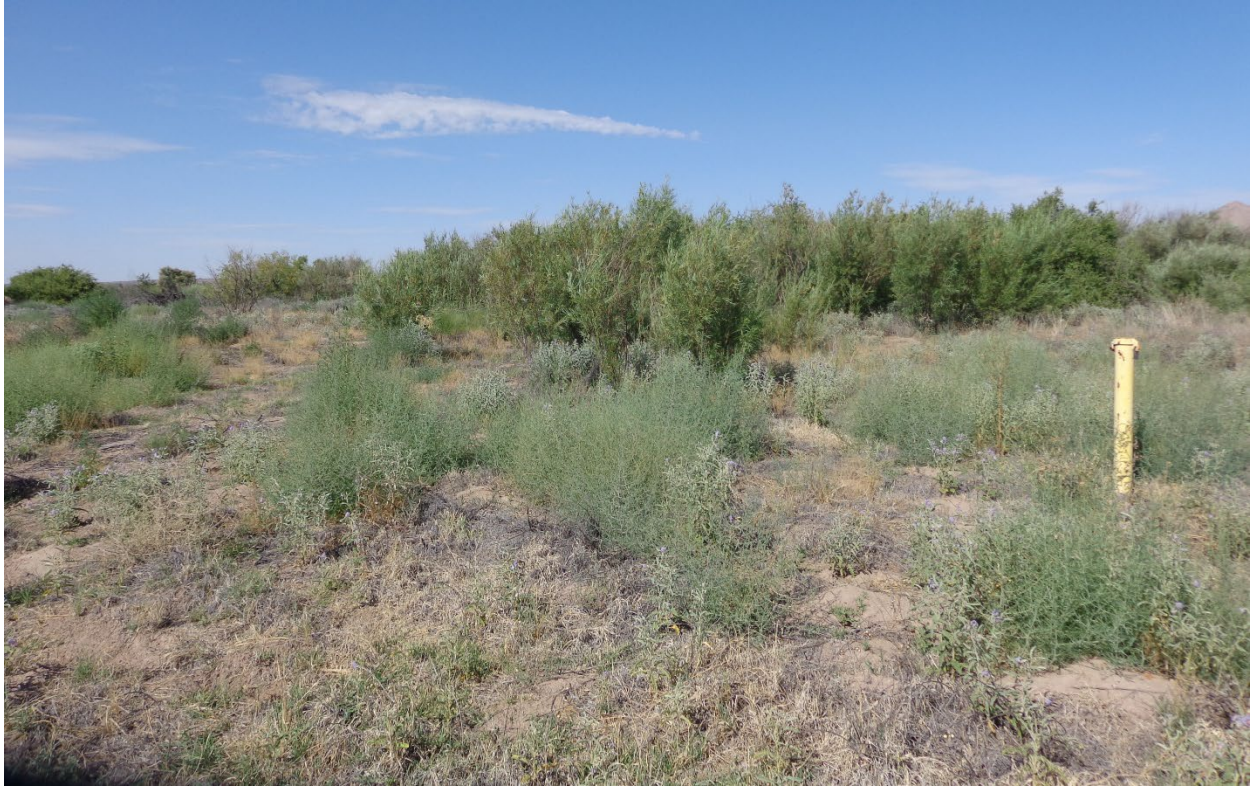
A bunch of brush near the well LEL-MW-3 with a willow stand nearby.

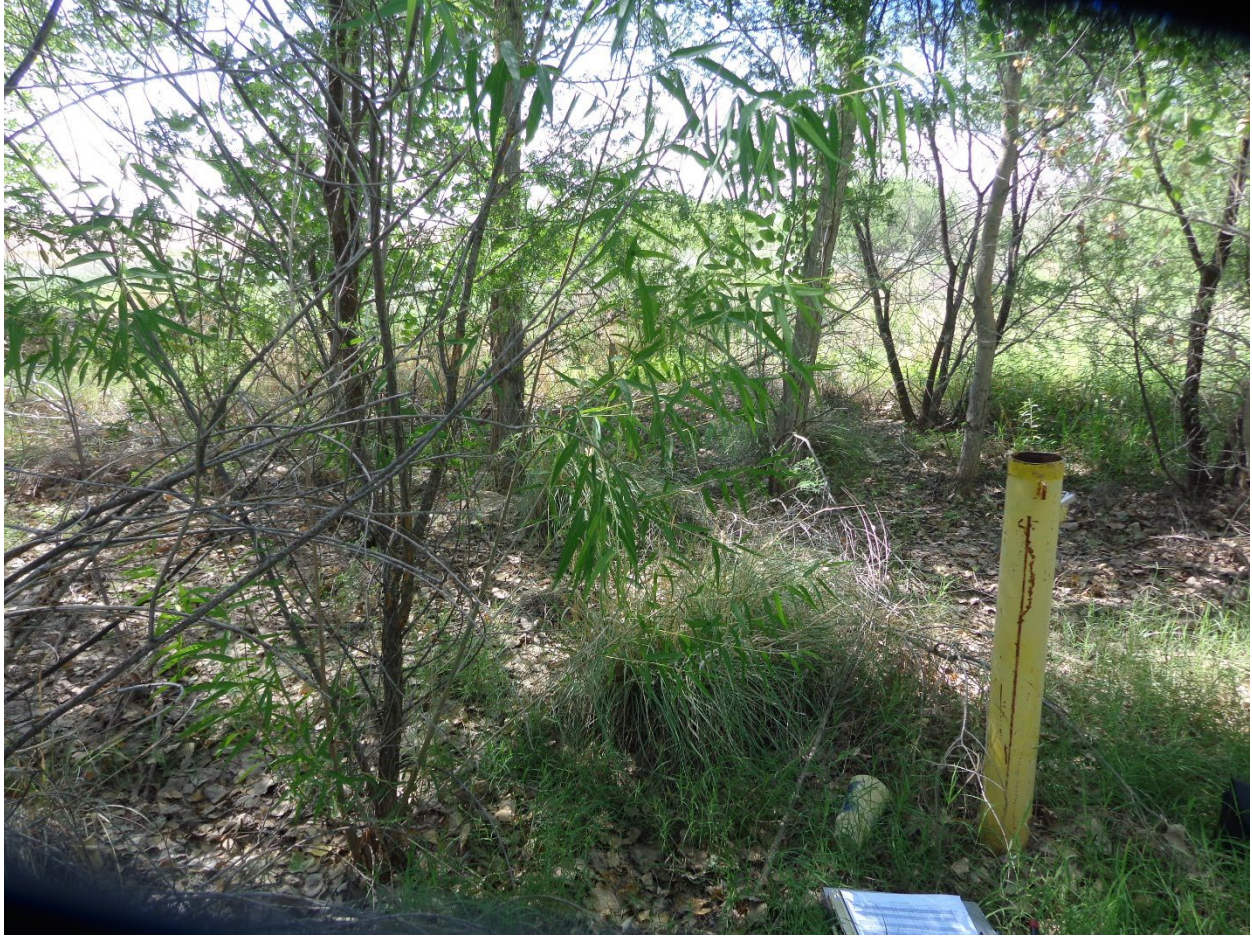
Picture of the irrigated area at well LEL-MW-2. Lots of vegetation including this large Gooding's willow, and it was hard to get to because of the overgrowth of the area.

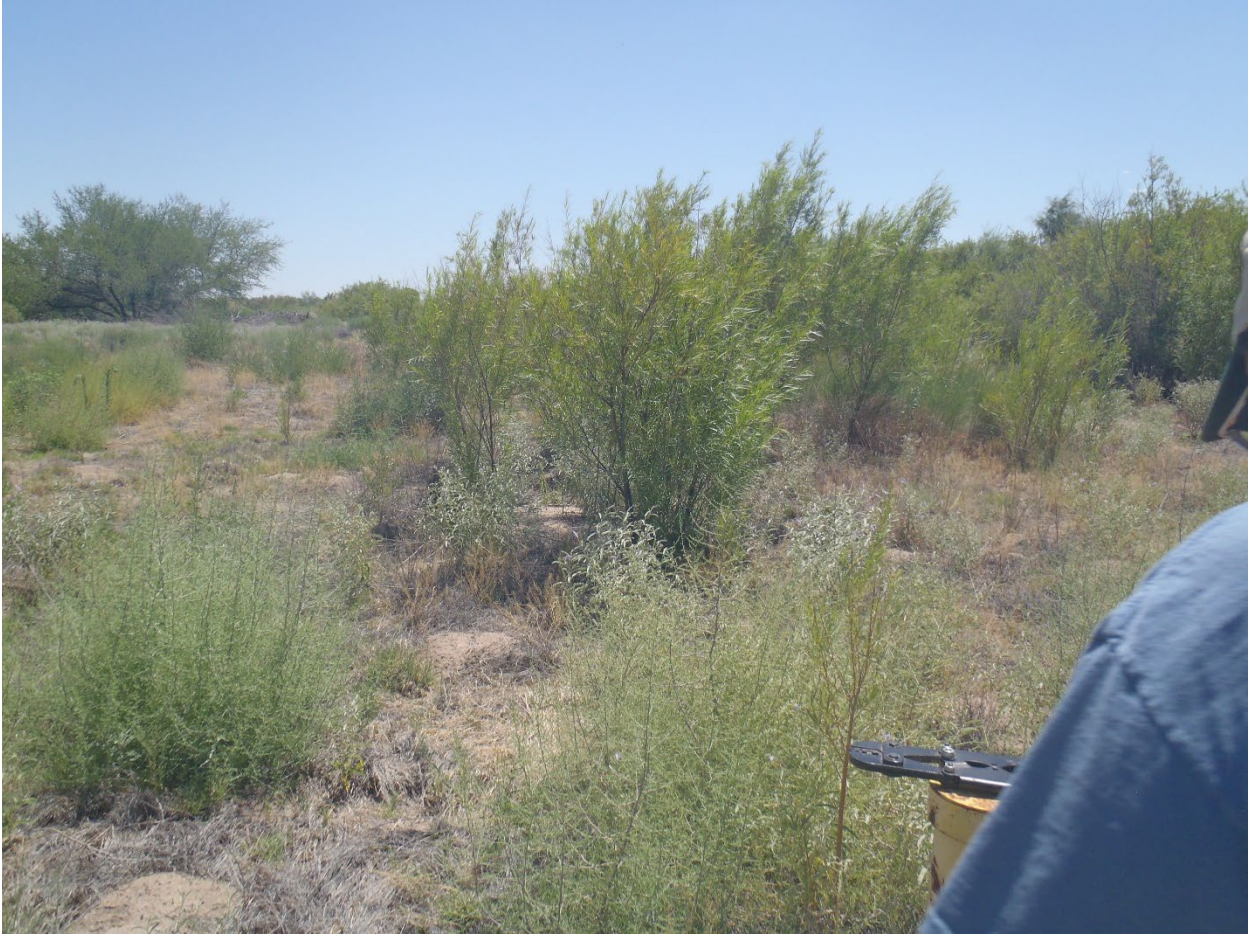
Shrubs close to the well and willows nearby, healthy and alive.

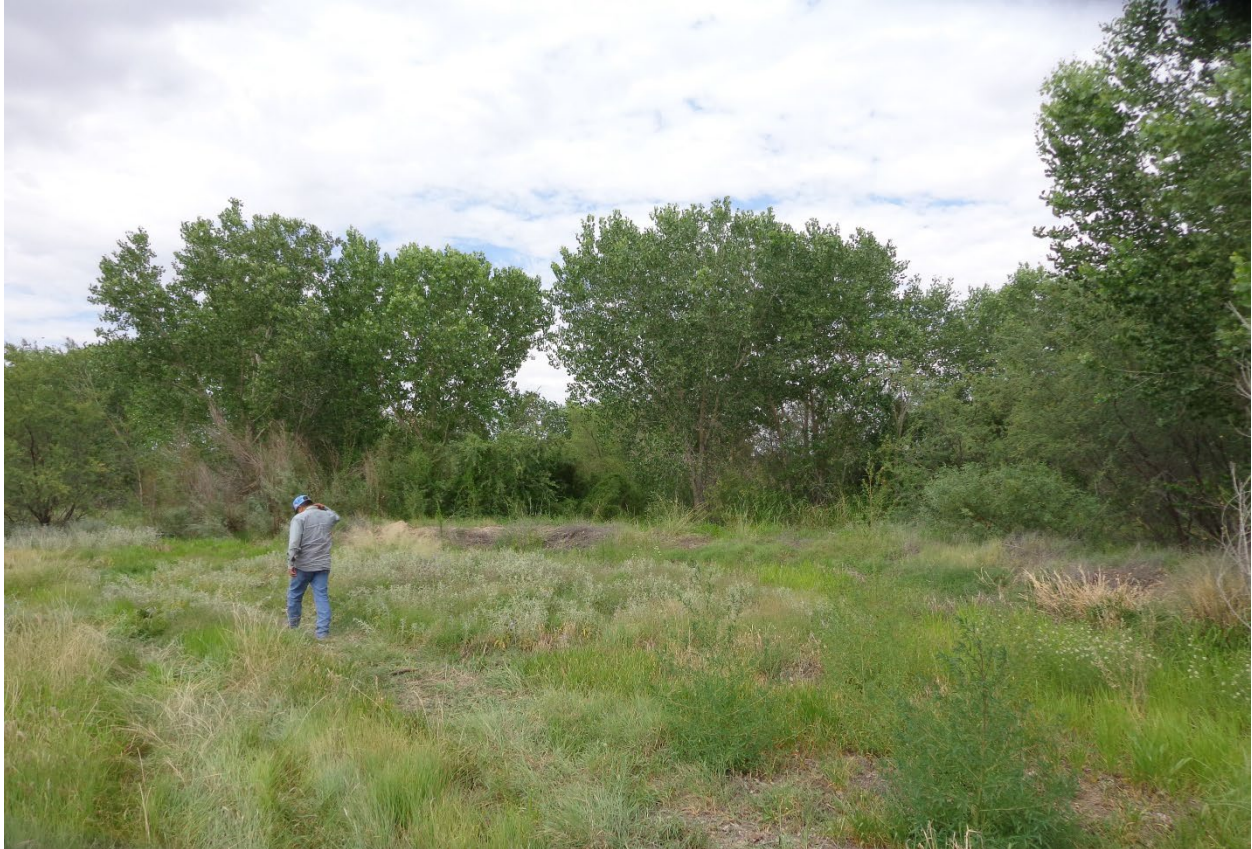
Following David, we can see more thriving vegetation and everything in this area looks really good and green. Survivability of this area is very high, and I estimate that it is above 80%.

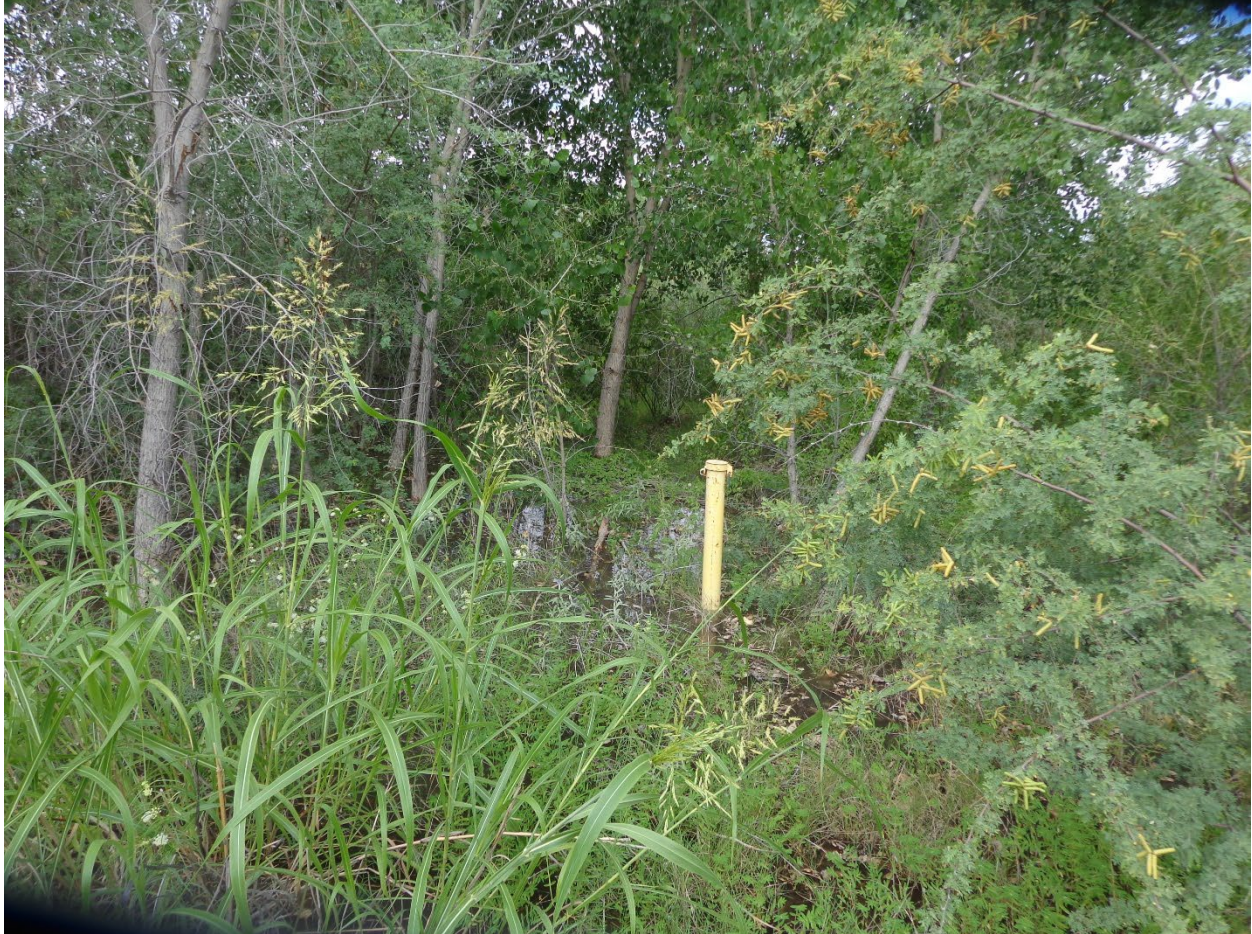
One of the monitoring wells that we were able to locate just visually (LEL-MW-1), some other wells were not as easy to spot in the thick foliage, and as you can see, there is a lot of water, and the irrigation continues to flow throughout the site.

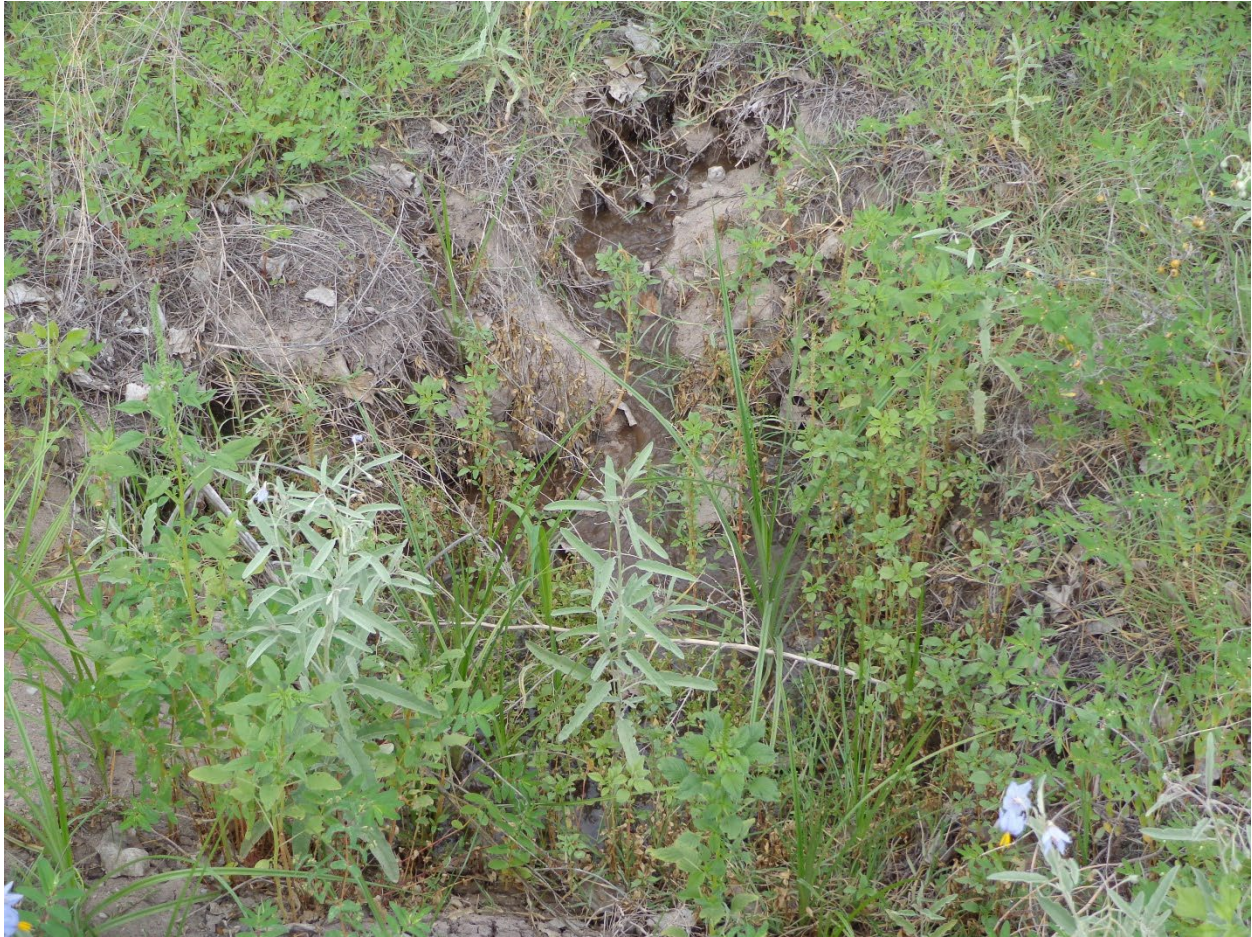
Water coming out of some of the holes in the ground near the back end of the site. Apparently, water sometimes hardly reaches the end, but they had around an hour and a half and most of this water was reaching the end which is very good.

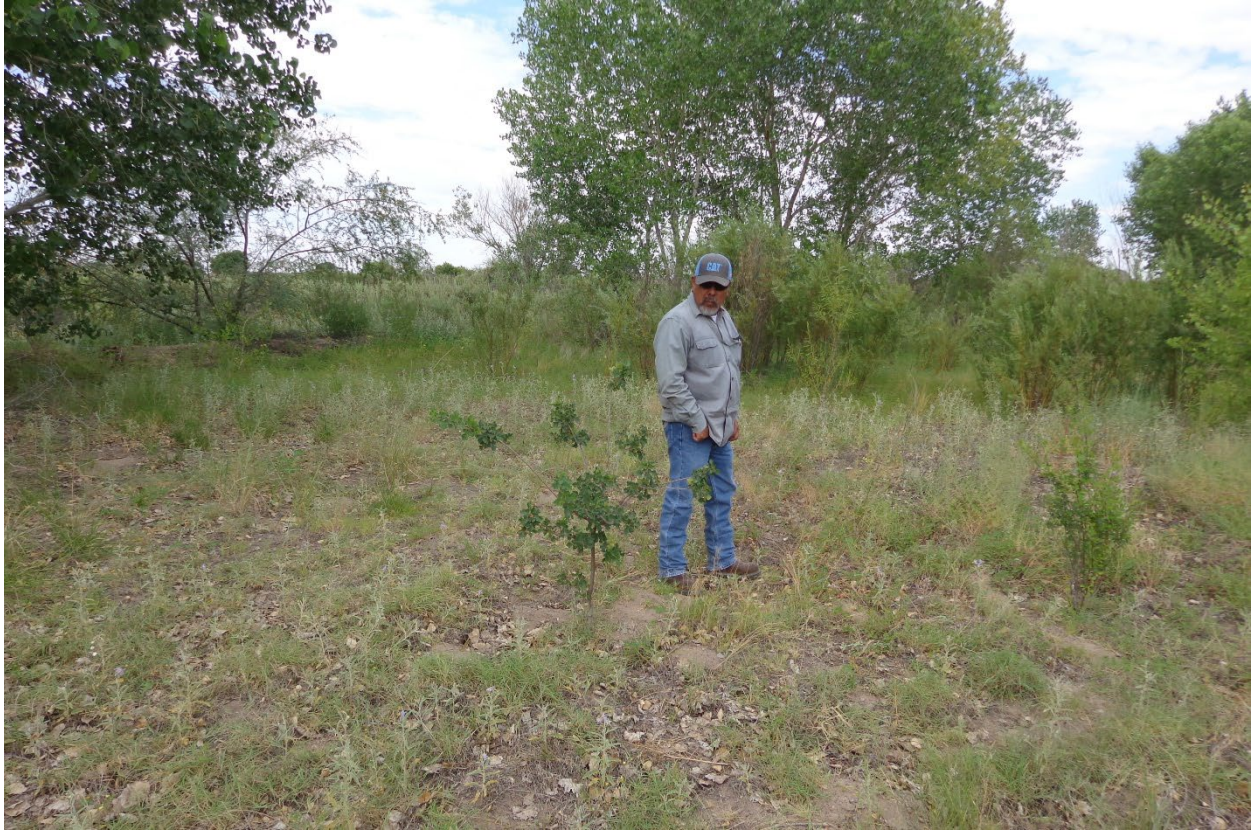
Small little shrub planting that has survived. Shrub plantings typically had low overall survival rates. Here David is standing nearby.

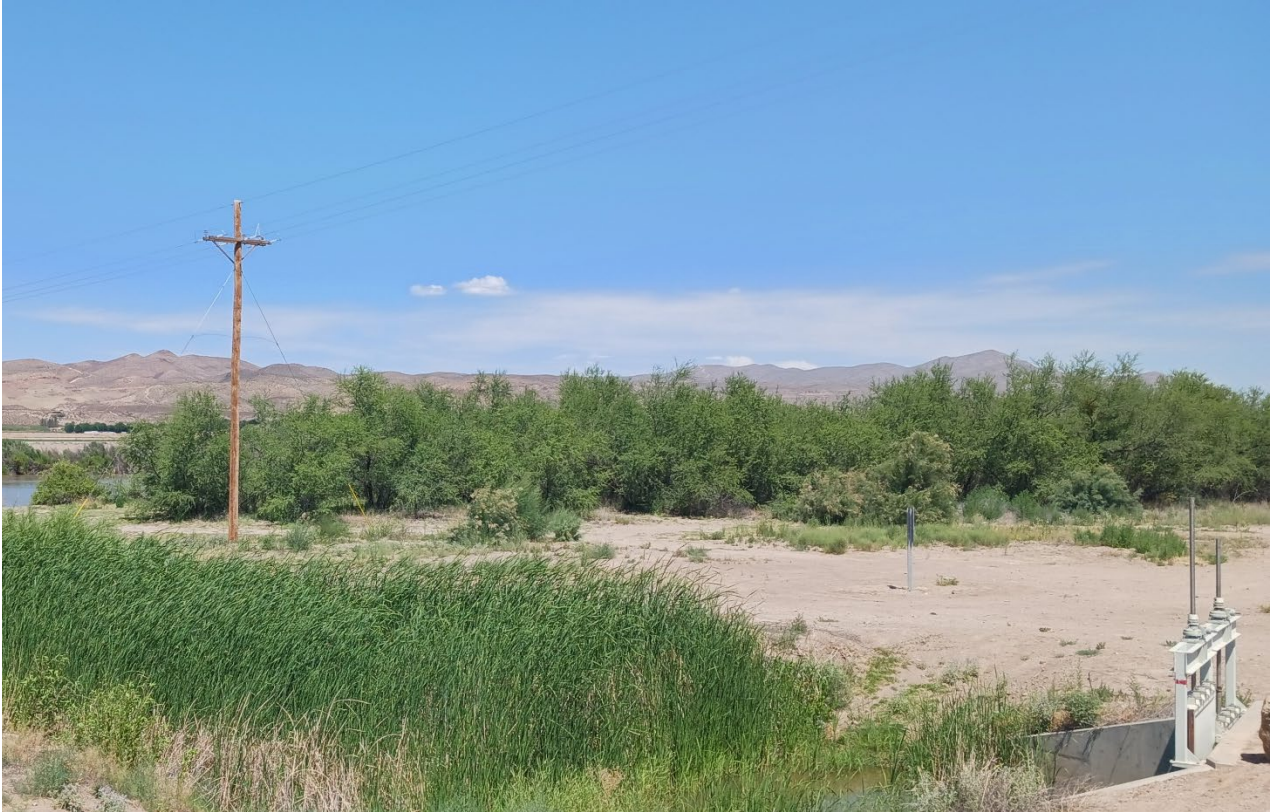
**We passed by Shalem Colony Restoration Site on July 11, 2023. This is the southern end of the site near Wasteway #5. Some saltcedar is resprouting and there are mature mesquites.**

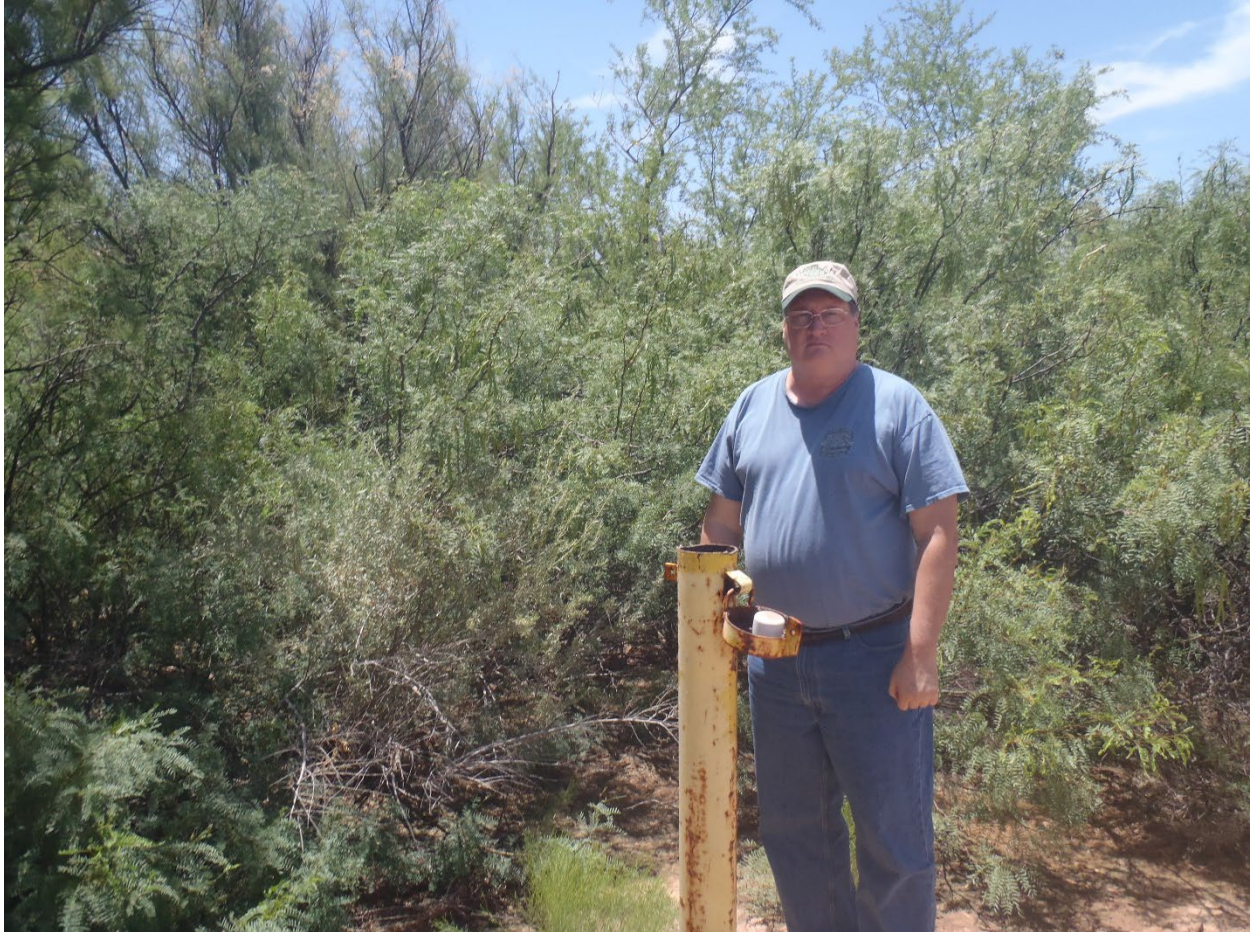
Mark and I visited Rincon Siphon No Mow Zone area on July 18, 2023. A lot of it was unfortunately inaccessible. The only 2 wells that had any visibility in the overgrown area was #7 and #4. Pictured above is RS-MW-7, and it was along the road leading up to it and very easy to access. In the picture you can see a lot of mesquite and some salt cedar, and the vegetation is engulfing the well site. This well is in the No Mow Zone outside of the Rincon Siphon Restoration Site.

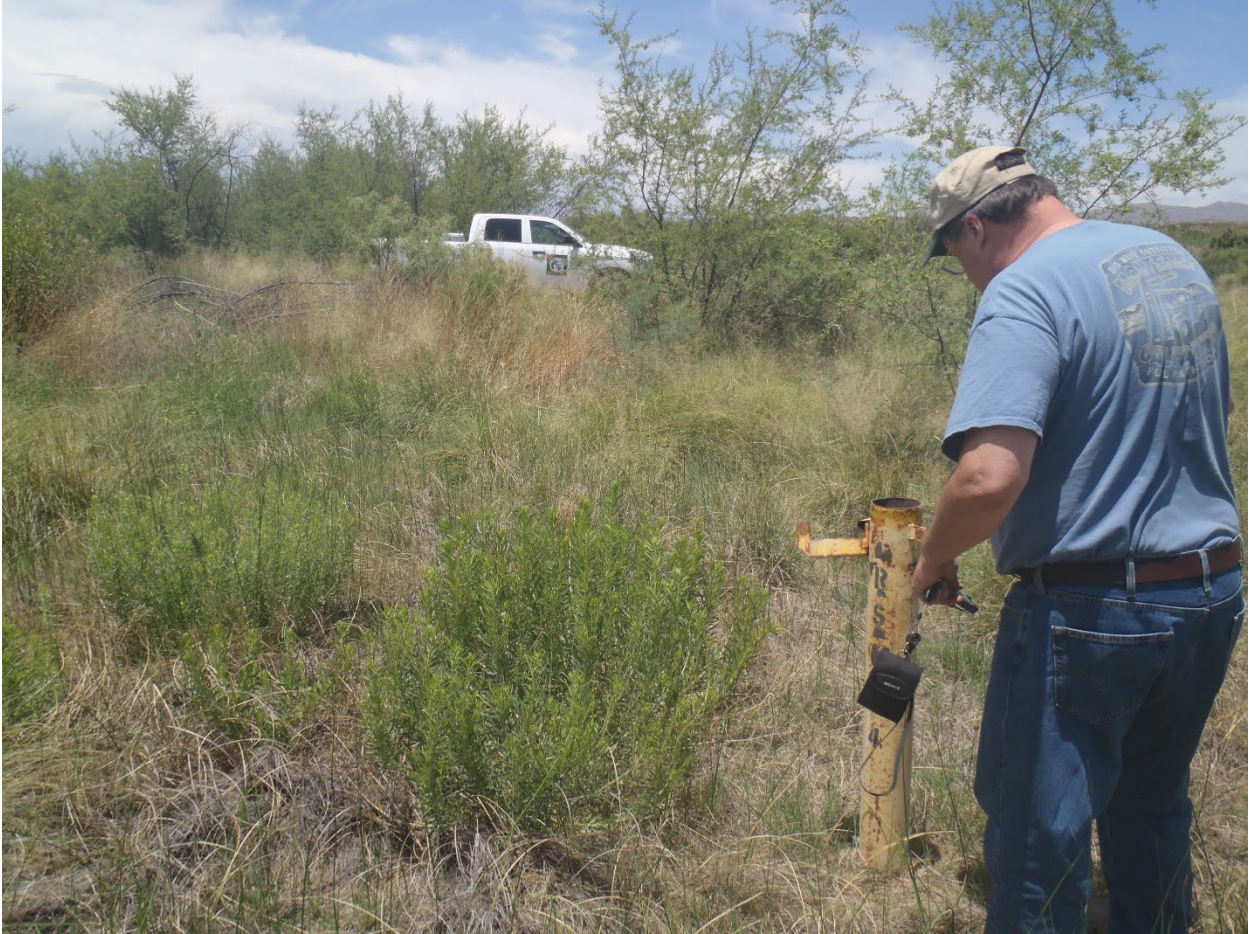
In and around the area was very thick with mud since the water table was so high.

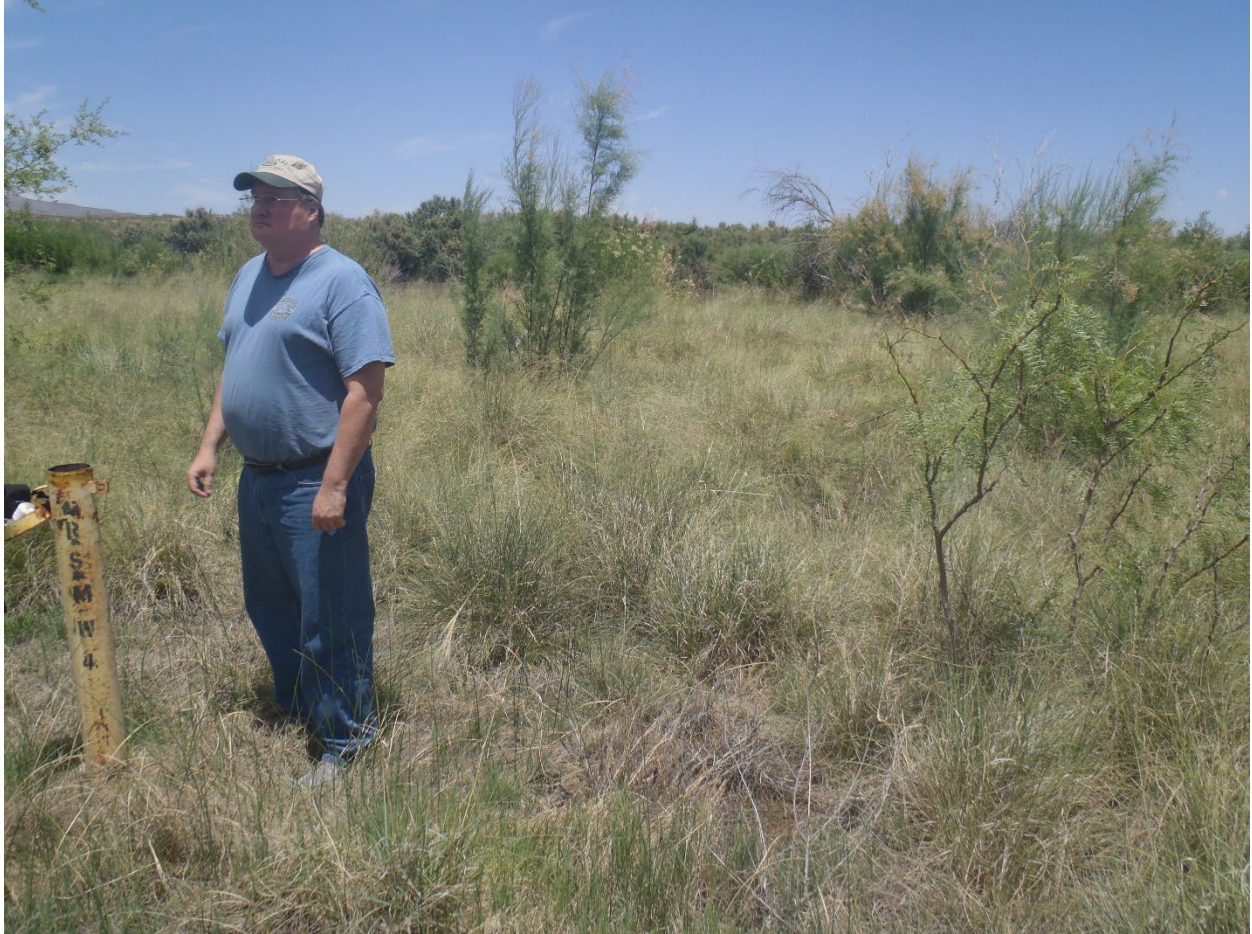
And as you can see there is a lot of native grass with different plants all surrounding the well. Bullrush is also present, indicating the shallow groundwater.

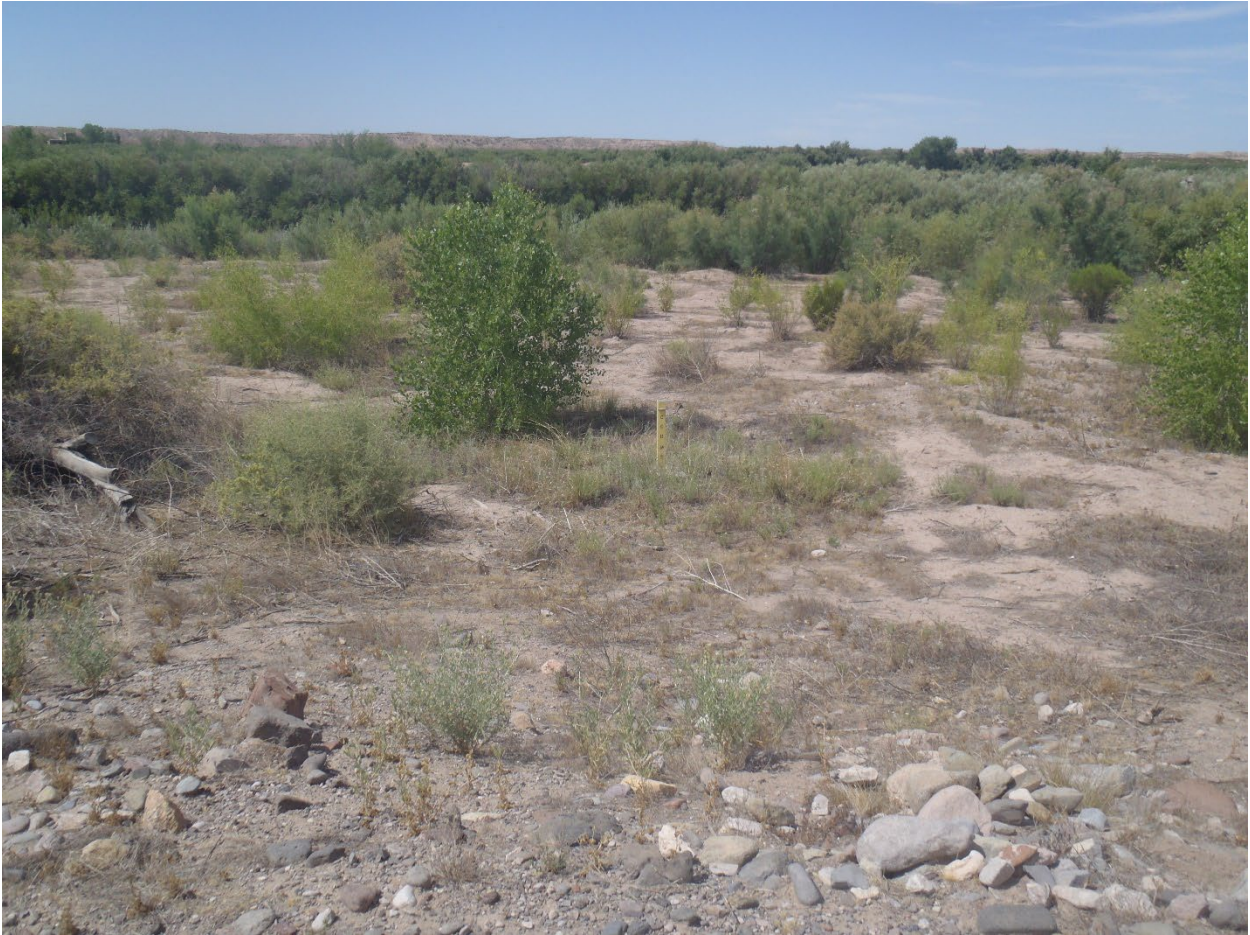
We visited Crow Canyon C on July 18, 2023. This was well CCB-MW-3 at Crow Canyon C. This site was targeted for dense riparian shrub habitat so it had more plantings than Crow Canyon A. We were overlooking a hill so you can see the riverbank just filled with coyote willow and shrubs here and there surrounding the well site.
