**USIBWC Habitat Restoration Sites and Groundwater Monitoring Wells**

**MONITORING NOTES AND PHOTOGRAPHS**

**SUMMER 2023**

**U.S. Section International Boundary and Water Commission**

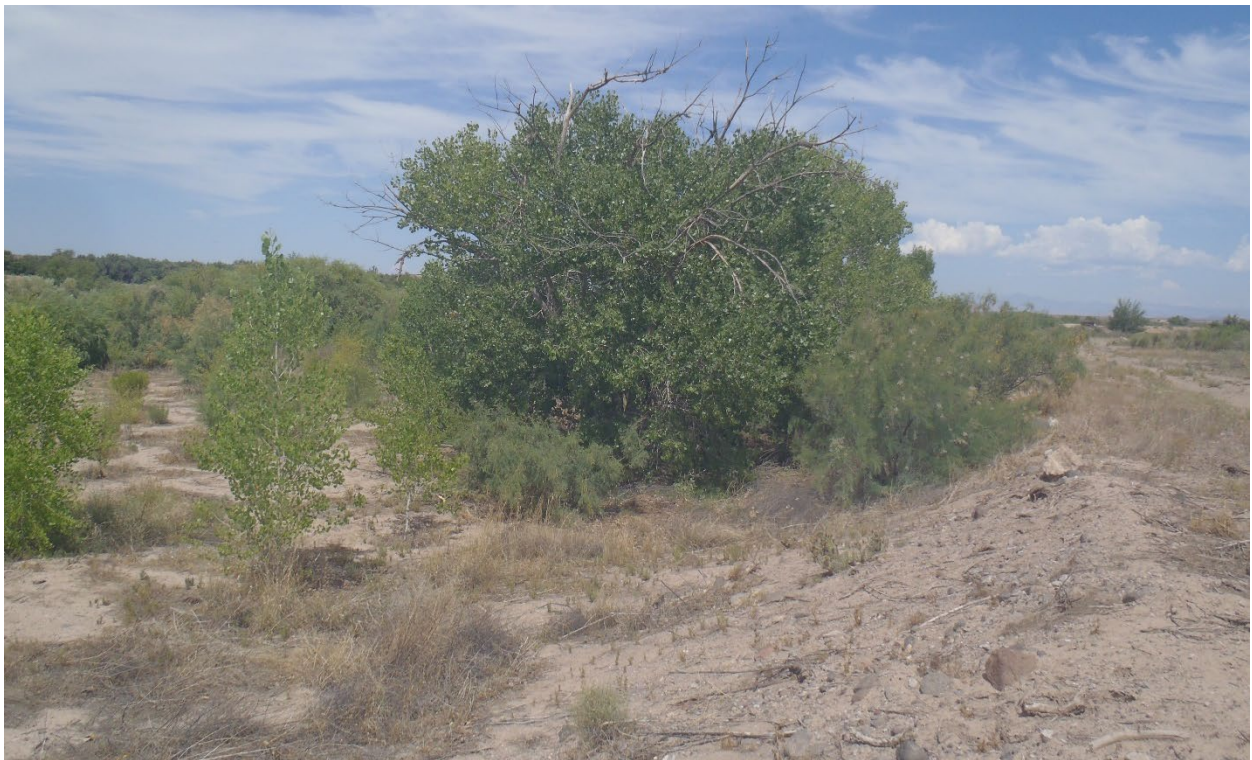
Looking down and to the right side of the well site. There is a massive old cottonwood with some smaller ones surrounding it. The smaller ones are plantings from 2017 and are surviving well at this site without irrigation.

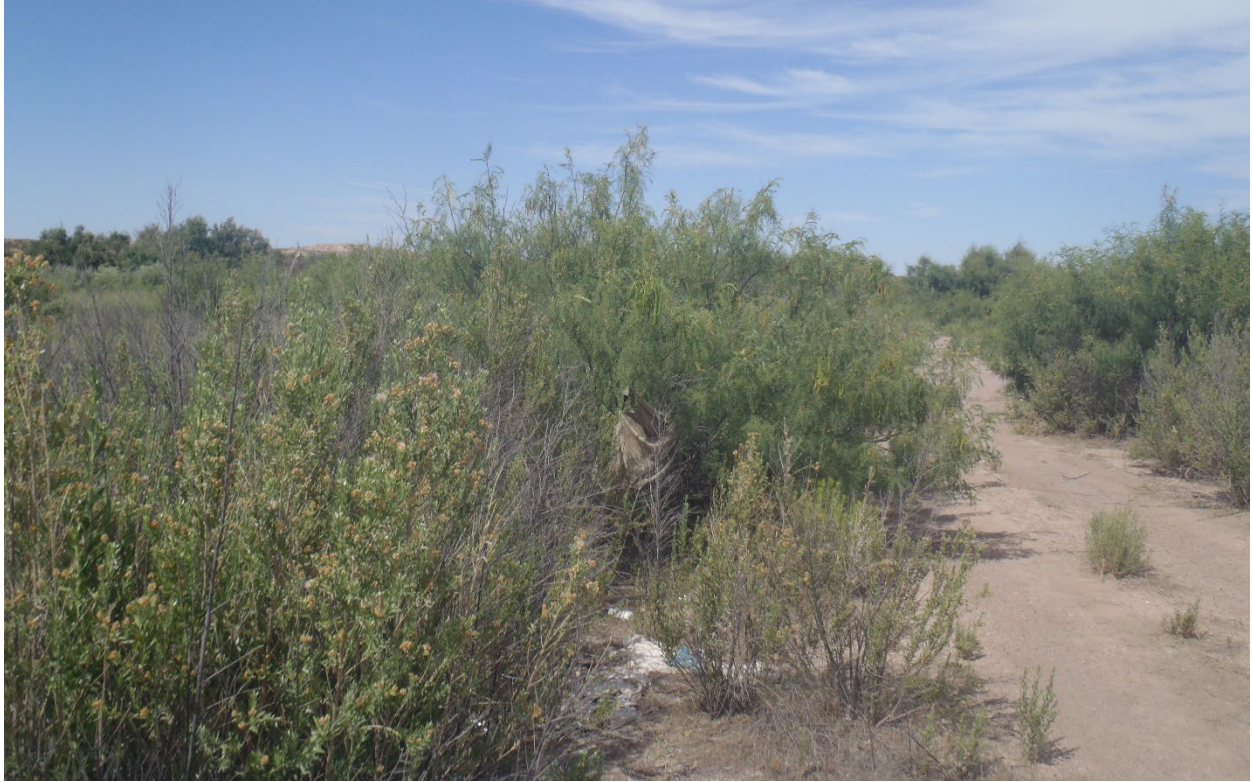
Road with some trash near the bushes. Some trash is visible.

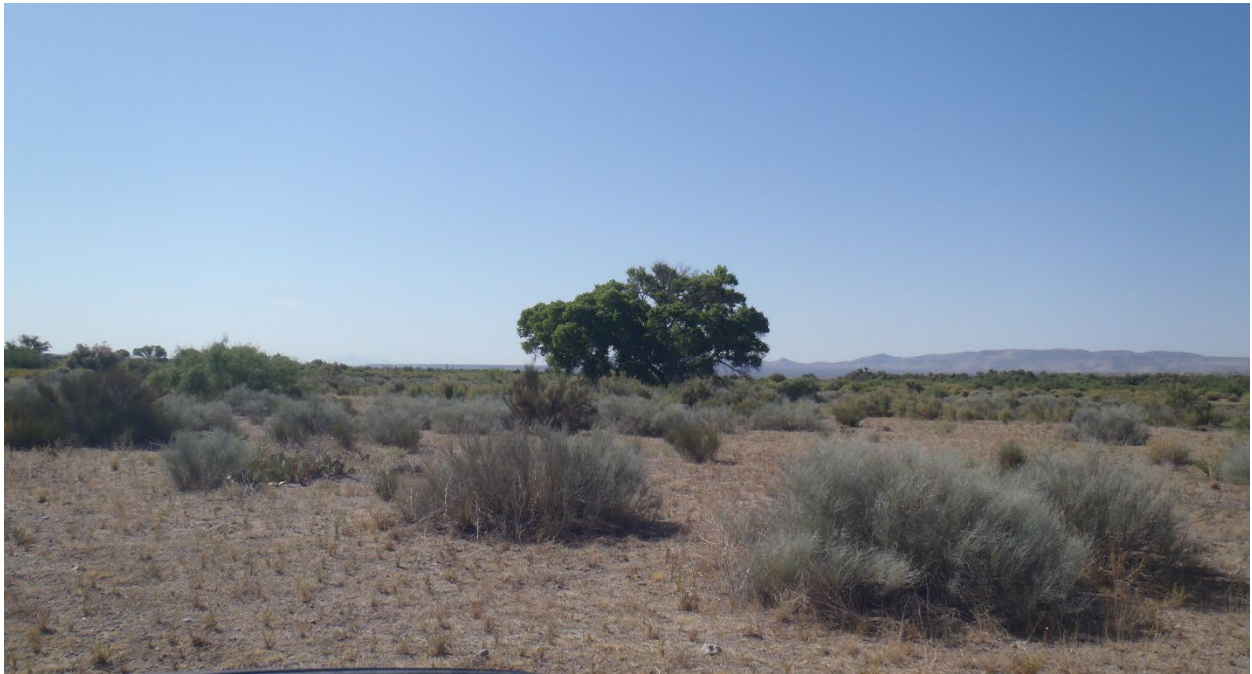
We visited Crow Canyon A on July 18, 2023. This is one of the first cottonwoods we spotted in Crow Canyon A. There was very little survivability of Cottonwoods in Crow Canyon A. Although Yeso East has close proximity to Crow Canyon, the target habitat types were different, so they are difficult to compare. Fewer cottonwoods were planted at Crow Canyon A than at Yeso East.

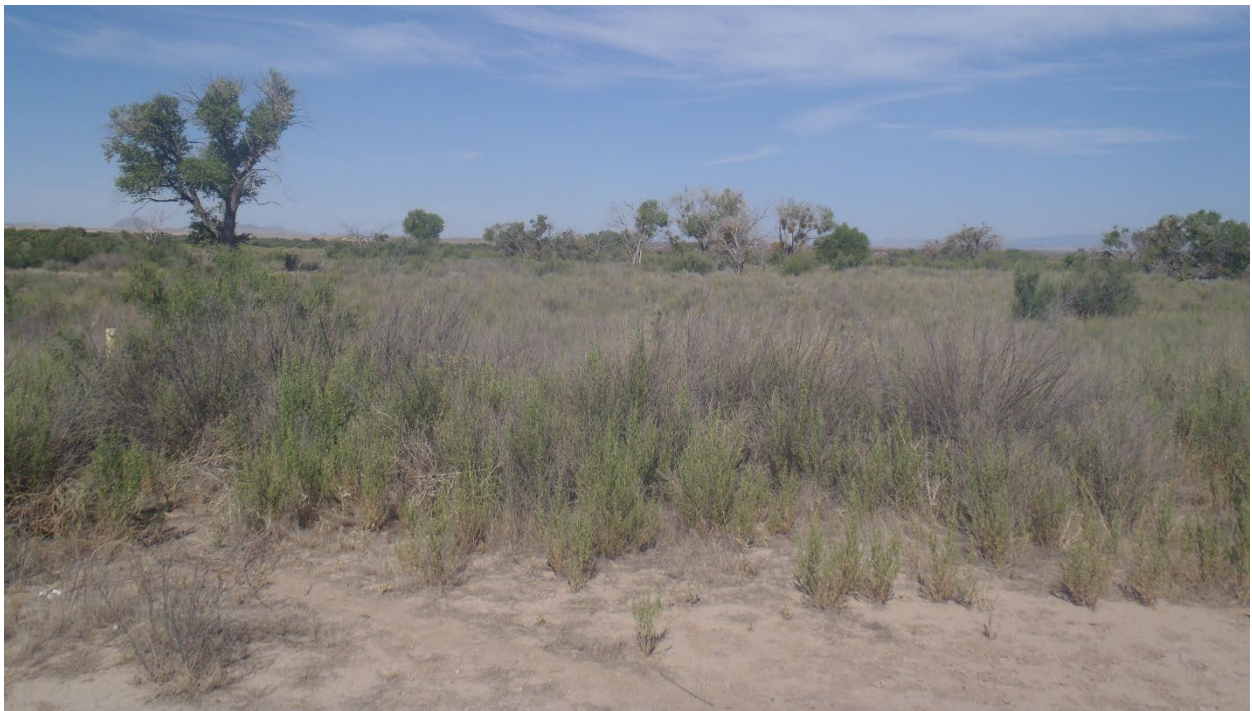
A better picture of the ailing cottonwoods.

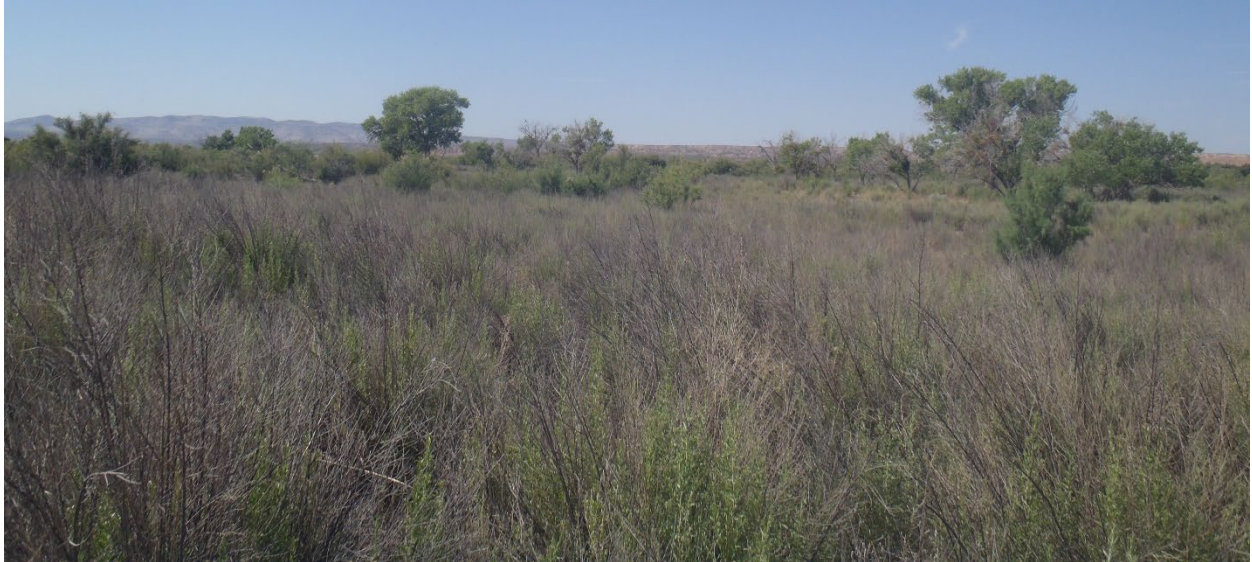
We can also observe the same pattern of dying plants on the left as well.

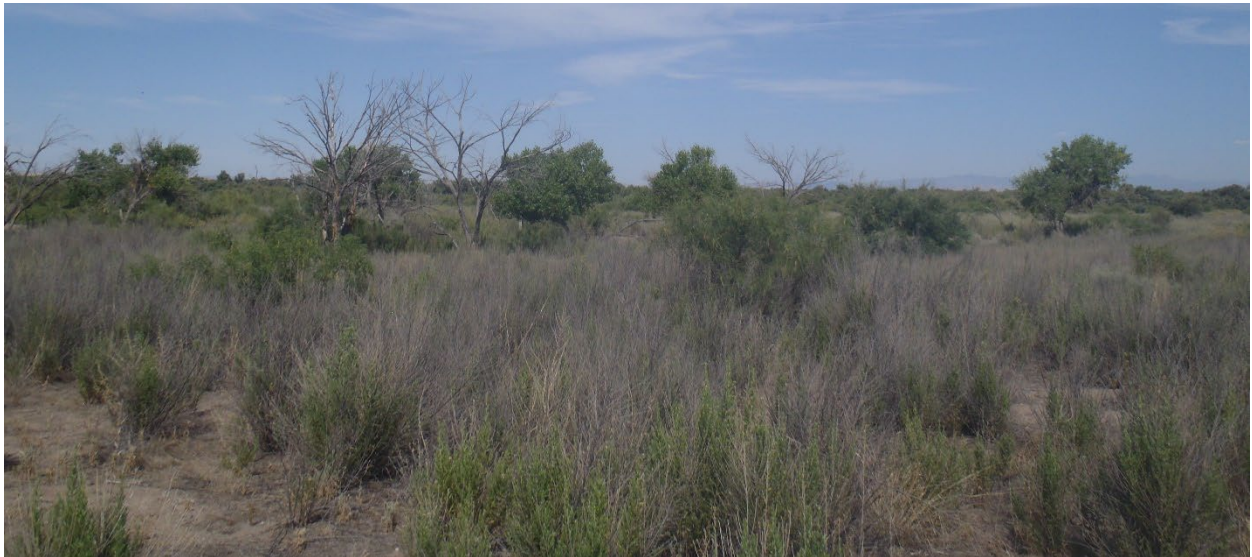
More dying cotton woods in Crow Canyon A, with mixed native and nonnative brush throughout the site.

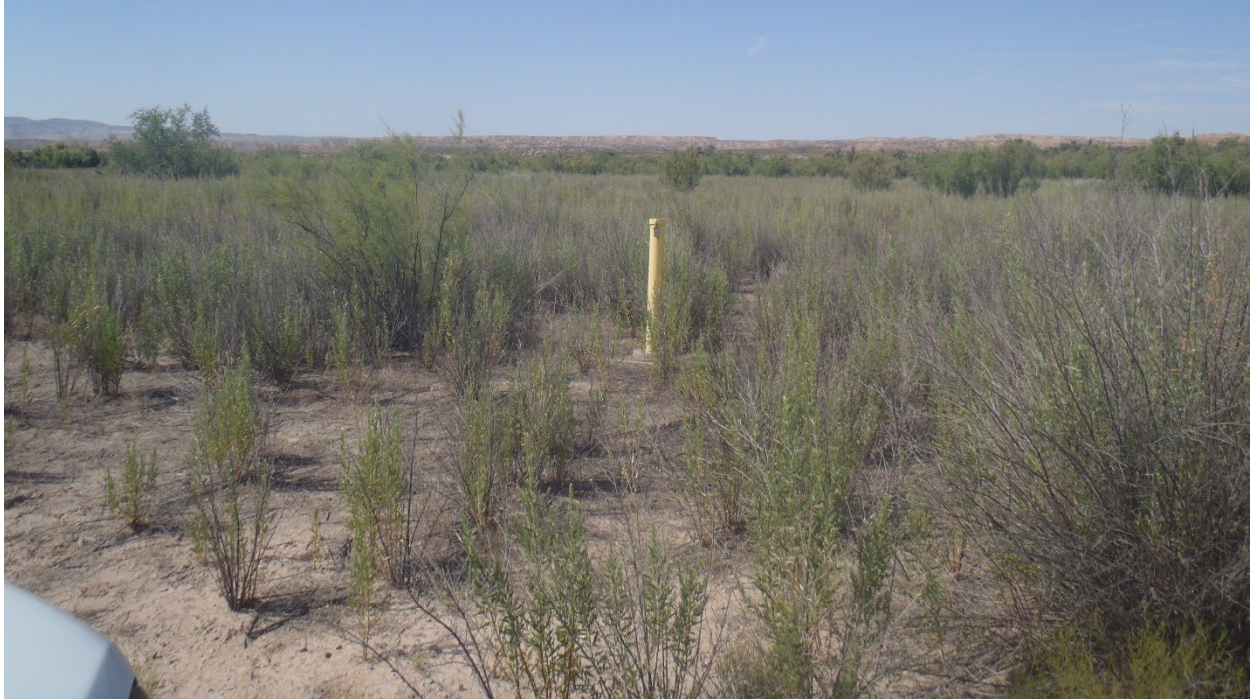
This was the well CCA-MW-1 that had the additional sonde. Unfortunately, it was not retrievable, and the well was obstructed so we couldn't get any reading on it.

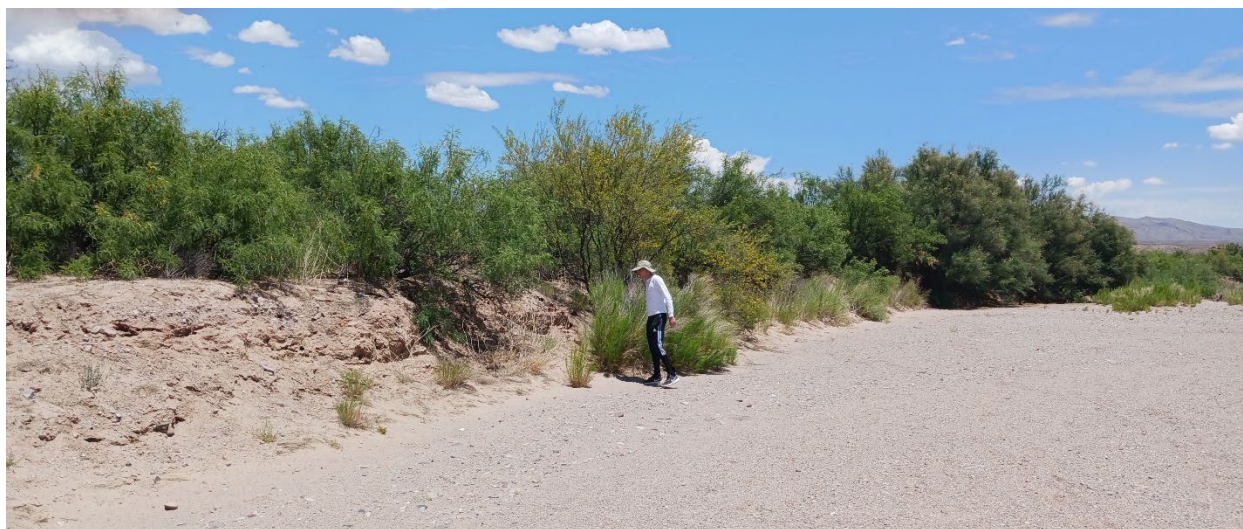
This is saltcedar and mesquite along the Arroyo Yeso. The Yeso West site was inaccessible.
