**Minute 323**  
**Colorado River Limitrophe and Delta**  
**Environmental Flows Monitoring**  
**Interim Report for 2018**  
**February 2022**

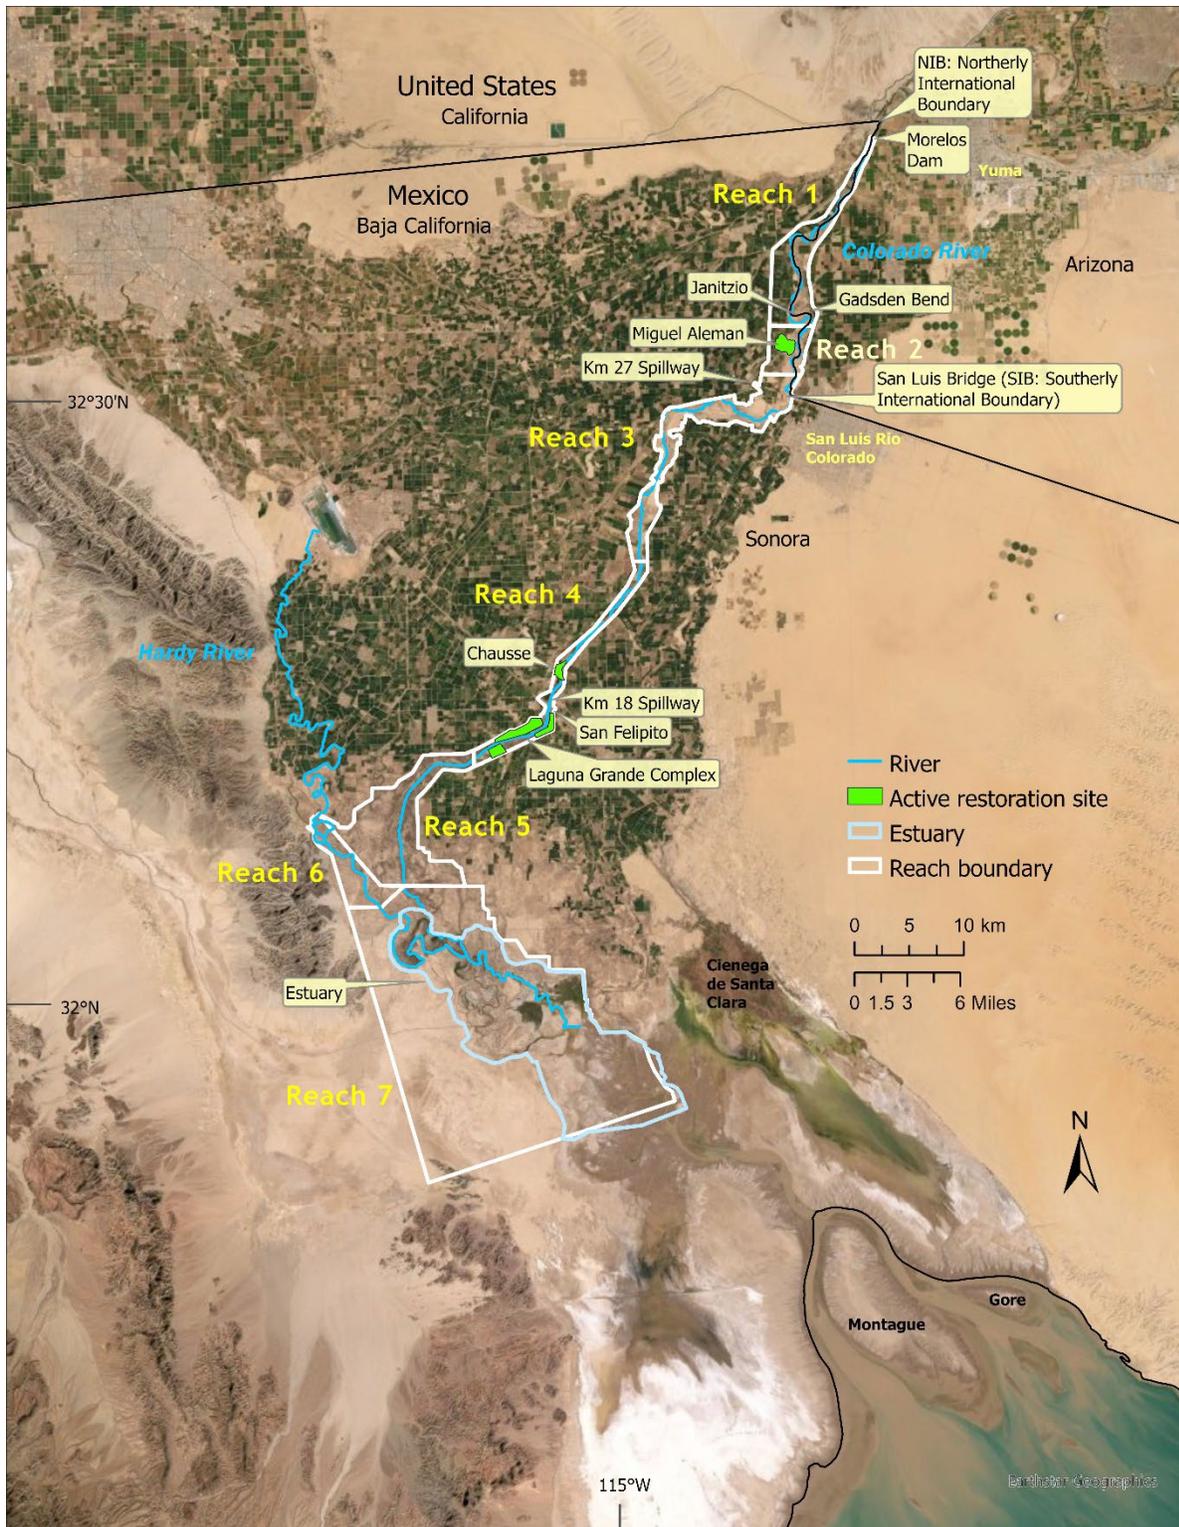
**Figure 1-1.** Colorado River Limitrophe (Reaches 1 and 2) and Delta reaches and locations mentioned in this report.

Ecological and hydrologic monitoring under the auspices of Minute 323 was conducted from January 1, 2018 to December 31, 2018. Monitoring activities were conducted in the Limitrophe and Delta (Fig. 1-1) by binational teams (Table 1-2).

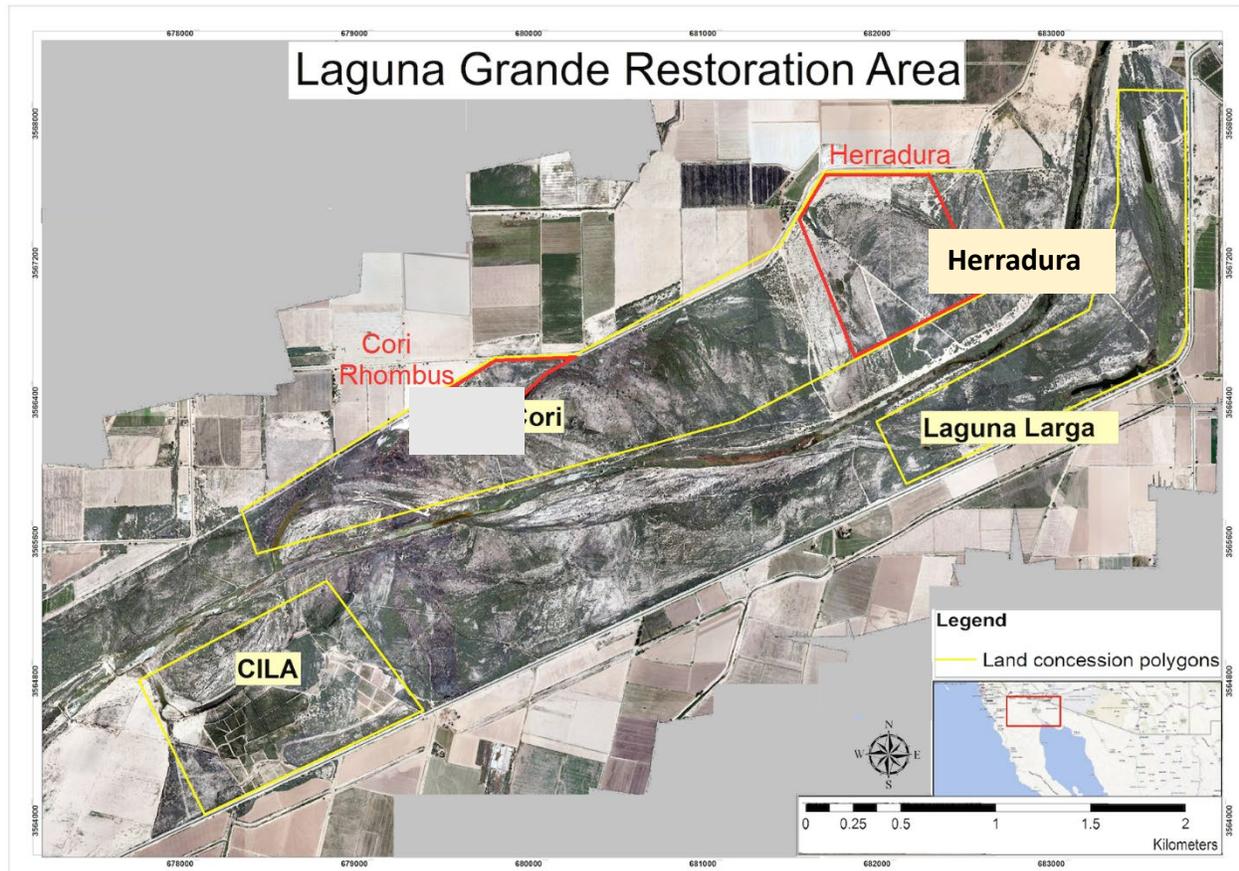
**Figure 3-2.** Map of the Laguna Grande restoration area and the three restoration sites discussed here: Cori, Herradura and CILA.

The Laguna Grande Restoration Area (Laguna Grande) is located in the central Delta region (Fig. 3-1) and extends from the railroad bridge (locally known as San Felipito) to about six river miles downstream. Laguna Grande consists of three separate land concessions (Mexican federal land designated for restoration)—CILA (115 ha/285 acres), Laguna Cori (318 ha/785 acres, which includes the Herradura and the Cori sites), and Laguna Larga (140 ha/345 acres) (Fig. 3-2).

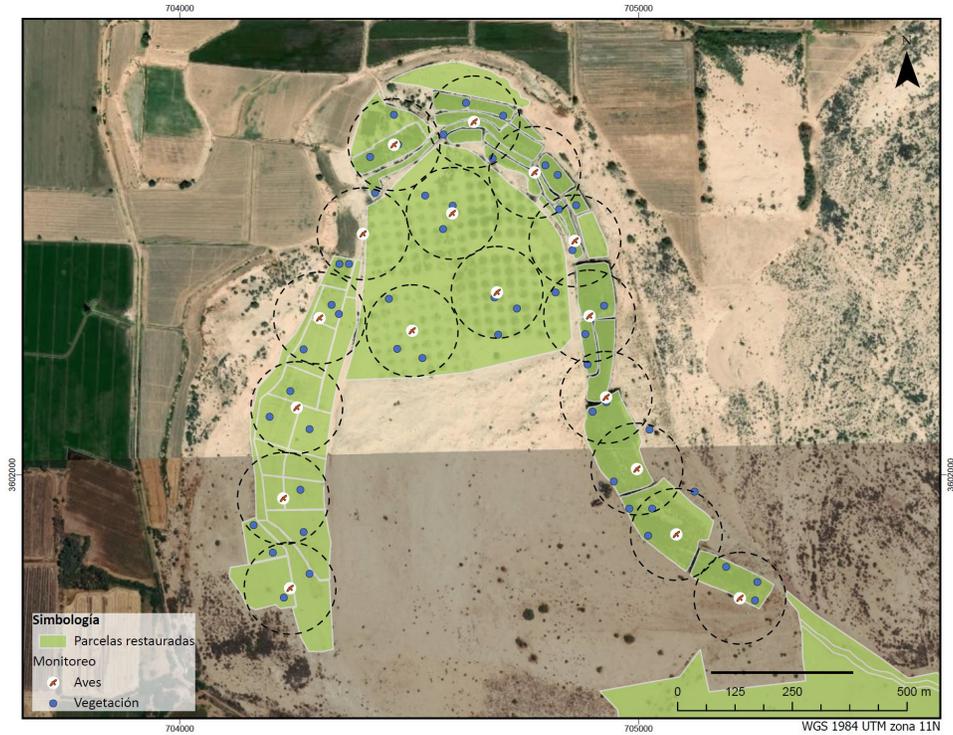
**Figure B-2.** The Miguel Aleman restoration site with 2018 bird and vegetation monitoring points. Bar above metric scale approx. 1000 ft.

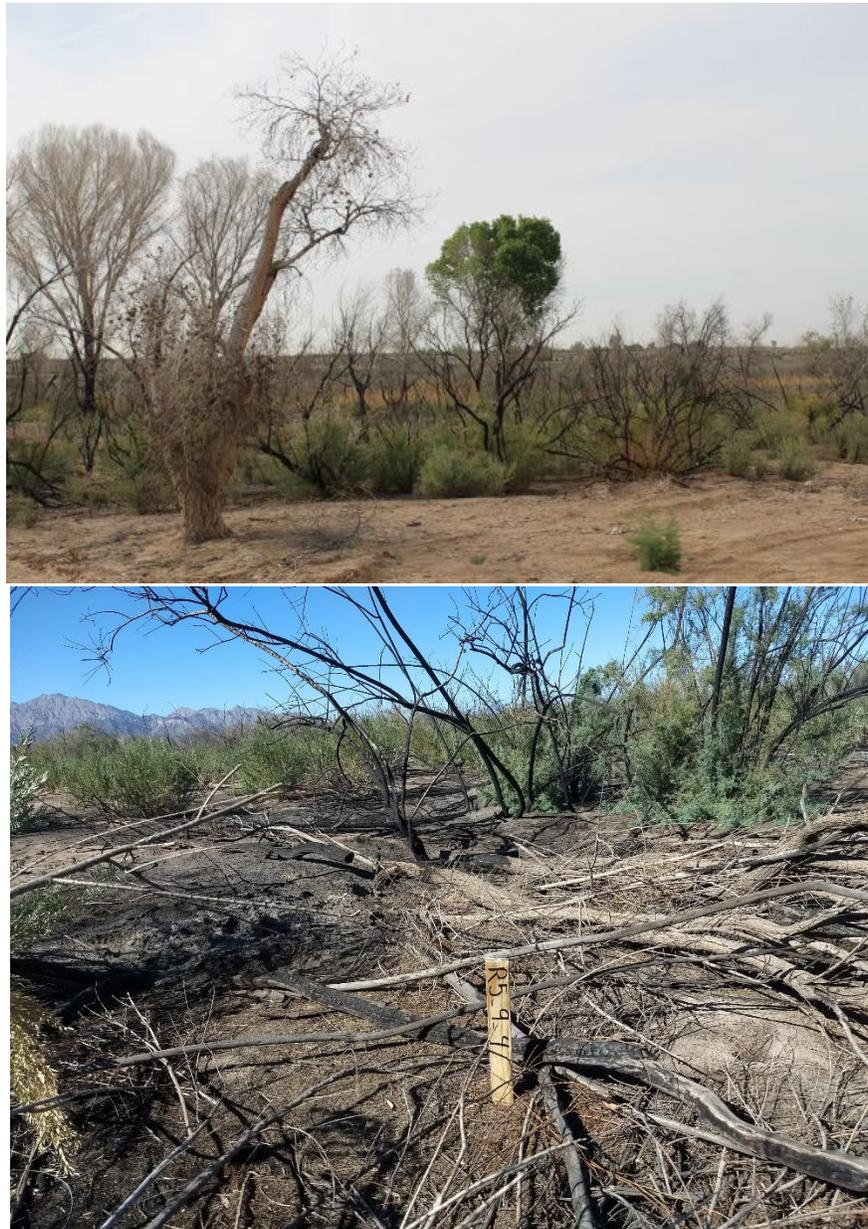
**Figure C-4.** *Top:* Control site 1 in Reach 1 showing burned vegetation after a fire that took place in early 2018 (image from March 2019). *Bottom:* Control site 9 in Reach 5 showing burned vegetation (image from November 2018).
